## SAINT ANTHONY'S CHAPEL FAÇADE PATHOLOGY DOCUMENTATION

Mario Gardiol<sup>1</sup>, Ana Maria Pighini<sup>2</sup>

**KEY WORDS:** cartography, interpretation, pathology, non-metric, low-cost

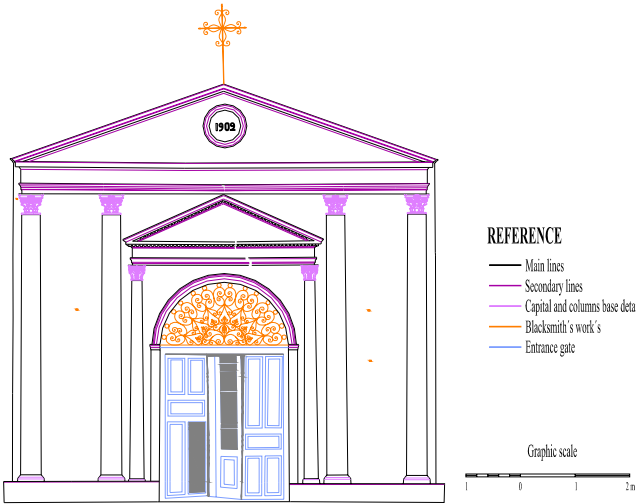
Figure 4. Morphologic features.

From the standpoint of morphology, the support base of the right columns is shorter than the support base of the left columns. The main entrance door has missing portions and has been poorly repaired. The capital of columns and the main details are well kept (Figure 4).

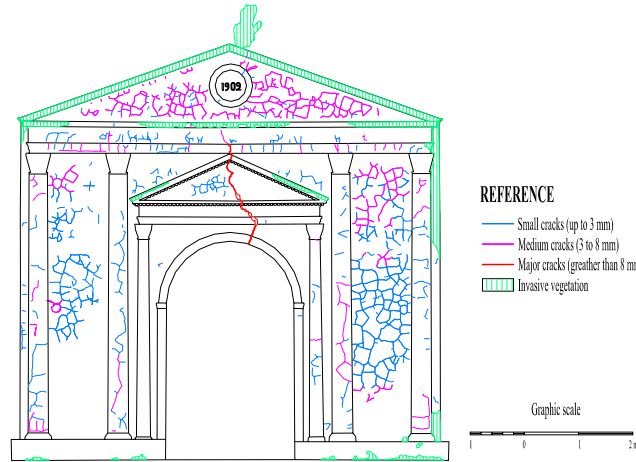
Figure 5. Distribution of cracks and invasive vegetation

With regards to pathologies, the major cracks are located mostly between the two main right-hand columns and in the upper triangle of the façade. Seemingly, the major crack, which is in fact a fissure through the brick, is affecting the structure of wall, since the façade details are displaced vertically. (Figure 5).

Invasive vegetation, such as lichen and moss, grows around the Chapel and now is on the edges of the façade upper triangle, and a lower amount of it can be seen in the small triangle. Grass and bracken has grown in the support base fissures. We also detected herbaceous plants on the roof, beside the cross.

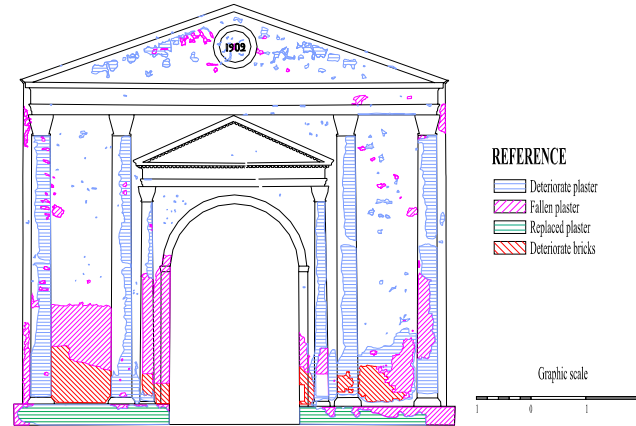
Figure 6. State of plaster

The fallen plaster, i.e. the exposed brick wall, is found chiefly in the lower section of the façade, and the most damaged areas are around its left side. These same sections are where deteriorated bricks show, and also where a few affected areas have been put plaster on in recent years.

Deteriorated plaster is seen almost in every area of the façade. Nevertheless, when we look at the four main columns, it is noticeable that their right-hand sides are the ones which present deteriorated plaster. This situation might be explained by the fact that the Southern wind is the prevailing wind in that region and, consequently, the column sides facing South are more severely affected than its other sides. (Figure 5).
