低碳高硫易切削钢冷加工开裂分析

(青岛钢铁控股集团有限责任公司, 山东 青岛 266043)

摘要:通过金相显微镜和扫描电镜分析,发现低碳高硫易切削钢开裂的原因为钢材近表面的大颗粒夹杂物。大颗粒夹杂物中含有Zr、Na、Mg等元素,是冶炼过程水口和耐火材料的严重侵蚀及保护渣卷渣造成的。

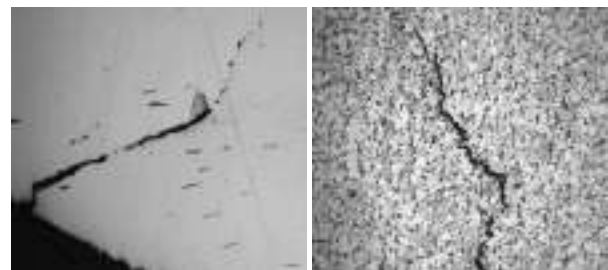
图1 近表面夹杂物 50× 图2 裂纹处组织 500×

试样横截面高倍显示:裂纹长560 μm且裂纹

周围及试样近表面存在大量大颗粒夹杂物,见图1;横截面最长夹杂物长70 μm,纵向长度因无法定位切割未测量;裂纹处金相组织为F+P,为正常组织形态,见图2。对试样进行常规项目检验,分析结果显示:钢材的组织为F+P,晶粒度为7.5~8.0级,心部纵向夹杂物评级为A>3级、D 0.5级,均符合要求。而图1所示分布在钢材近表面的大颗粒夹杂物属于异常现象,在盘条的常规生产检测过程中,钢材的横截面不应出现大颗粒夹杂物。

通过对试样进行高倍显微镜分析和扫描电镜分析得知,引起开裂的原因为钢材近表面存在大量大颗粒夹杂物。大颗粒夹杂物主要是在冶炼过程中,现场操作人员对水口、保护渣和耐材的在线检测不及时,发生侵蚀现象时没能及时发现,使被侵蚀掉的杂质带入钢液中而形成。

在冷拉拔过程中大颗粒夹杂物难以变形,在基体变形的同时,大颗粒夹杂物受到周围基体的挤压,在拉拔方向承受拉应力断裂形成微裂纹;同时由于大颗粒夹杂物与钢材基体的塑性不同,在变形过程中,大颗粒夹杂物与钢基体之间也会形成微裂纹^[4]。随着拉拔的进行,应力沿微裂纹得到释放产生裂缝^[4];因大颗粒夹杂物沿纵向断续分布且处于近表面,所以在拉拔过程中,裂纹会随着拉拔的进行持续扩展、放大,于是就产生了沿材料拉拔方向的长裂纹,造成材料报废。

钢材近表面的大颗粒夹杂物在拉拔过程中容易导致材料发生开裂,而大颗粒夹杂是由冶炼过程中卷渣造成的。低碳高硫易切削钢在冶炼及浇铸过程中极易出现卷渣现象,使盘条内部存在大颗粒夹杂物,所以在冶炼及浇铸过程中应采取防范措施,并加强对成品盘条中横向大颗粒夹杂物的检测,保证出库盘条的质量。

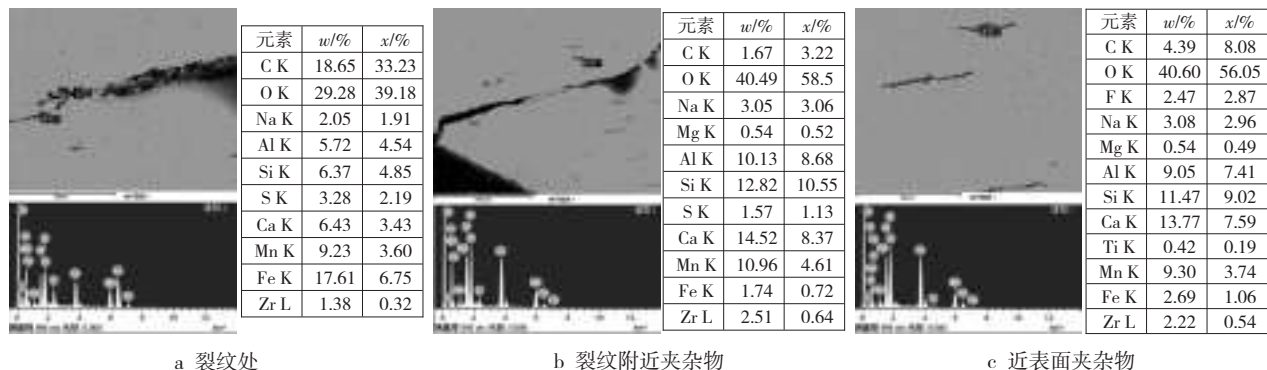
图3 试样扫描电镜及能谱分析结果(横向)

对试样横向裂纹处、裂纹附近以及近表面的大颗粒夹杂物进行电镜扫描及能谱分析,检测结果见图3(其中w为质量分数,%;x为原子分数,%).

电镜扫描结果显示,横向裂纹处、裂纹附近以

及近表面夹杂物的元素较多。还存在外来异常元素,如Zr、Na、Mg等,这些元素成分与冶炼环节中的水口、保护渣和耐火材料等有关^[3],说明冶炼及浇铸过程存在水口和耐火材料侵蚀及保护渣卷渣等异

常现象。
