# 锅炉旋风分离器中心筒失效分析

**摘要:**锅炉旋风分离器中心筒上部吊挂腰筋和腰筋附近的筒体开裂,筒体上大面积出现蜂窝状剥落坑,筒体变径处出现大量贯穿性孔洞。采用化学成分分析、宏观和金相检验等方法对中心筒进行了分析。结果表明,中心筒焊补区存在未熔合缺陷,裂纹在未熔合缺陷处萌生和长大形成宏观裂纹,导致材料失效;中心筒存在许多铸造皮下气孔,此为形成剥落坑的主要原因;剥落坑附近析出许多块状和棒状碳化物,在晶界处有链状碳化物,这是产生宏观剥落坑的诱因。

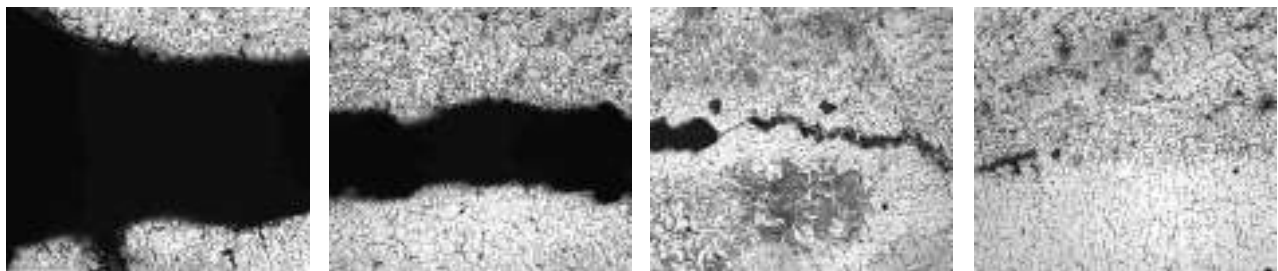
图1 焊补区裂纹及其两侧组织形貌 100×

分别在焊补区、剥落坑处及表面无明显缺陷处取金相试样进行检验分析。首先在焊补区取样做金相检验分析,试样表面有清晰可见的裂纹。在显微镜下观察发现,裂纹两侧组织有明显的差别,存在未熔合缺陷,裂纹沿熔合线扩展,如图1所示。

a 未熔合区附近的裂纹形貌      b 未熔合区的微观形貌      c 裂纹沿熔合线扩展的典型形态      d 裂纹尖端处熔合区的组织特征

通过金相检验可知,该中心筒的裂纹主要在焊接区形成,焊接区存在未熔合缺陷,未熔合缺陷为裂纹源,裂纹在此形成并沿熔合线扩展。现场勘验发现,多数裂纹均发生在焊接部位,包括加强筋在内的焊接部位均有不同程度的开裂。这是因为焊接区是2种金属的过渡部分,为组织薄弱区。裂纹在这些组织薄弱区或未熔合缺陷处容易萌生和长大,最后形成宏观裂纹导致材料失效。

4.2 中心筒焊补区存在未熔合缺陷,未熔合缺陷是裂纹源。裂纹在未熔合缺陷处萌生和长大形成宏观裂纹,导致材料失效。此为产生裂纹的主要原因。
