VISIBLE AND THERMAL IR DOCUMENTATION OF A MASONRY BRICKWORK BUILDING

J.L. Lerma^a, C. Mileto^b, F. Vegas^b, M. Cabrelles^a

Figure 1. Country house

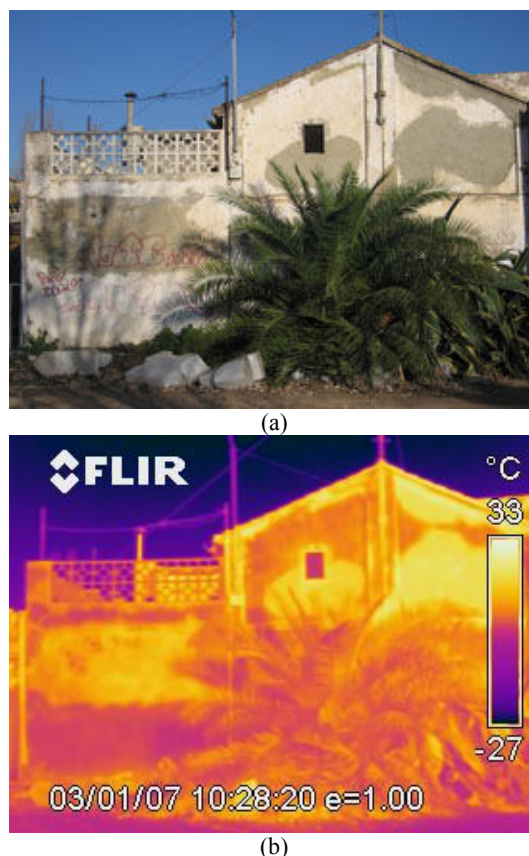
Figure 3. Southern façade: (a) Visible; (b) Thermal IR.

This section shows different building inspections on the aforementioned country house, corresponding to both inner and outer building parts. The first set of images (Fig. 3) tackles the southern façade. They were taken on a sunny day, late in the morning and in January, 2007. It is obvious on both images the lack of whitewash due to the partial cement mortar rendering. Meanwhile this difference in colour is apparent on the visible image (Fig. 3a), the thermal one (Fig. 3b) shows cement mortar areas warmer than their surroundings. Metallic features such as tubes behave in a similar way.

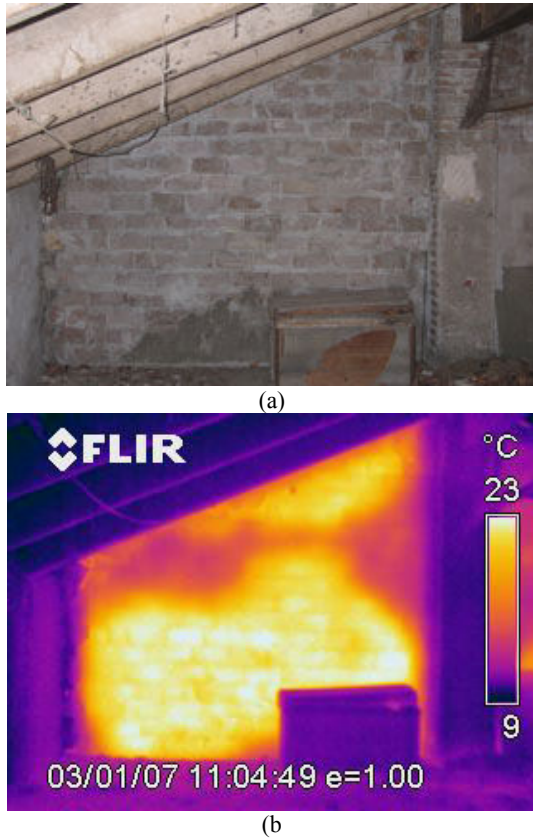
Figure 4. Outer wall pictures taken from the first storey: (a) Visible; (b) Thermal IR.

Analysing the same façade from inside, first storey (Fig. 4), similar results are obtained for the thermal image in spite of spatial resolution (Fig. 4b). However, the information regarding this heat transfer difference is not achieved at all from the visible image. This thermal image would suggest some need of painting to avoid heat losses in the future. Bricks structure is well-defined in the visible image and can also be guessed from the thermal IR image. On the other hand, mortar rendering on

this side of the wall does not affect heat transfer from the exterior of the building. Particularly interesting is the cool stripe area on the left hand side of the image reflecting some moisture presence in the corner. Besides, wood trunk's cover shows thermal differences because of the inner framework.

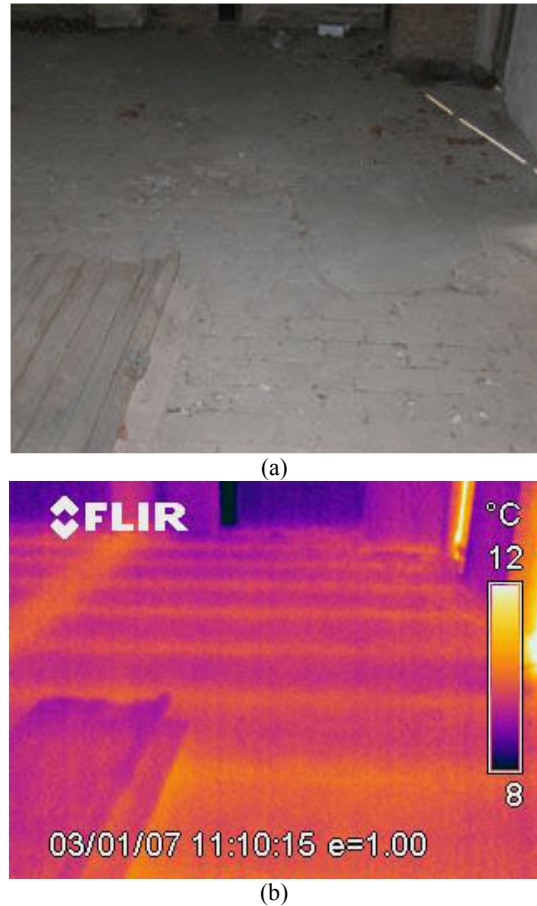
Figure 5. First floor pictures taken from the first storey: (a) Visible; (b) Thermal IR.

Next set of images was taken inside and empty room on the first storey in order to reflect the floor structure of regular beams. It was even possible to report beams by means of thickness. Fig. 5 shows one out of seven pairs of images (visible and thermal), used to build up a vector map about the structural analysis on this level (Fig. 6). For that purpose, visible images were rectified without control points by making use of a wooden square target and mosaiced to create a continuous raster image. In a similar way, thermal IR images were also rectified over the visible mosaic to overlay beams drawings (in AutoCad format).

It is interesting to notice how the heat transfer from the beams is transmitted outwards in a way that is hardly dependent on upper materials with small thickness (diameter smaller than 4 cm) such as bricks and plaster.

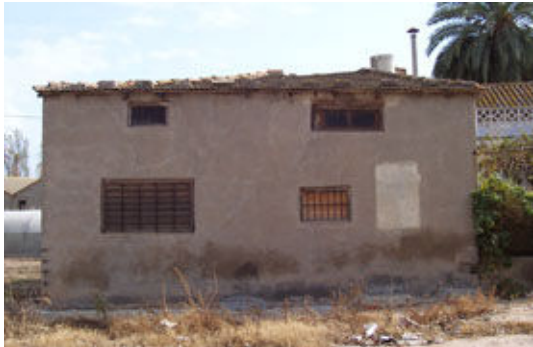
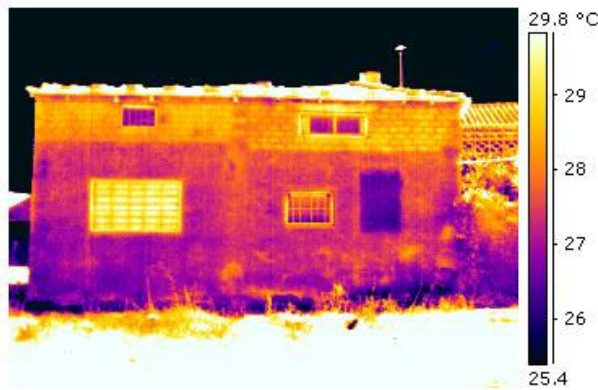
Figure 7. Western façade: (a) Visible; (b) Thermal IR.

The last set of imagery was taken on the same building but on the Western façade (Fig. 7). They were shot in the morning before midday. The visible image allowed us to inspect the outer part of the building, finding a cement mortar wall with a

clear walled up (rendered with different colour on the right), four windows and some moisture shapes, some of them invisible to the eyes. Additionally, it was possible to locate some attachments near the ground as well as some plaster detachments. The thermal image also allowed us to both differentiate brickwork activities on the façade (the layout of the upper fourth of the wall is neatly different to the rest), and identify a pilaster in the middle of the facade, as well as some moisture spots as well as some water channels.

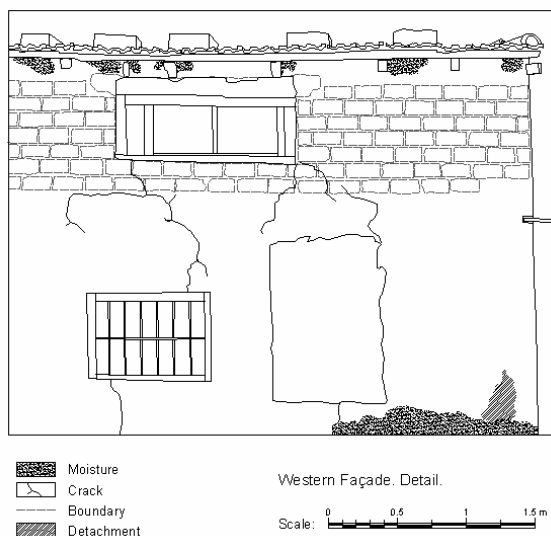
Figure 8. Drawing of the upper right part of the Western façade.

After rectification and merging of the visible and thermal IR imagery, it was possible to draw a vector elevation map with alterations and damages on the façade (Fig. 8).
