LASER SCANNING FOR HISTORICAL AND GEOTECHNICAL STUDIES AT POINTE DU HOC

R.B. Warden^{a,*}, R. Burt^a, J-L Briaud^b, M. Everett^c

^a Texas A&M University, Center for Heritage Conservation

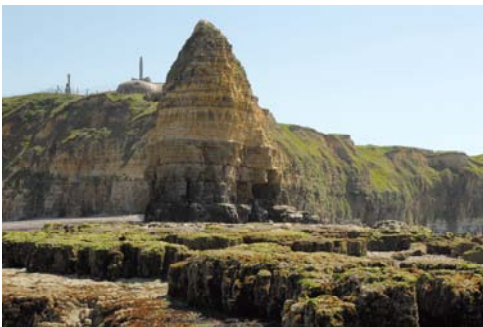
Figure 1: Observation Post and Cliff

For most tourists the memorial and the O.P. are the most significant objects of Pointe du Hoc. In 2001 the O.P., with its close proximity to the cliff edge, was closed to tourists because of concerns emanating from various collapses of the cliffs. This decision separated the most symbolic elements of the site from the public, but more importantly it created a debate over what, if anything should or could be done, to save the signature building and its Ranger Memorial from falling victim to a future cliff collapse.

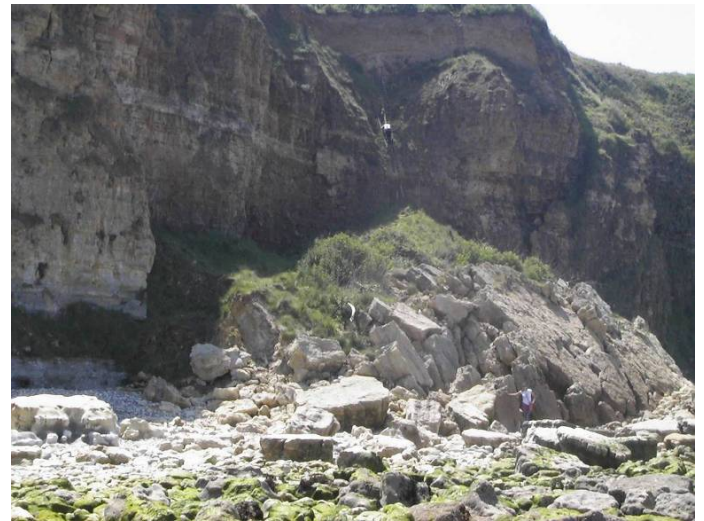
The site reconnaissance revealed the following observations: The O.P. which is nearest to the cliff edge appears to be intact; however, some cracks in the O.P. walkway and entrance stairs were identified. Massive rock failures (Figure 2) were observed along the beach, all of them had a vertical plane of failure. The West side of the cliff head was found to be more concaved than the East side; this may indicate that the predominant wave and wind direction is from the west. The rock bedding is nearly horizontal, dipping down towards the north with an approximate angle of 5°. Fresh water seepage from the cliff face was noticed in several places at a level of approximately 2-3 m above the base of the cliff and sometimes higher. The predominant conjugate perpendicular joints on the West side of the Pointe appeared at an orientation of Azimuth angles 30° and 120°, yet on the East side, another set of conjugate perpendicular joints appeared at an orientation of Azimuth angles 0° and 90°. The observed joints' spacing ranged between 1 and 2 m. On the East side of the Pointe, just under the O.P., two extended joints appeared at the cliff face with the possibility that they coincide with the O.P. walkway cracks. Some large size undercutting and caverns were found to have heights up to 3.5 m and depth (i.e. perpendicular to the cliff face) from 3 to 4 m (Figure 3). The high tide level may reach up to 3 m from the cliff base at some locations and the waves may add another 6 m of water attack above that. Calculations of the erosion rate over the years from aerial photos indicate that at the most aggressive locations, the Pointe Du Hoc site experienced about 10 m of erosion due

to collapse over the last 56 years (from 1944 to 2000), or an average erosion rate of 0.18 m/year. This erosion rate is consistent with the numbers found in the literature.

Figure 2: Massive collapse about 300m west of the O.P.

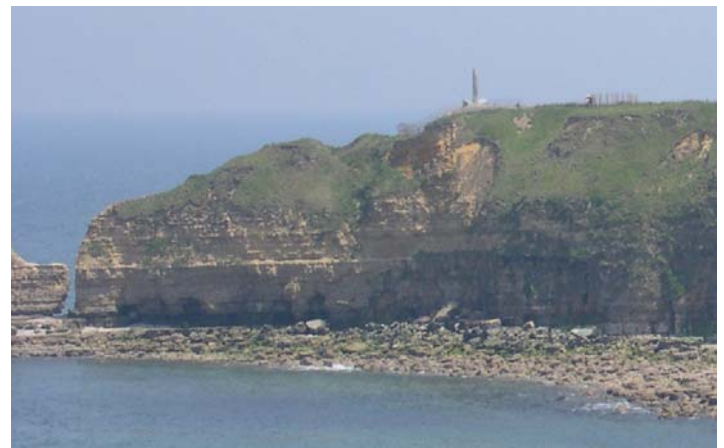
Figure 3: Caverns near the Observation Post (West side)

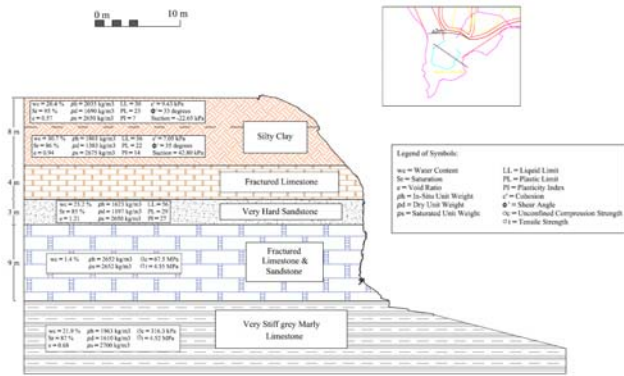
The reconnaissance work included the drilling of six bore holes numbered from B1 to B6 to a depth of 30 meters. B1 and B3 were equipped with piezometers and B4 was equipped with a settlement benchmark. B1 and B5 were core drilling boreholes, and the rest of the boreholes were destructive drilling. In the destructive boreholes, the following drilling parameters were recorded during the drilling: instantaneous penetration speed, pressure on tool, rotation torque pressure, and drilling fluid injection pressure. One part (12 samples) of the intact samples taken during soundings B1, B1', and B5 was sent to the FUGRO Geotechnical Laboratory in France. The second part (10 samples) was sent to Texas A&M University, College Station, Texas, USA. The boring logs lead to the stratigraphy shown in Figure 4.

Figure 4: Stratigraphy and soil/rock properties at boring B1

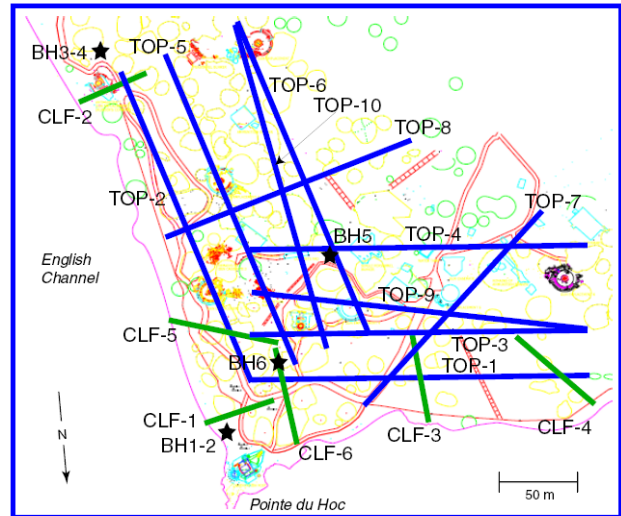
Figure 5. Pointe du Hoc 2006 Geophysical Site Map

A grid of ten top-side and six cliff-side multi-resistivity (MER) profiles were acquired (Figure 5). Two-dimensional resistivity fence diagrams have been assembled, from which suggested routes of groundwater infiltration into the fractured chalk are identified. We provide final 2D geological interpretations of the individual MER profiles and a quasi-3D synoptic interpretation based on the fence diagrams. We also present a fully 3D resistivity tomogram constructed from the entire data set, along with an interpretation of the tomogram in terms of the geostability hazard.

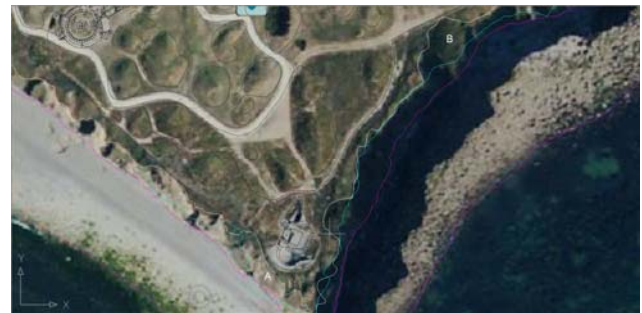
Figure 6: Cliff Line Comparison

Cliff retreat inferred by the physical evidence has been corroborated through study of historical aerial photographs. By marking cliff edges on photographs taken prior to German construction and allied bombing and comparing those lines with current edges marked through 3D laser scanning we discovered those portions of the cliff edge that have registered the greatest retreat. It is clear from photographic study that failures occur sporadically with some portions of the current edge matching closely with historical edges while other portions show a retreat in some areas up to 7–10 m over the last 60 years. Clear photographs are difficult to obtain in every decade but we were

able to verify that failures in two key areas were not significant until after 1966.

The two areas are indicated in Figure 6. The area marked “A” near the Observation Post (O.P.) is on the east side of the point stack. The area marked “B” is on the west side of the stack about 85 m east of the O.P. The cyan line marks the outline of the cliff-top in 1942. The white line marks the current outline of the cliff-top as given by laser scanning while the magenta line marks the cliff-base from the laser scans. On the east side at “A” we see a significant loss of cliff-top (difference between white and cyan).

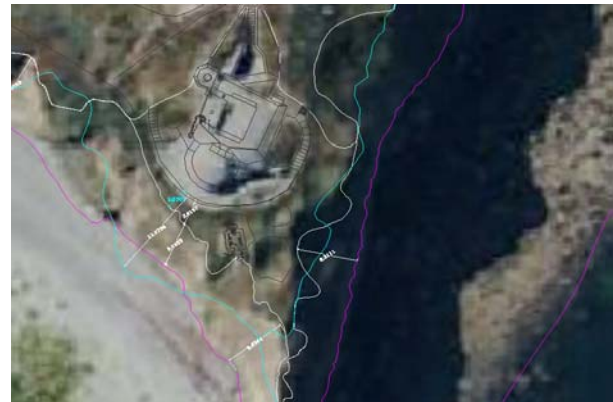
Figure 7: Cliff Edge Dimensions

Figure 7 details some dimensions in this area. We see the distance from the front of the O.P. walkway to the 1942 line is about 12.9 m. The distance from the same walkway to the current cliff line is 3.8 m, thus demonstrating a 10 m loss of cliff over 64 years. However this loss is not the full height of the cliff. We see a 3m difference from the 1942 line and the current cliff-base line suggesting that that most of the 10 m loss was in the softer soils above the base.

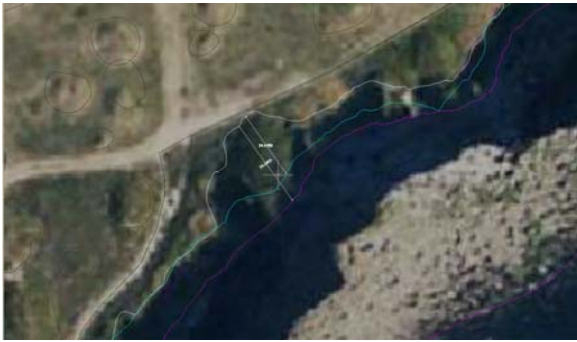
Figure 8 shows that on the west side at “B” we see about a 15m loss since 1942 in the upper 11m of cliff with about a 5m difference between the current cliff-base line and the 1942 cliff-top. In both cases we see about a 3m-5m difference between 1942 cliff-line and the current cliff base in most places along the cliff, though the west side shows an area at “C” in Figure 9 with about a 10m difference. This suggests that basal erosion on the west side is greater than on the east.

Figure 8: Cliff Dimensions at 'B'

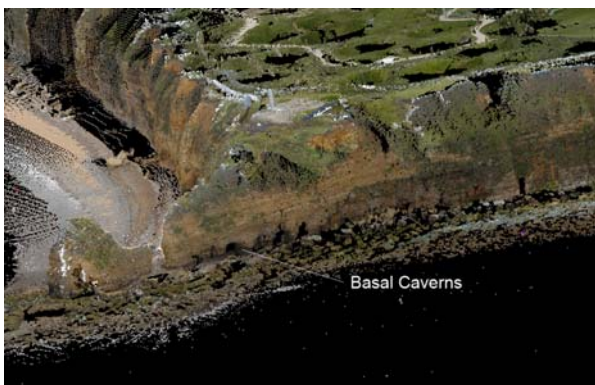
Differences in historical cliff lines between the east and west sides of the point stack are significant because the west-side cliff base shows evidence of basal notching (Figure 10) and deep cavern formation which is absent on the east side (Figure 11). This observation, taken alone, suggests that any failure from basal cavern formation should occur only on the west. The lack of observable cavern formation on the east side of the

Figure 10: Scan Showing Basal Caverns West

Measurements of previous cliff-base failures on the west indicate that when a cavern reaches an unsupported depth of about 4 m a failure is likely to occur. Observation and measurement of caverns on the west with depths approaching 4 m raises a caution about the future stability of the cliff in those areas. Cavern formation is a complicated process that involves the long-term dissolution of the limestone by acidic groundwater circulating within and enlarging the pre-existing cracks and voids of primary tectonic genesis. These avenues for continued groundwater action create a wide network for possible groundwater flow within the vadose, or unsaturated, zone to the cliff face. As fissures at the cliff base widen, large blocks of stone become vulnerable to significant mechanical action of the sea eventually causing their removal.

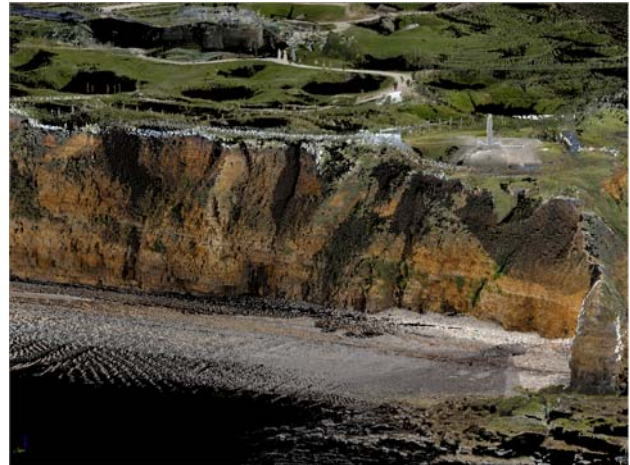
significant westerly direction of the tide, the sea action on the leeward east side of the stack has much less erosive power than it does on the exposed, windward west. This difference has caused a gravel spit of significant thickness to accumulate on the east. The spit, or shingle, has raised the apparent level of the cliff base by 3 m above that of the west. It is possible that caverns similar to those found on the west occur on the east but they evade observation due to the elevation of the gravel. Nevertheless, putative east-side caverns are effectively shielded from sea attack by the gravel and, should they exist, are not likely to be enlarged at an appreciable rate that would threaten the historic buildings at the cliff edge.

Figure 11: East Scan with Pointe Stack

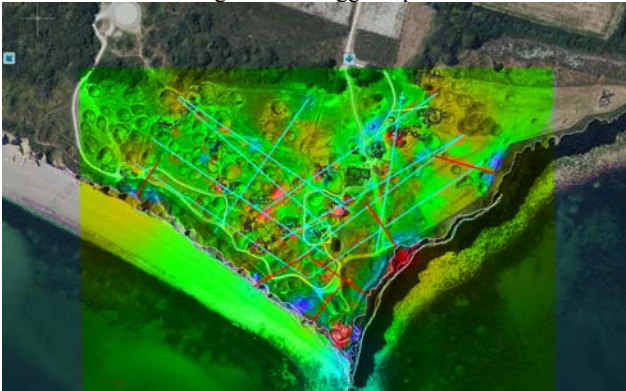
Figure 12: 3D Resistivity Tomogram with Site

Wedge failure of the upper cliff at "A" represented by the 1942 line is suggested by the 3D resistivity tomogram overlaid on the

site survey (Figure 12). A significant, likely persistent, source of ground water is apparent in the upper layers of the cliff near the O.P. The 3D tomogram also suggests possible

karstic action in the form of enlarged voids on the lower east side near and beneath the O.P. The tomographic evidence is consistent with observation of groundwater seepage from beach gravel at low tide. It is also consistent with drilling logs in boreholes near the O.P. that show a 2 m drop in the bit indicative of a subterranean void, at about 20 m depth. It is possible that caverns or voids would be visible on the east face of the cliff if the beach gravel were removed. The top of the voids on the west cliff face lie at -23.8m with respect to our established benchmark while the gravel intersection with the cliff on the east occurs at -24.1 m from the same benchmark. Still, it is unlikely that any void formations on the east would be as significant as those on the west because of protection afforded against tidal action by the gravel and the reduced force of wave action on the east side of the point stack.
