*The Sichuan Earthquake: structural engineering
perspectives*

Ray KL Su

Post-Earthquake Field Study

29 June to 3 July 2008, a post-earthquake field investigation team comprising of the earthquake engineering researchers from The University of Hong Kong, The University of Melbourne and The Swinburne University of Technology visited the earthquake affected areas.

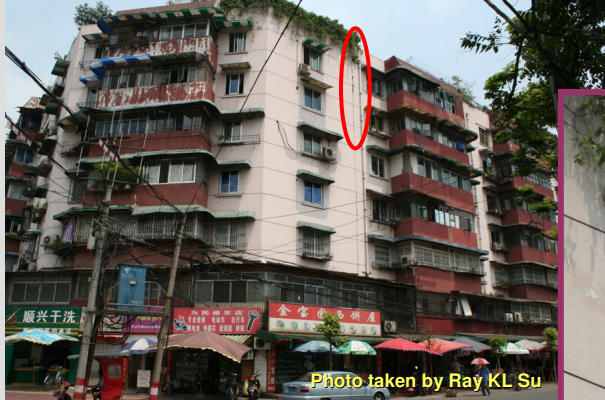
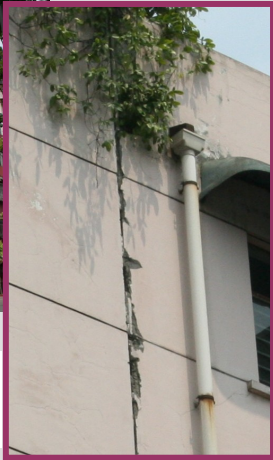
Pounding at the movement joint
Damage to plaster

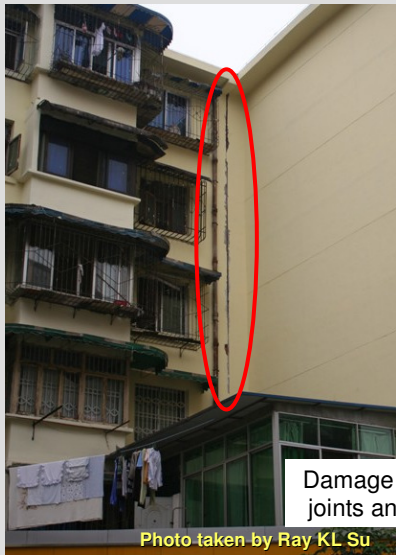
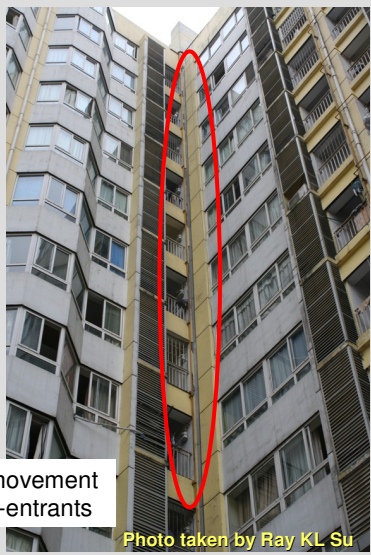
Damage to movement joints and re-entrants

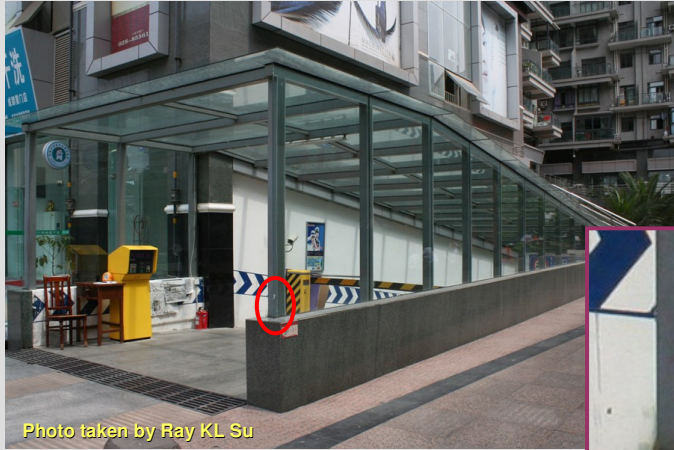
Minor damage to glass structures

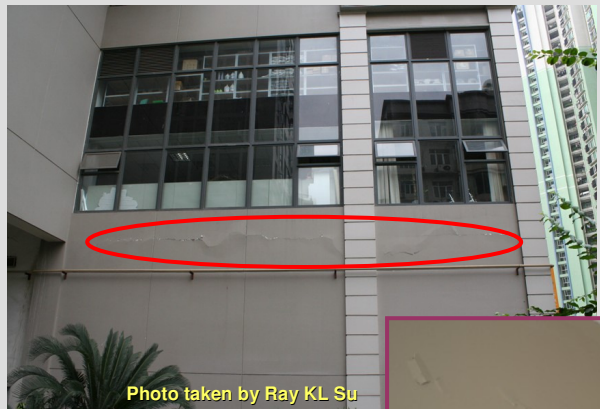
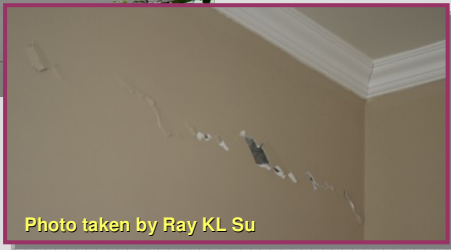
Damage at the interface between RC part and the brick work

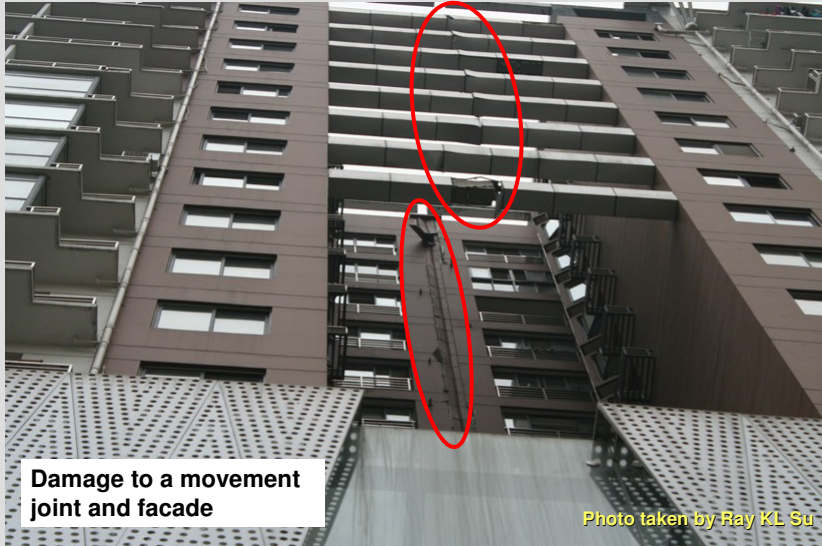
Damage to a movement joint and facade

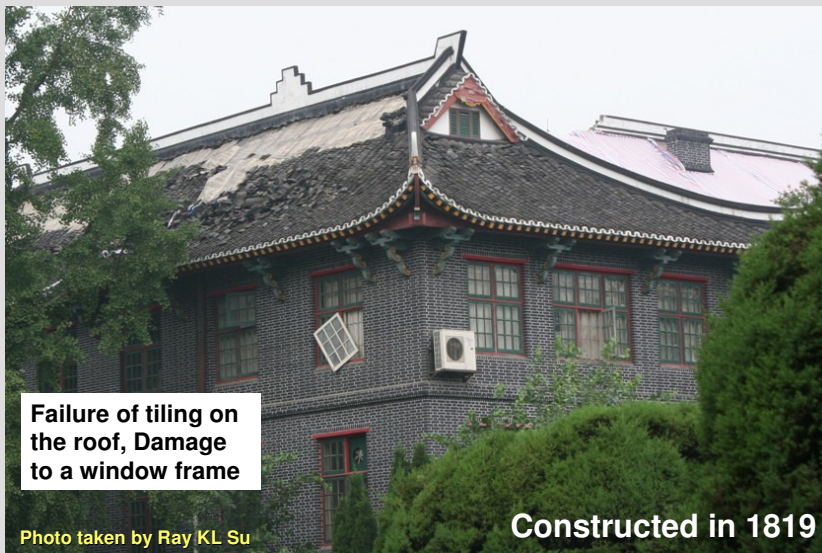
Failure of tiling on the roof, Damage to a window frame

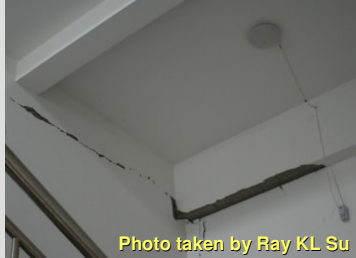
Damage to plaster, tiles and brick work

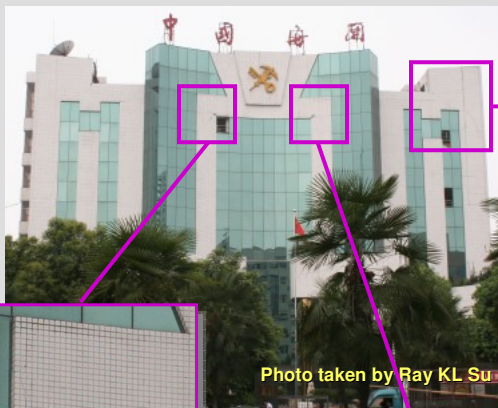
Damage to tiles and windows

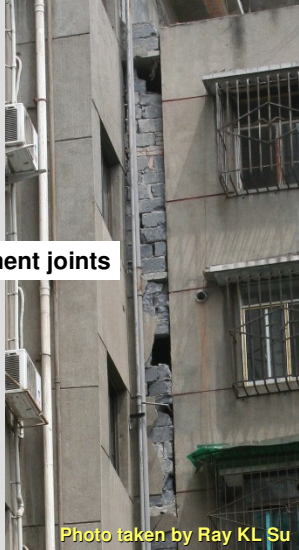
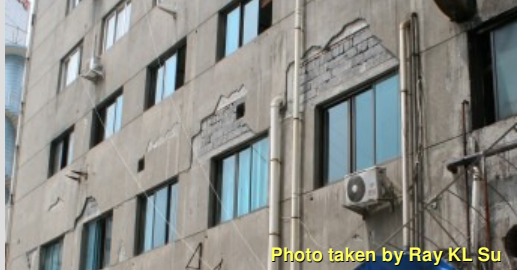
Quite serious damage to plasters and movement joints

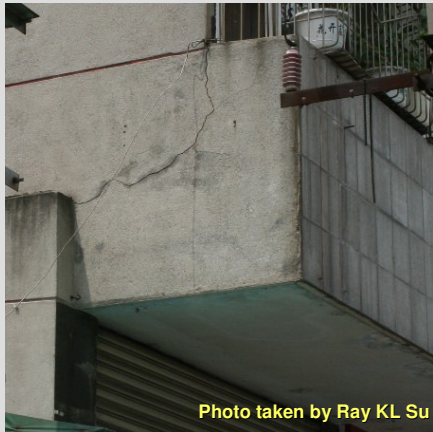
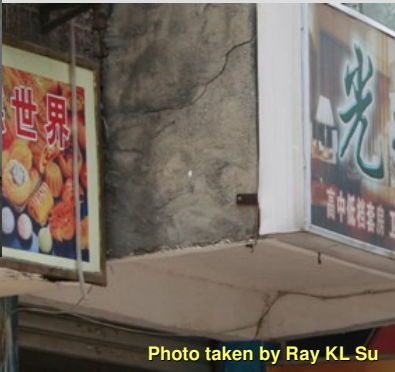
Cracks above
cantilever beams

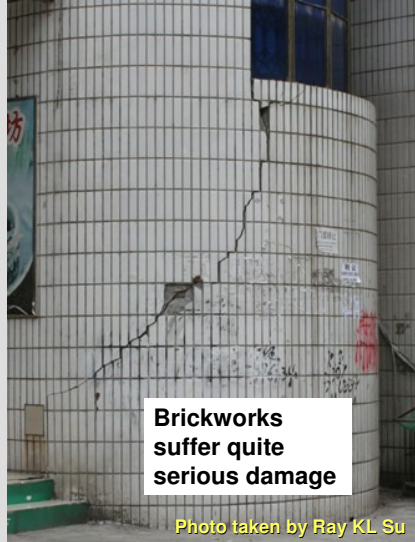
**Brickworks
suffer quite
serious damage**

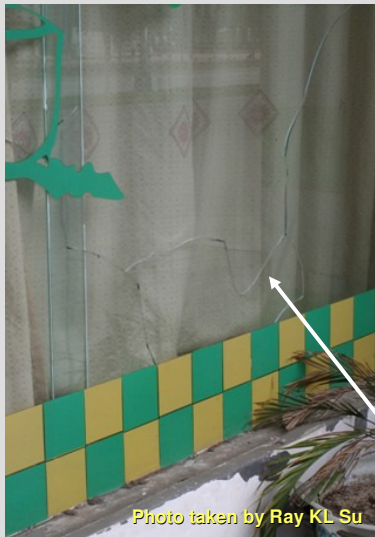
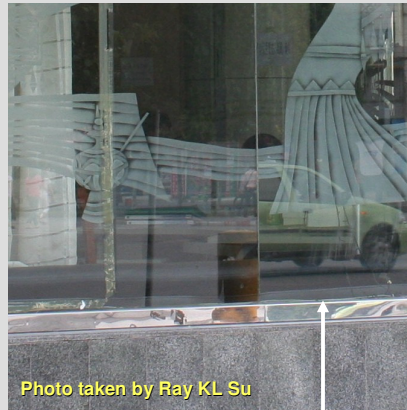
**Damage to
glazing with
dry support**

**No damage
with sealant
support**

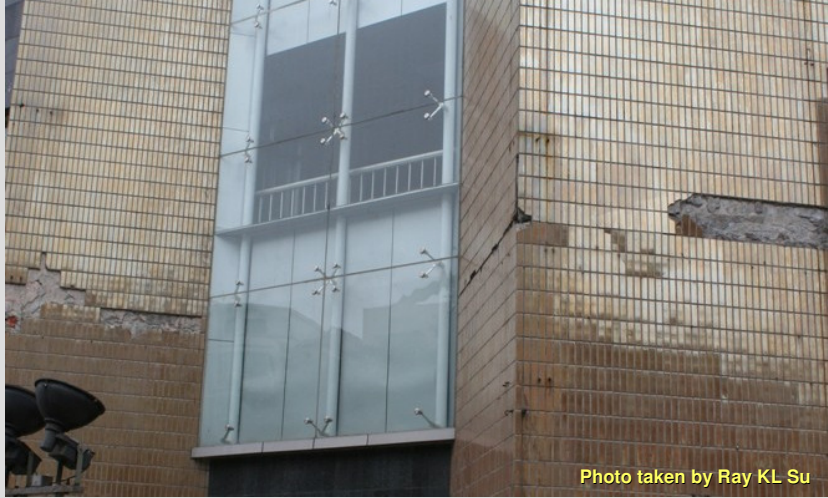
Tiles damaged but not glazing

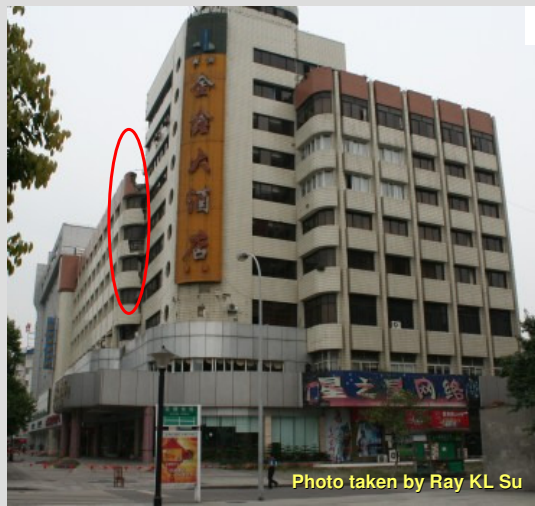
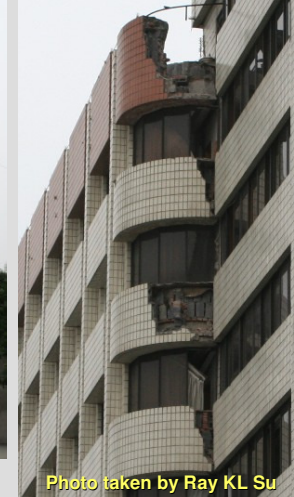
An unsafe building

Damage to parapet walls

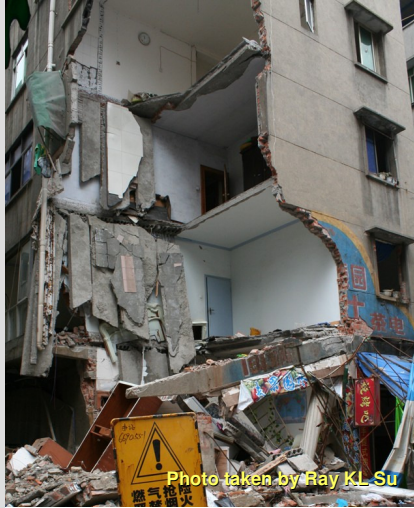
Partial collapse of a six storey building

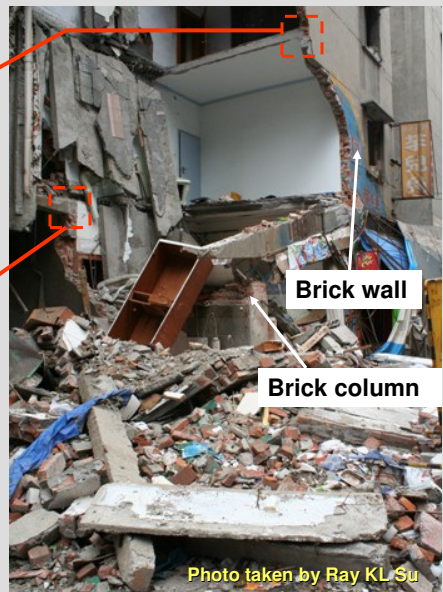
precast slabs
just sit on a
brick wall

No ties
between
beams

The integrity of the building is
poor.

- All medium-rise buildings (>10 storeys) passed the earthquake attack.
- Low-rise brick buildings with precast slab failed badly under seismic load.
- A proper tie system (with internal and peripheral ties) and appropriate joint details should be provided for precast structures to improve their overall structural integrity.

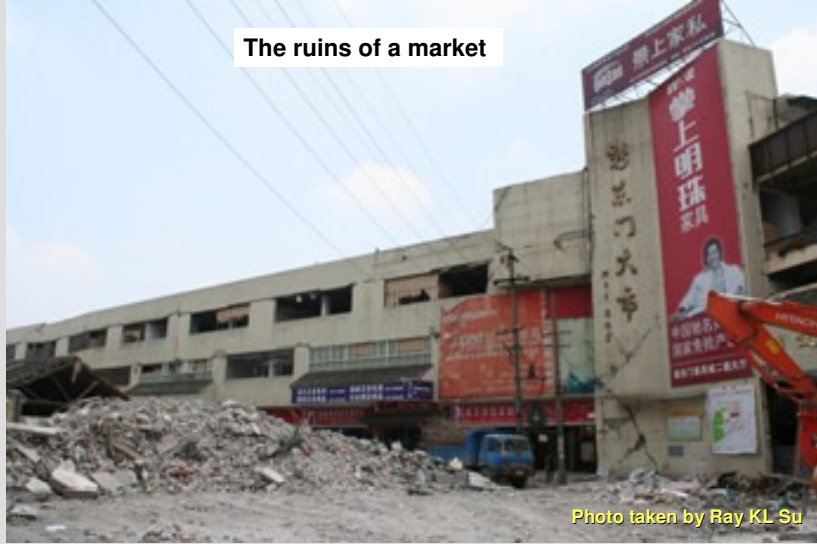
The ruins of a market

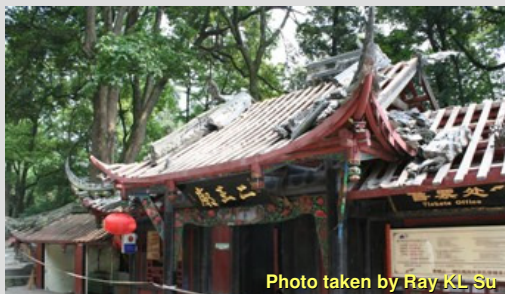
Serious damage
to an old timber
temple

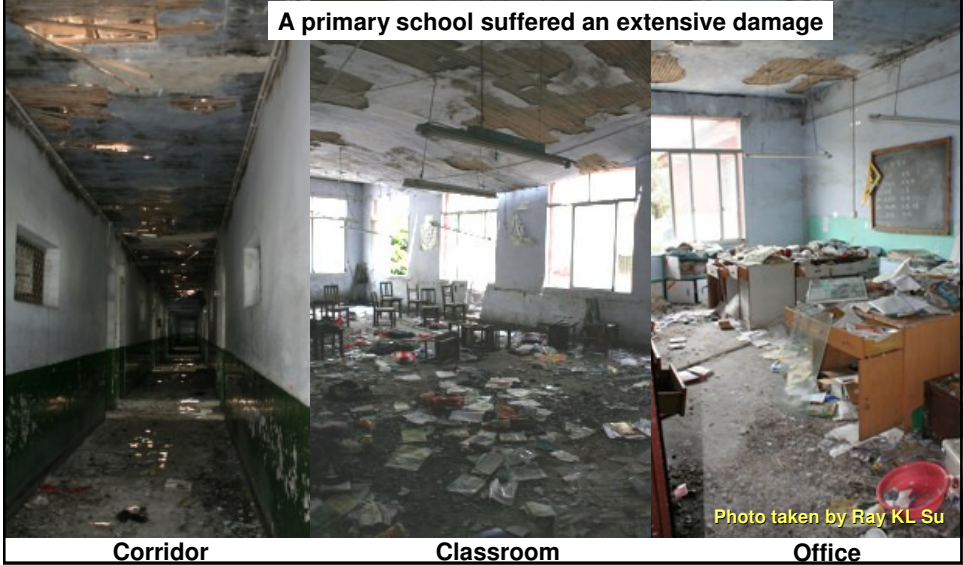
A primary school suffered an extensive damage

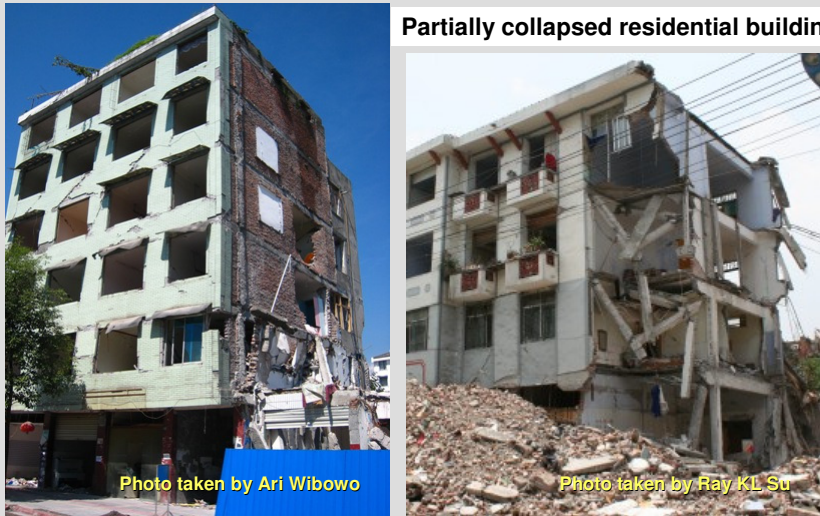
Partially collapsed residential buildings

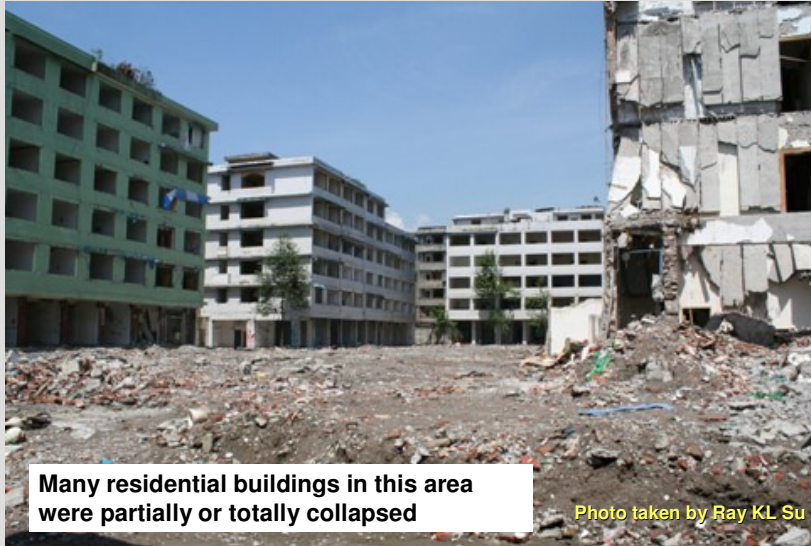
Many residential buildings in this area were partially or totally collapsed

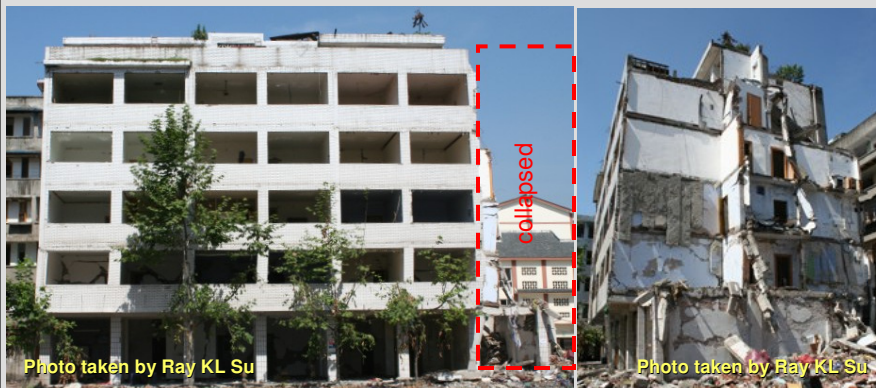
A partially collapsed 6-storey residential buildings

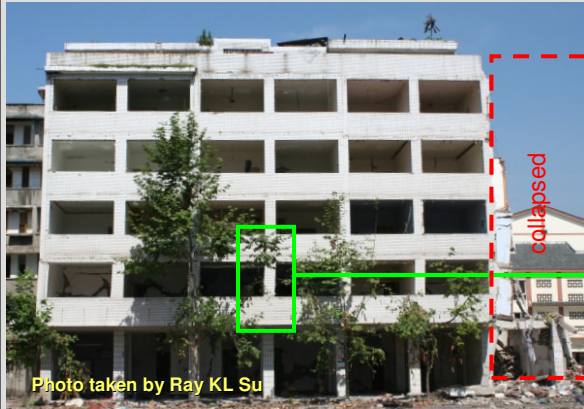
Soft storey on the 2nd floor of the building

4% inter-storey drift ratio is too high for unreinforced masonry structures

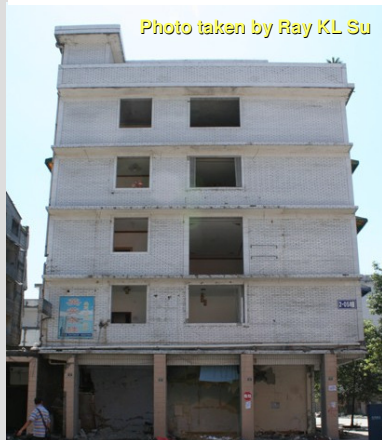
A 6-storey building with soft-storey damage but without collapse

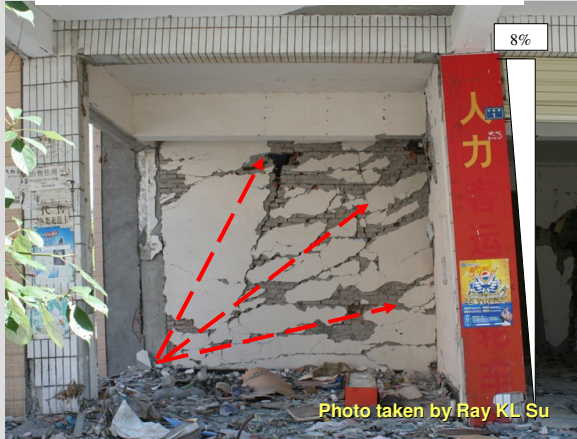
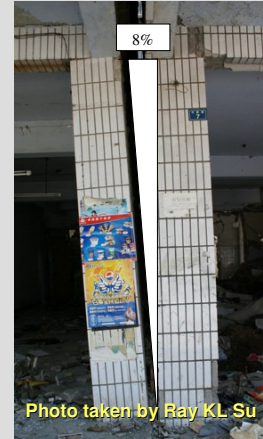
The inter-storey drift ratio goes up to 8%.

The infill wall at G/L acting as a buttress protecting the whole building

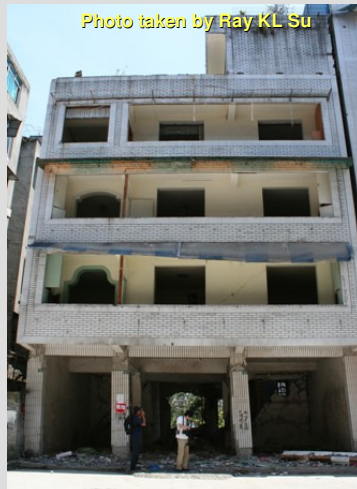
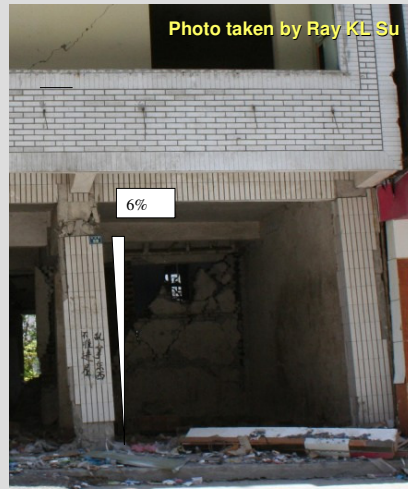
A 5-storey building with soft-storey damage without collapse

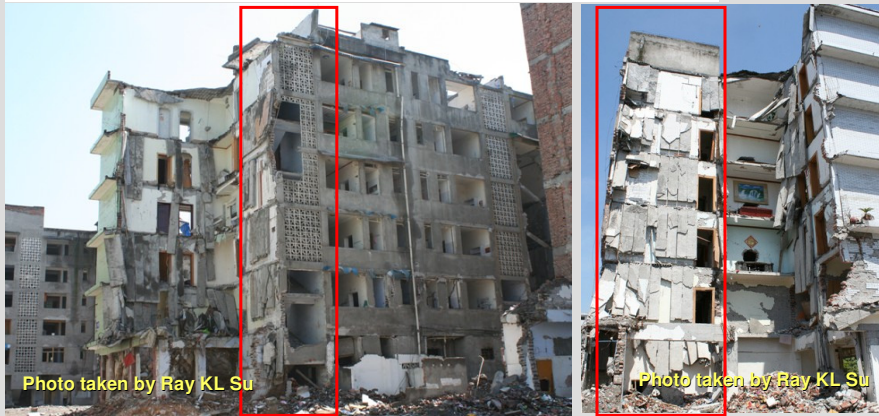
Partial collapse of residential buildings adjacent to stairwells

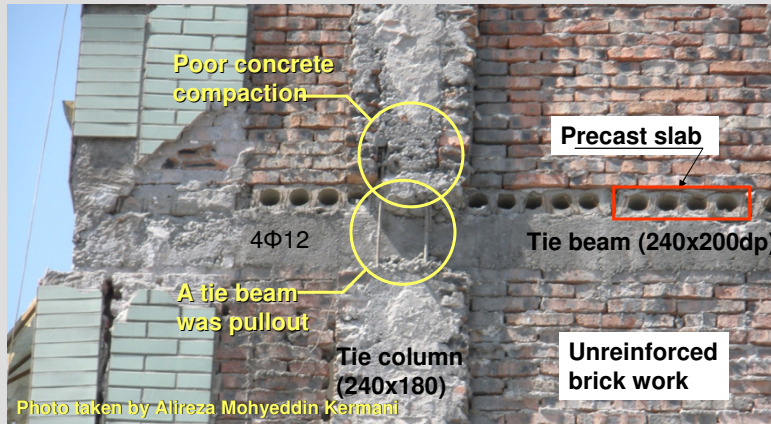
Poor details and workmanship

Precast slab panels directly sit on tie beams

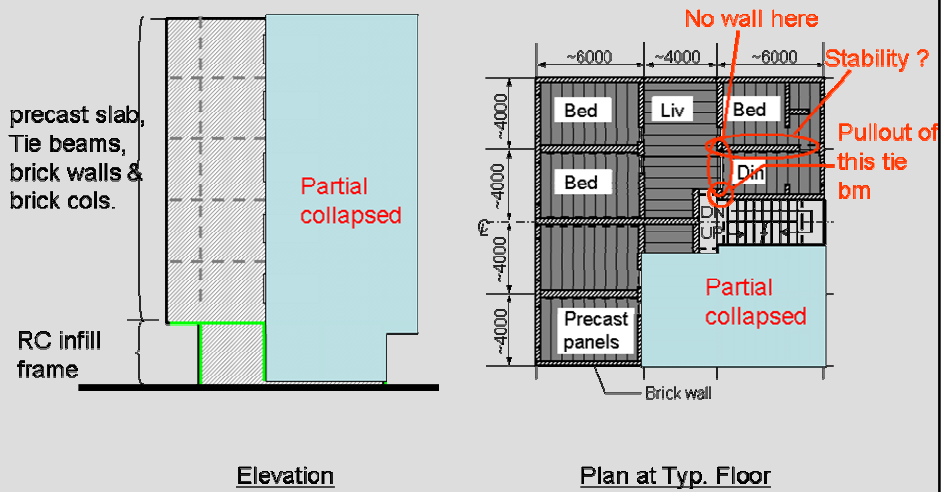
Deficiency in the layout plan

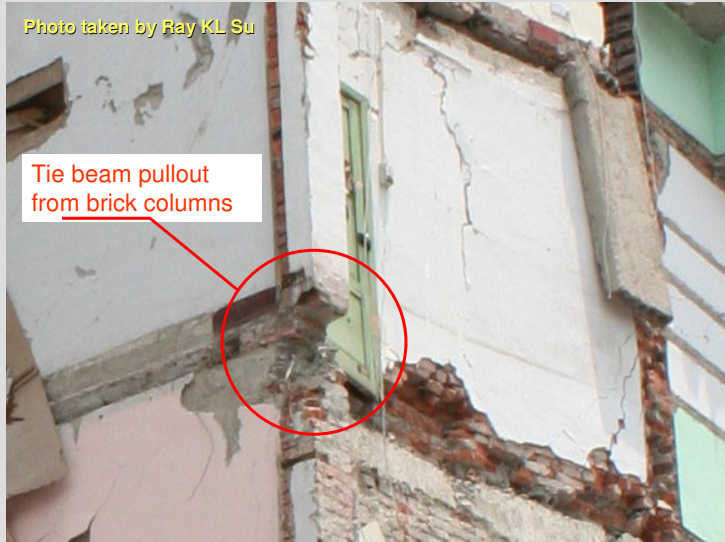
Example of pullout failure of tie beams

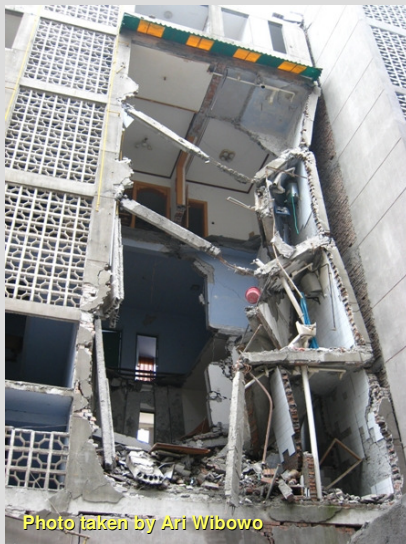
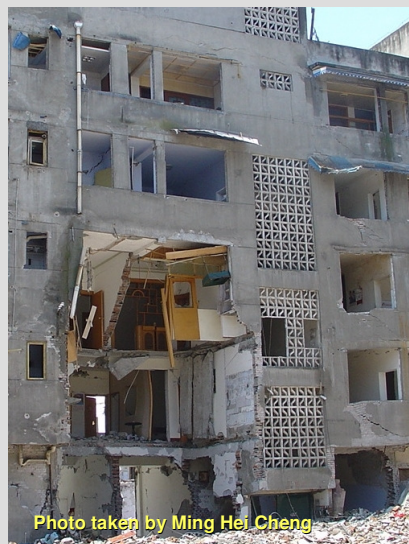
Examples of buckling of external wall & collapse of internal walls

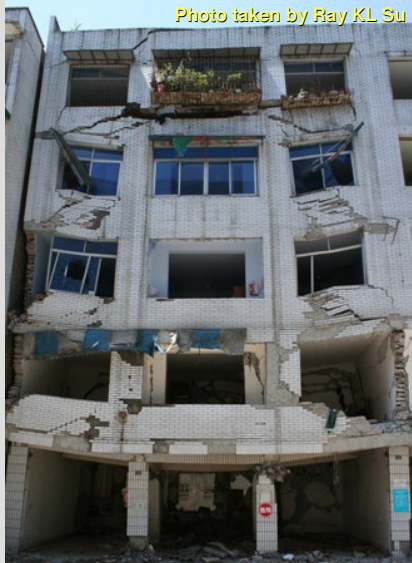
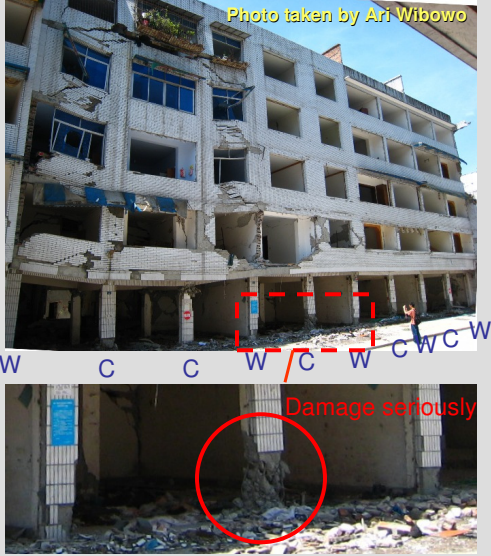
Columns failed under seismic loading and then gravity axial load

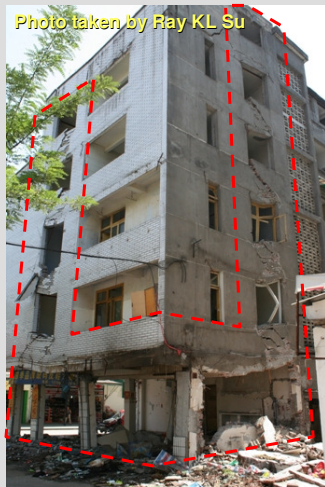
Foundation failure

Settlement of columns

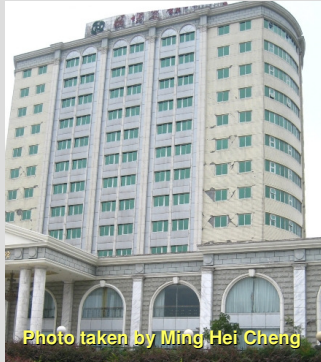
12 to 16 storey high-rise buildings with negligible damage

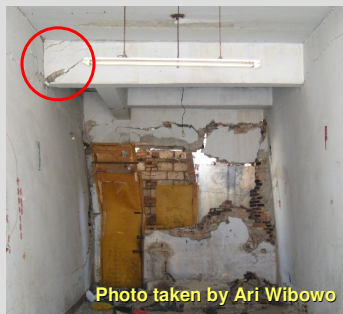
Beams failed in shear rather than bending, no formation of plastic hinge

- The RC beams supporting the infill walls usually failed in shear rather than bending.
- After a lot of damage to columns, significant amount of gravity load was transferred from columns to infill brick walls. (without infill wall, building would experience very large settlement)

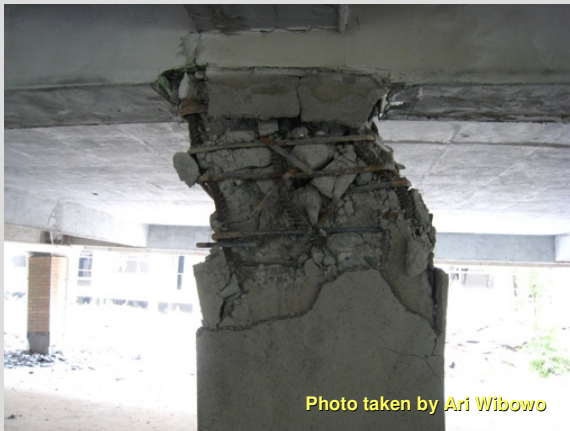
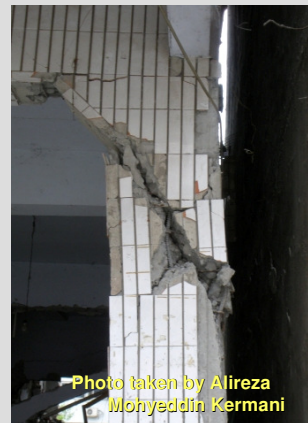
Columns failed in shear

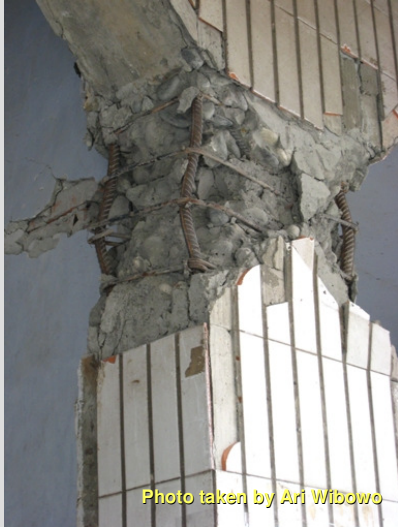
Columns failed in bending and axial load

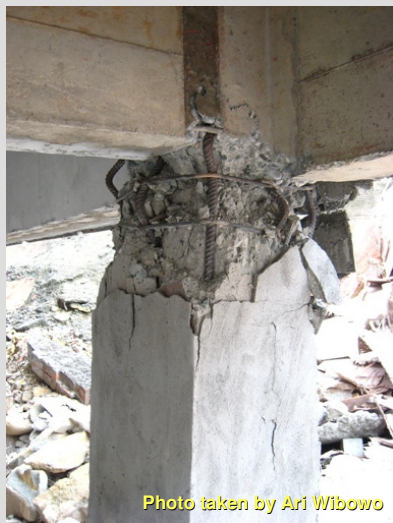
Columns failed in buckling

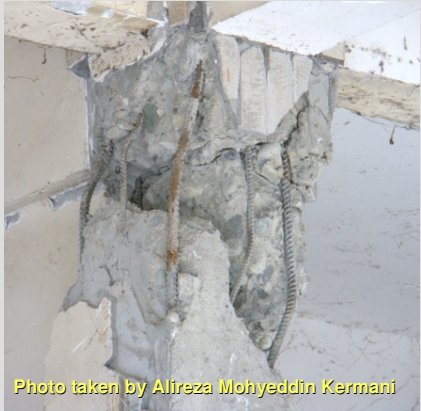
Column failure poor design or workmanship

Insufficient links

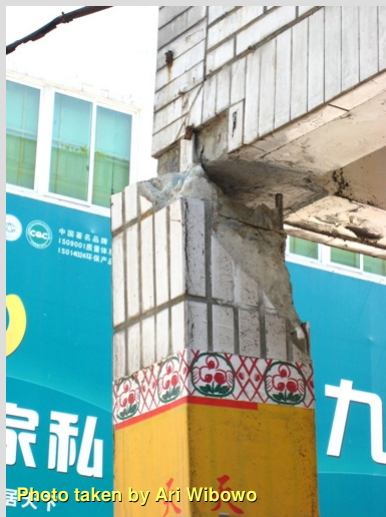
Column failure poor design or workmanship

lack of bar anchorage

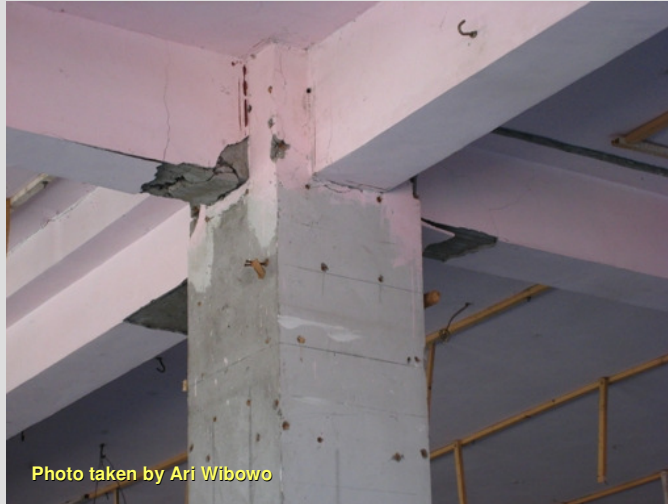
Preferred failure mode - Beams failed but not columns

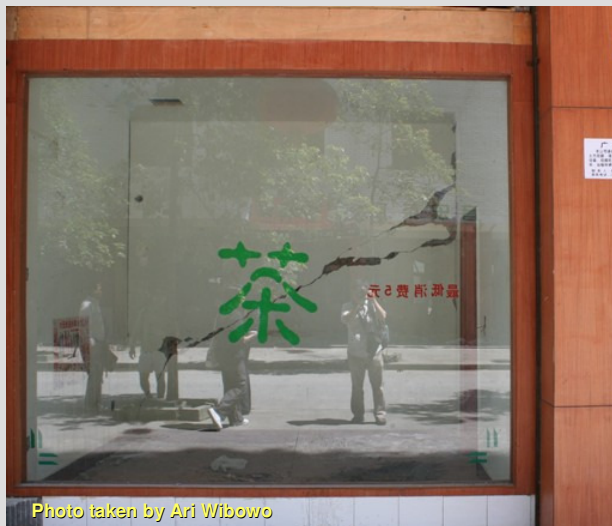
Glass is less fragile as expected
