# Corrosion of evaporator tubes in low emission steam boilers

**Purpose:** of this paper is to reveal the mechanisms of corrosion processes of outer surfaces of low-emission steam boiler evaporator tubes. Examinations were performed to find the reasons of different corrosion susceptibility of tubes situated at combustion chamber on various levels.

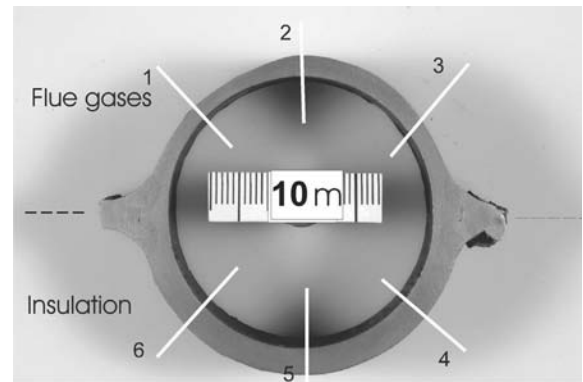
Tubes wall thicknesses were measured on the cross sections at the places indicated in Fig. 1. The results are collected in Table 1. The reduction in wall thickness was not uniform on tube's perimeter. The front side of the tube facing the combustion radiant heat suffered the worst metal wastage and reaches 58% of its nominal value. Reductions in wall thickness from insulation side of tubes were not observed. The highest reduction in wall thickness was detected at points 1 and 3 from the fire side of the tube. Thickness reduction was considerable on the segments taken from the level of 10 m, when at level 18 m this reduction was small.

Fig. 1. Cross section of  $\varnothing 57 \times 5.0$  mm evaporator tube (level of 10 m)

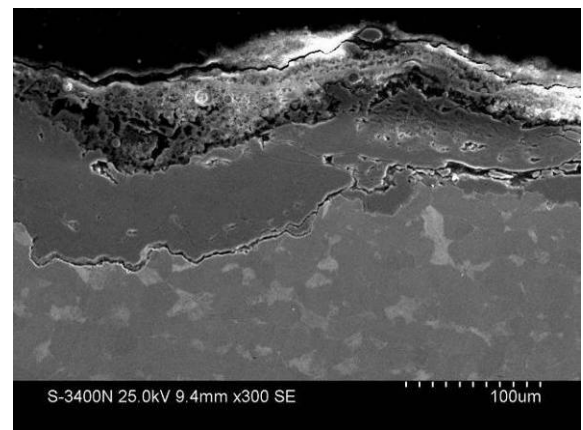
The view of cross section of the tube surface is shown in Fig.2. The deposits on the tube's surfaces differ in the thickness from 100 to 300  $\mu\text{m}$ . Scale consists of two layers, external, which is porous and weakly connected with the tube surface, and internal, which is dense and adherent to the base metal.

Fig. 2. Cross section of  $\varnothing 57 \times 5.0$  mm evaporator tube after two years exploitation. Deposits on the fireside of the tube

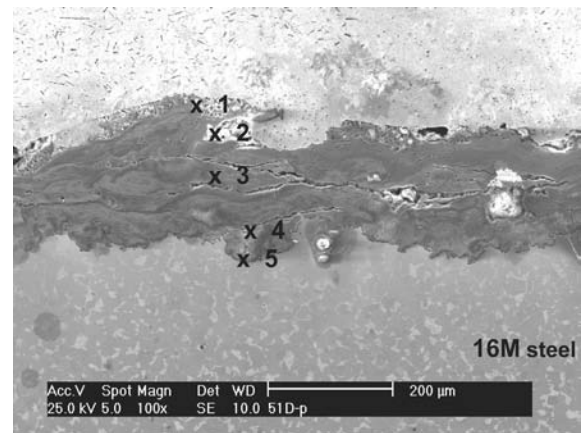
Scales consist mainly of iron oxides with considerable amount of sulfides. Detected elements were not uniformly spaced at the scale. The bands rich in sulfur were detected as well as zones enriched in chlorine. More alkaline metals were observed at scales covered samples taken from the level of 18m. Maximum sulfur contents were 32% and chlorine about 6%.

Fig. 7. Cross section of the fire side face of water wall tube. Sample 51D taken from the level of 10 m, "X" indicate points of spot analysis

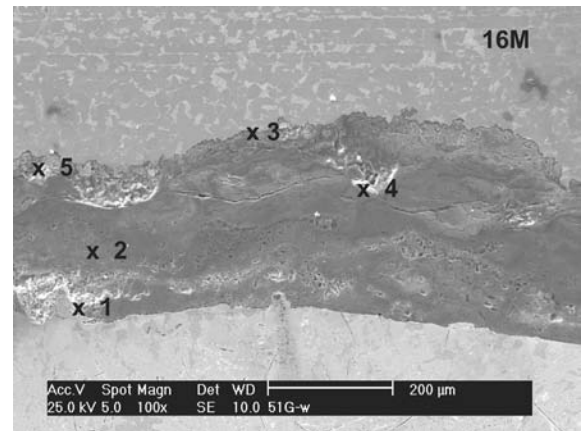
Fig. 8. Cross section of the fire side face of water wall tube. Sample 51G taken from the level of 18 m, "X" indicate points of spot analysis

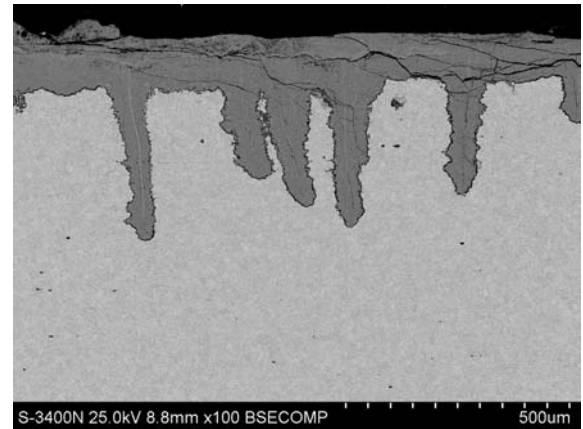
Detailed observations revealed pits and deep penetrations into the tube wall on the samples taken from the level of 18 m (Fig. 12). Such deep pits can form as a result of low melting ash constituent action. Local microanalyses of chemical composition (Figs. 13 and 14) indicated enriched concentrations of sulfur, chlorine and potassium close to the borderline of base material and scale.

Fig. 12. Cross section of fire-side face of water wall tube, level - 18m. Dip penetrations into the tube wall

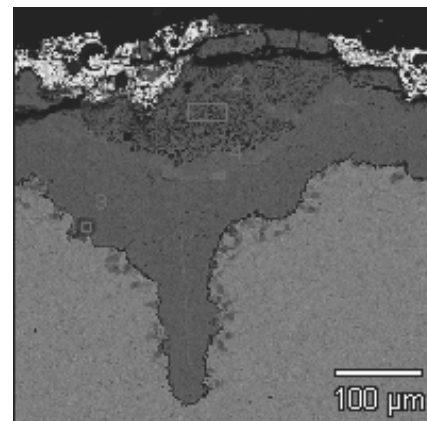
Fig. 13. Chemical analysis of the scale at the corrosion pit (wt.%). Level - 18m, measure points indicated in micrograph
