低碳高硫易切削钢冷加工开裂分析

赵东记,蔡德鹏,徐凯

(青岛钢铁控股集团有限责任公司,山东 青岛 266043)

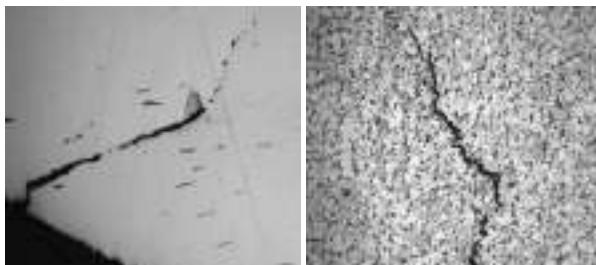
图1 近表面夹杂物 50×

试样横截面高倍显示:裂纹长560 μm且裂纹

周围及试样近表面存在大量大颗粒夹杂物,见图1;横截面最长夹杂物长70 μm,纵向长度因无法定位切割未测量;裂纹处金相组织为F+P,为正常组织形态,见图2。对试样进行常规项目检验,分析结果显示:钢材的组织为F+P,晶粒度为7.5~8.0级,心部纵向夹杂物评级为A>3级、D 0.5级,均符合要求。而图1所示分布在钢材近表面的大颗粒夹杂物属于异常现象,在盘条的常规生产检测过程中,钢材的横截面不应出现大颗粒夹杂物。

通过对试样进行高倍显微镜分析和扫描电镜分析得知,引起开裂的原因为钢材近表面存在大量大颗粒夹杂物。大颗粒夹杂物主要是在冶炼过程中,现场操作人员对水口、保护渣和耐材的在线检测不及时,发生侵蚀现象时没能及时发现,使被侵蚀掉的杂质带入钢液中而形成。

在冷拉拔过程中大颗粒夹杂物难以变形,在基体变形的同时,大颗粒夹杂物受到周围基体的挤压,在拉拔方向承受拉应力断裂形成微裂纹;同时由于大颗粒夹杂物与钢材基体的塑性不同,在变形过程中,大颗粒夹杂物与钢基体之间也会形成微裂纹^[4]。随着拉拔的进行,应力沿微裂纹得到释放产生裂缝^[4];因大颗粒夹杂物沿纵向断续分布且处于近表面,所以在拉拔过程中,裂纹会随着拉拔的进行持续扩展、放大,于是就产生了沿材料拉拔方向的长裂纹,造成材料报废。

钢材近表面的大颗粒夹杂物在拉拔过程中容易导致材料发生开裂,而大颗粒夹杂是由冶炼过程中卷渣造成的。低碳高硫易切削钢在冶炼及浇铸过程中极易出现卷渣现象,使盘条内部存在大颗粒夹杂物,所以在冶炼及浇铸过程中应采取防范措施,并加强对成品盘条中横向大颗粒夹杂物的检测,保证出库盘条的质量。
