试验研究

低镍奥氏体不锈钢焊管开裂原因分析

陈 坤,陈培敦,王俊海

(山东泰山钢铁集团有限公司,山东 莱芜 271100)

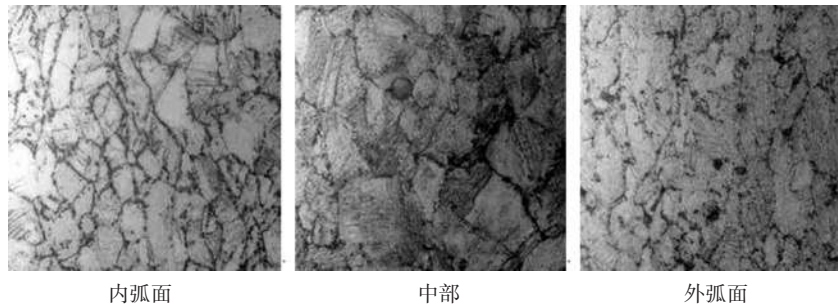
图2 焊管试样金相组织 1 000×

体+少量铁素体+马氏体,大量碳化物沿晶界、基体析出,内弧面晶界明晰,变形较小,外弧面晶界不清,变形较大,如图2所示。裂纹主要是沿晶开裂、同时也有穿晶裂纹存在,如图3所示。夹杂物以A类、C类为主,级别较高,A类夹杂物达到2.5级,具体评级结果见表2,典型夹杂物形貌见图4。

钢板在卷管过程中外表面受拉应力,内表面受压应力,中心不受力。焊管在卷管应力作用下会产生应力集中,焊管裂纹沿轴向开裂,与焊管弯曲受力面相垂直。焊管厂在未经退火处理的条件下,对热轧黑皮卷进行冷卷管焊接加工,碳化物未固溶于基体,会在碳化物附近产生应力集中,降低材料的塑性。通过金相分析、断口电镜能谱微区分析发现,缺陷试样敏化状态严重,大量脆性碳化物沿晶

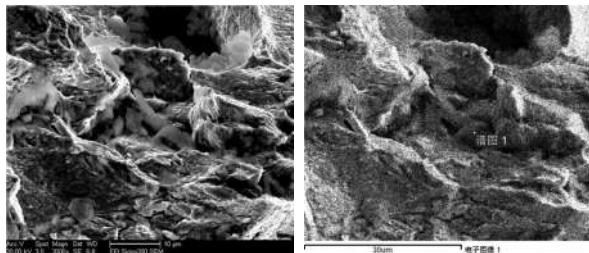
图5 断口形貌及微区分析对应点

4)电镜能谱微区分析。裂纹源附近断口形貌如图5a所示。韧窝底部有大量夹杂物颗粒,碳化物沿晶界、基体析出数量较多。对断口表面进行扫描电镜能谱分析,分析谱图1(见图5b)位置微区成分,结果见表3,主要是Cr的复合碳化物。由于试样在现场存放时间较长,断口存在氧化层,故微区成分分析显示氧含量较高。

a 断口形貌 b 微区分析点示意
