PHOTOGRAMMETRIC MONITORING OF GLACIER MARGIN LAKES

C. Mulsow, R. Koschitzki, H.-G. Maas

Institute of Photogrammetry and Remote Sensing, Technische Universität Dresden, D-01062 Dresden,
christian.mulsow@tu-dresden.de

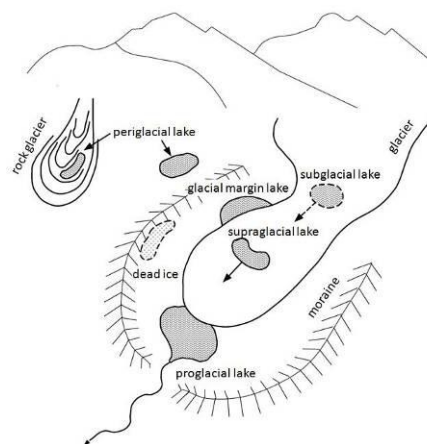
Figure 1. Water bodies next to a glacier (after Raymond et al., 2003)

Glacial margin lakes are water bodies next to a glacier (figure 1). The glacier functions as a dam, restraining the water of the lake (Raymond et al., 2003). Normally the lake is filled with meltwater. If the barrier fails, glacial margin lakes may drain within minutes to days. These phenomena are called GLOF's (Glacier Lake Outburst Flood). The accumulation and draining of a glacial margin lake can be repetitive if the dam is establishing again and an ongoing inflow of meltwater is present. The peak flow depends on water volume inside the lake and the draining speed. Peak flows up to several thousand cubic meters per second are not unusual. For example, the outburst flood of *Lago Chachet II* in the Chilean Andes from April 2008 showed a peak flow of 2500m³/s (Dussailant e al., 2009). GLOF's often cause disastrous flood waves downstream the glacier, accompanied by death and destruction of nature, economy and infrastructure (see figure 2).

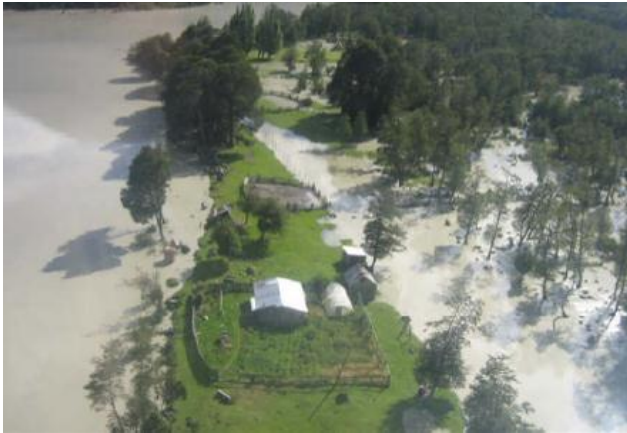
Figure 2. Flooded areas at Rio Baker after the GLOF-event at Lago Cachet II, Patagonia Chile, in April 2008 (Wendt et al., 2011)

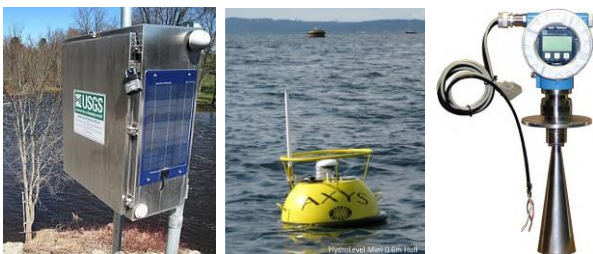
Figure 3: Common gauging systems: gauging station (USGS), GPS buoy (AXYS technologies) and radar level sensor (USGS).

Common gauging systems are for example gauge boards gauging stations, supersonic water gauges, radar level sensors or GPS buoys (figure 3). Unfortunately these are not well suited for GLOF monitoring, as they may be affected by ice fall or landslides in the lake basin. Also the lakes can be very deep (up to 100 meters), so a large measurement range is necessary. A method which fulfils the demands is the observation of the water level by a camera (figure 4). An image based monitoring system should be able to acquire images automatically, should be stable against movements, should work a solar panel and should be able to store the image data. The expansion of the monitoring system to an early warning system requires the inclusion of a data telemetry system transferring raw images or image analysis results. In the simplest configuration the image capture could be transferred to a human operator, who decides if a warning should be given. The bottleneck here may be in the data volume, if data transfer is only possible via satellite telephone in remote areas. So, a better method of operation could be the processing of the image data right on place by a small computer next to the camera. The software should be able to detect the waterline in the images automatically. In a next step, the position of the line in the image must be transformed into a water level height. Then, only the level must be submitted to a control center. A further decrease of transfer costs could be reached if only critical heights are submitted.

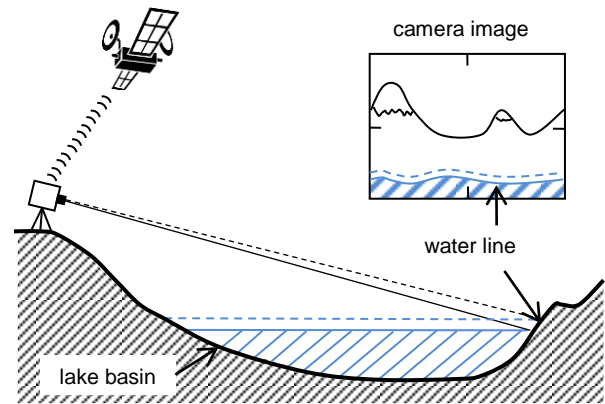
Figure 4. Concept on an image based warning system. The main component is a camera, which observes the water line. Assuming that the exterior and the interior orientation is known, an image ray can be projected into the object space. By intersecting the oriented ray with a georeferenced 3D-model or profile of the lake basin, a height for the water line can be computed. The water level data can be submitted to a control center

This last step requires information about the exterior and interior orientation of the camera as well as the scale parameters on the water line (see section 3.1). Geometrically, this can be interpreted as a line-surface intersection problem, where the line is represented by the image ray and the surface by a digital lake basin model (see also figure 4).

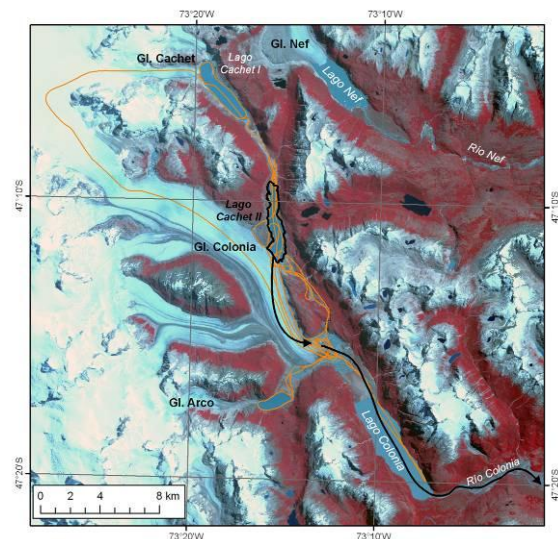
Figure 5: Satellite image of Lago Chachet II glacier lake drainage paths (in black) at Glaciar Colonia (Cassasa et al., 2009).

An impressive example is the GLOF event at *Lago Chachet II* in April 2008. The figure below shows the glacial margin lake filled by meltwater from *Glaciar Chachet* and dammed by *Glaciar Colonia* (figure 5). *Lago Chachet II* has a dimension of 5 km length, 1 km width and up to 100 m depth. When completely filled, it holds a water reservoir of 200.000.000 m³. it has a natural drainage through a small valley on the east side of the glacier. The damming function of *Glaciar Chachet* is weakening over time, for instance the surface showed a decrease of 9.1 km² from 1979 to 2000 (Rivera et al., 2007). In the same time, the glacier front retreated by about 1 km (Masiokas et al., 2009). Casassa (2009) reports a thinning of the glacier tongue in the region of *Lago Chachet II* with a rate of 2 m per year.

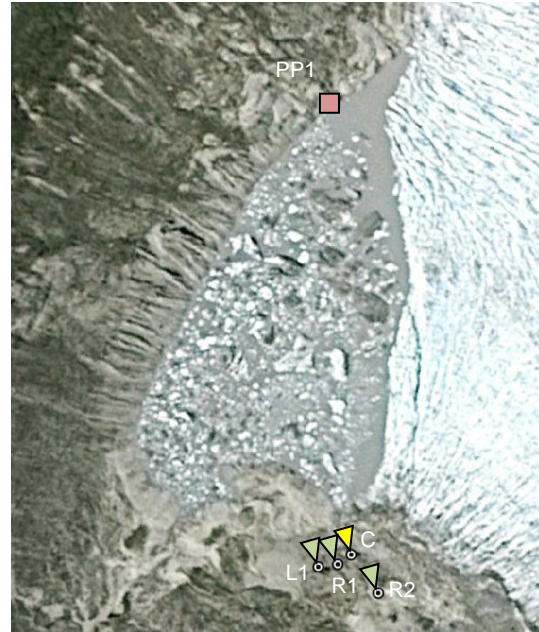
Figure 6. Photogrammetric network design on *Lago Nef Norte* with time lapse camera (C - with field of view in dark red) and the images (with field of view in yellow) for georeferencing (L1, R1, R2). Point PP-1 is a control point on the opposite lake front (900m from camera C)

The transformation of the monoscopic image sequence measurements (see section 3.3) into water level heights requires the georeferencing of the camera and scale parameters on the object. During the campaign in 2010, a multi-image GPS-supported photogrammetric network was established on each time lapse camera position (Maas et al., 2013). The image acquisition was done with a 12 Mpix digital consumer camera (NIKON-D-100). Due to weight restrictions, only a single channel hand held GPS receiver could be used. Additionally, a GEO-tagger was attached to the NIKON-camera. The accuracy of the GPS-data in X- and Y-direction can be estimated with 9 m (absolute) and 4 m (relative) (Wanninger, 2011). A decrease of accuracy of factor 1.5 for the height component can be assumed. At first glance, the GPS-data are not precise enough, but as shown in section 4, the accuracy is suitable for this specific measurement task, as errors only become effective in a water level change scale factor. In the field, an ideal network configuration could not be achieved, because of the difficult conditions and the accessibility of the area. As shown in figure 6 (*Lago Nef Norte*) for example, the ratio between distance and base is far from a stable network design. Nevertheless, it was possible to process the data for the cameras on *Lago Colonia* and *Lago Nef Norte* (see Mulsow et al., 2011). In case of *Lago Colonia*, the standard deviation of a point at a distance of 1000 m was 20m in camera direction, 5 m in lateral direction and 1.2 m in height. Because of a control point on the opposite side of *Lago Nef Norte* it was possible to determine points in a distance of 700 m from the camera position with a much higher precision: 1.5 m in longitudinal, 0.3 m in lateral and 0.2 m in vertical direction. It can be assumed, that the relative accuracy is at least 2 times better. A simultaneous camera calibration was not possible because of the limited coverage of image format with tie points. The camera calibration was done afterwards and the parameters where introduced in the bundle adjustment as fixed. Additional constraints can be defined to support the bundle adjustment, like the coplanarity of points on a waterline.

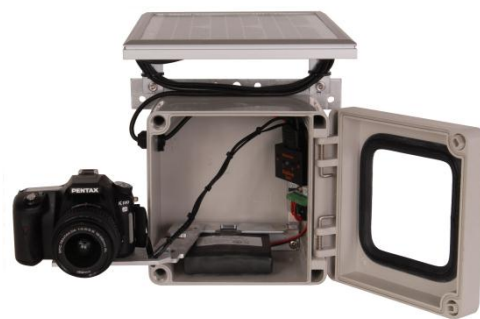
Figure 7. *Harbortronics* time lapse package with solar panel (top), SLR camera, time lapse controller (box right in the housing) and buffer battery (bottom)

The installed cameras were *Harbortronics* time lapse camera systems (figure 7). Components are a 11 Mpix digital SLR consumer camera, a timer module, a buffer battery, a solar panel and a waterproof housing. The systems were fixed on stable permanent tripods (figure 8). To verify the stability of camera orientation, some fiducials were installed on the foreground. The systems are programmed to take images in defined time steps over the day.

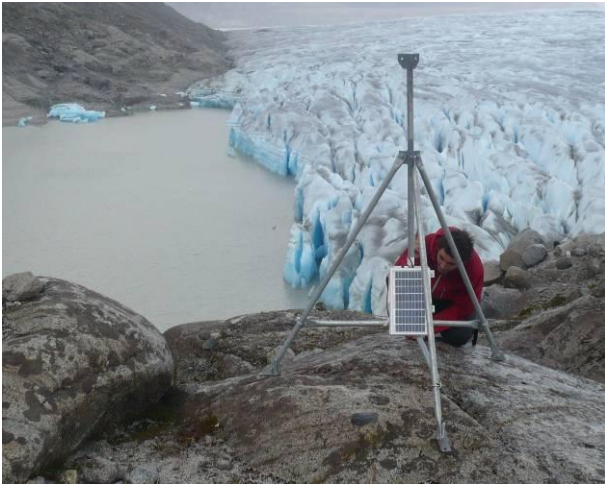
Figure 8. Time lapse camera system installation at *Lago Nef Norte* (Maas et al., 2012)

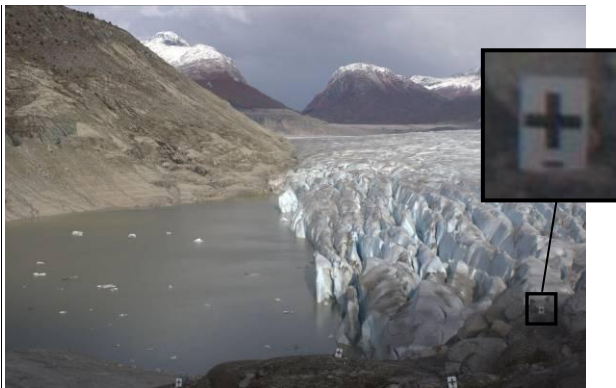
Figure 9. Image of sequence taken on *Lago Nef Norte*. In the foreground the fiducials are visible

Compensation of camera movements induced by wind and temperature variations based on fiducials in front of the camera: First, the positions of the fiducials in the first image of the sequence are defined as reference (figure 9). Then the fiducials are measured in the following images by least squares matching. A 2D affine transformation is used to map the measured coordinates onto the reference coordinates and to correct all further image measurements for camera movement effects. For each transformation the significance is checked. In most cases a set of only two shift parameters will be suitable.

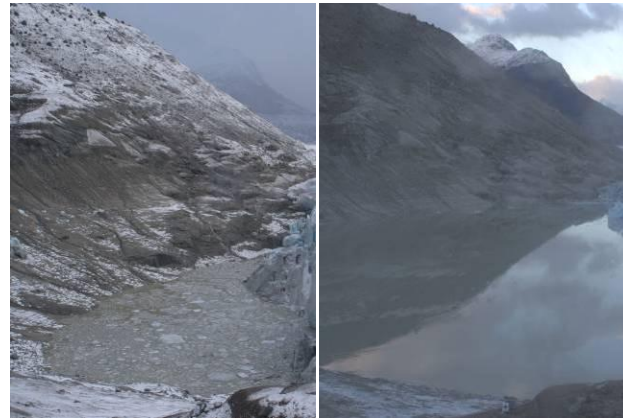
Figure 10. Two images of a sequence taken on *Lago Nef Norte* showing the same area under different conditions. Effects in the images (reflections, ice and snow on the water etc.) hamper the automatic water line measurement

Determination of the water line in the images: In the initial phase of the project, some tests were conducted to measure the water line automatically. Unfortunately, up to now no automatic procedure turned out to be reliable enough. The main reasons are changing light conditions, ice on the water, reflections on the water surface and sediments in the water (see figure 10). Therefore, the water line has so far been measured manually in

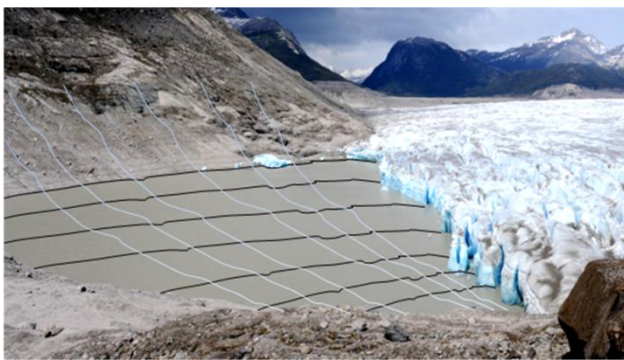
Figure 11. Tracking changes of the lake basin. The water lines can be interpreted as contour lines (level curves)

The last method is quite promising, because the change of the lake basin can be determined from an image sequence. By defining a stable area inside the lake basin, the water level height can be determined. Then the image rays of the extracted water line can be intersected with the water surface, which can be assumed as a plane (figure 11).

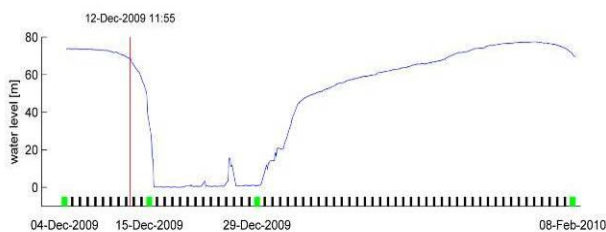
Figure 12. Water level variations at Lago Nef Norte between 4.12.2009 and 8.2.2010

At *Lago Nef Norte*, the first sequence was taken with an interval of two hours, starting 6am and ending 6pm. The graph in figure 12 shows the water height level variations over this period. One GLOF event is evident in the data between 12th and 15th December. The falling graph at the end of the sequence could be an indicator for a coming GLOF event. Actually the lake drained completely at 20th February - two days after the end of the sequence due to a re-installation of the camera.

The second sequence was taken with the same time interval. Because of the poor light conditions during austral winter, the first as well as the last image of each day were neglected. For some images processing was impossible, either due to humidity in the camera housing or snow in front of the camera. The data show one event during winter time (29.7. – 8.8.) with a significantly slower draining speed comparing to the event on 12.12.2009 - (see figure 12 and 13).

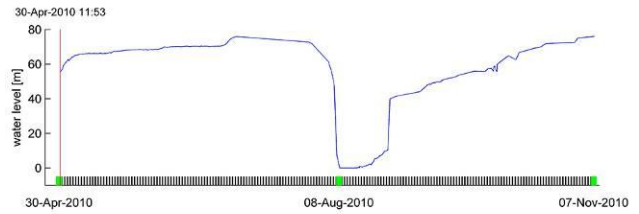
Figure 13. Water level variations at Lago Nef Norte between 30.3. and 7.11.2010

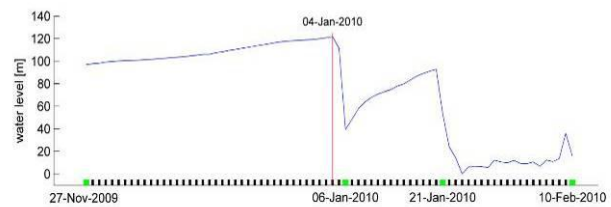
Figure 14. Water level variations at Lago Cachet II 27.11.2009 - 10.2.2010

The first sequence at *Lago Cachet II* was taken with an interval of only one image per day. Figure 14 shows two GLOF events - one starting on 4th January with a partial draining ending on 6th January and a second one between 20th and 24th January, ending with a complete drainage. For the second sequence, the interval was changed to five images per day – starting from 10am and ending 6pm. Over the acquired time period no GLOF events show up in the data (figure 15). Additionally, the rate of filling the lake is much lower in this time period. As this curve represents the austral winter, it matches with the theory of the dependence of the amount of meltwater from temperature and solar radiation. Also, it can be assumed that during winter the glacier tongue is more stable in this area.

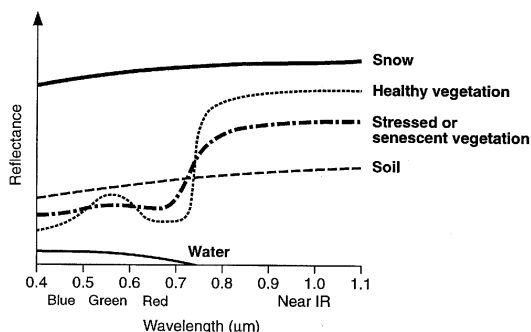
Figure 16. Spectral reflectance curves of snow, healthy and stressed vegetation, soil and water (Harris, 1987)

The automatic measurement of the water line in the images is still unsolved. In order to overcome this problem, the use of a near infrared camera is planned. This should give better image contrast for automatic differentiation between shore and water. The usage of NIR-data for classification is well known from remote sensing. As seen in figure 16, water is nearly invisible in the NIR, snow is bright over all bands, and soil has a medium reflectance in all bands. However, in contrast to vertical imagery in remote sensing, the viewing direction of the camera causes disturbing effects in the image, due to the mirroring on the water surface. That means, in the acquired image the water shows the mirror image of the surrounding, when the water surface is flat (windless). On the water's edge this will be the lake basin, which is then difficult to separate from each other. Another effect is caused by the amount of sediments and dissolved minerals in the water. The spectral signature is then shifting from water to the material inside the water. All this problems have to be further investigated in the future.
