DOCUMENTATION OF THE GEOMETRY AND EARLIER INTERVENTIONS OF THE ANCIENT THEATER OF DODONA

KEY WORDS: Dodona, ancient theater, restoration, laser scanning, Digital Terrain Model

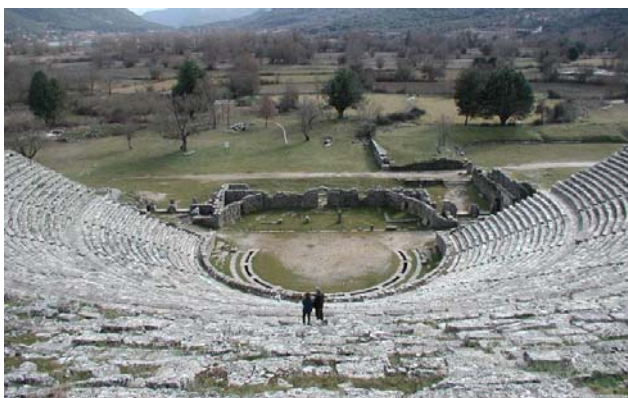
Figure 1. General view of the Theatre of Dodona

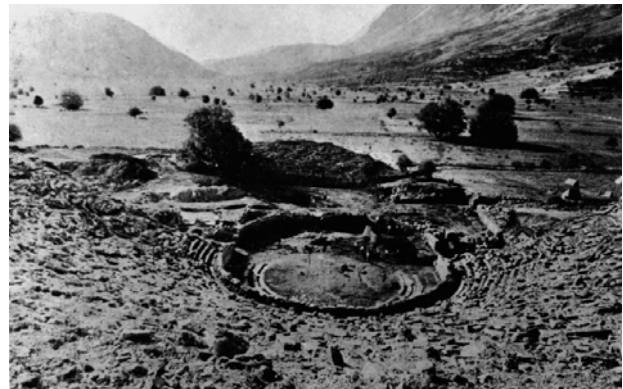
Figure 2. The Theatre at the end of 1959 (Dakaris, 1960)

Even though it is totally excavated since 1959 (Fig. 2), and was restored and partially reconstructed in 1960, (Dakaris, 1960, p.17) the ancient theatre of Dodona had up to 2006 minimal architectural and topographical documentation and recording, except from parts of the retaining walls and the scene. The project for the Study for the Restoration of the Ancient Theater of Dodona was commissioned to our study group in November 2004, by the Committee for the Protection and Restoration of the monuments of Dodona.

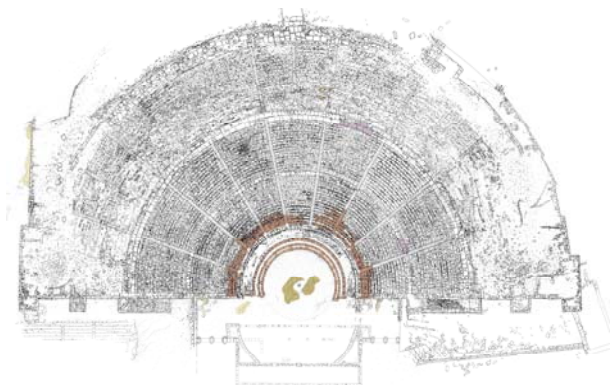
Figure 3. In situ parts of the theatre

The only curved edges of the edolia which preserve their original position are those of the few in situ rows at the lower part of the cave. (Fig. 3) These edges were the guidelines for the original geometry of the cave. They have been considered as parts of a circle and the calculation made by Geomet Ltd resulted in an ellipse axis ratio more than 0,995 (Vozikis, 2005, p 23) which is nearly a circle.

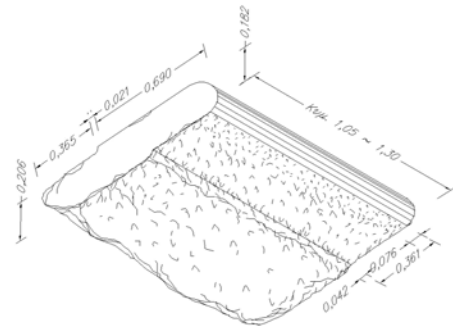
Figure 4. The capital stone of the wall of diazoma A

Similarly the DTM was used also at the second zone of the cave. There, the detailed recording of the capital stones of the wall of the diazoma A (Fig. 4), determined the position of the first row of that zone. The architectural recording of the surviving slabs of diazoma B resulted in the width of that diazoma.

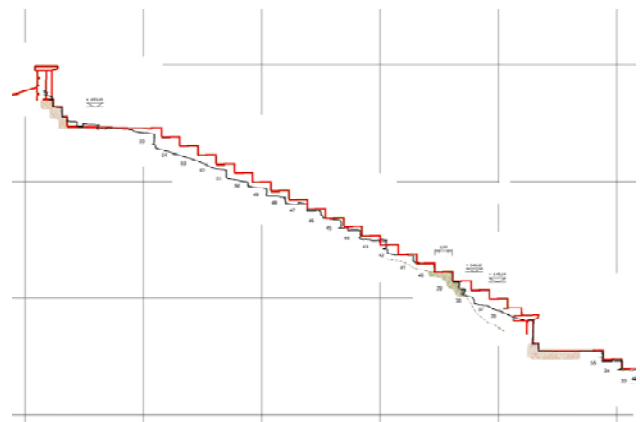
Figure 5. Detailed section of the epitheatron

Since that form was given, the presence of the edolia curved on the natural rock and the in situ parts of the krepis of the retaining wall on peridromos, indicate the original number of the rows in epithetro. The precision of the DTM data in the detailed section, (Fig. 5) eliminates the chances for a mistake.

For that calculation were drawn several alternative cases with the width and height of the rows that varied. The section that was adjusting better to all the above critical spots, is that

proposed as the one of the original layout. (Fig. 5, in red) As it derives from that geometry it varies slightly in the width of the rows from the lower parts of the theatre and little more in height. Thus, the height of the rows in the epithetron is nearly half centimetre more than in the lower part of the monument.

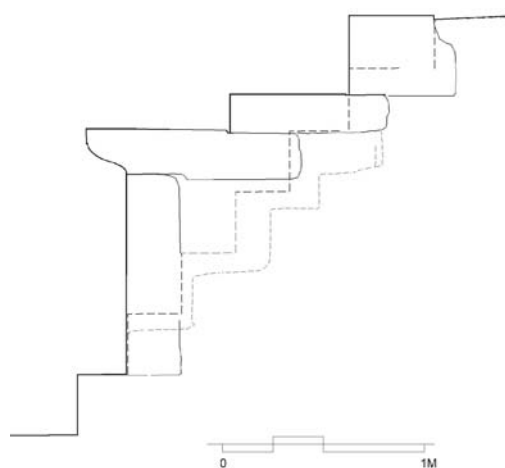
Figure 6. Formation of the retaining wall at diazoma B

In addition to that, the precision given by the DTM along with the architectural remarks and comparison with similar monuments documented the most probable shape of the retaining wall at diazoma B. The form that occurred (Fig. 6) is the result of testing the four most possible arrangements on the section of the DTM with the undoubtable check points i.e. the seats curved on the rock and the in situ krepis of peridromos. The similarity of that form with the equivalent construction at the stadium of Delphoi is evident. (Fig. 7)

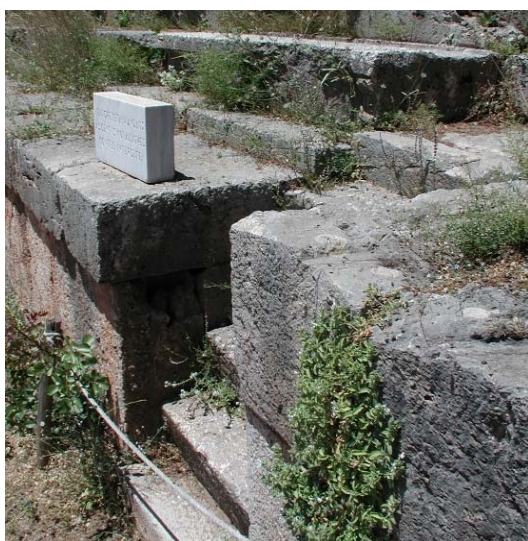
Figure 7. Formation of the retaining wall at Stadium in Delphoi

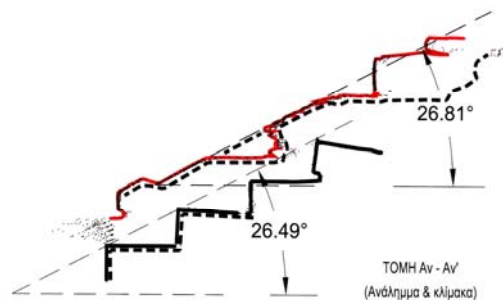
Figure 8. Section of the Eastern edge of the retaining wall

The results indicated a different inclination between the east wall, in which is $\sim 26, 81^\circ$ and the west one in which is $25, 72^\circ$. (Fig. 7, Fig. 8) In addition to that was measured as well the inclination of the stairs adjusted on these walls. The detailed measurements showed also the difference between the inclination of the wall and the stair. That difference has already been recorded by V. Harisis in 1960, not only at the walls but also at the external staircases.

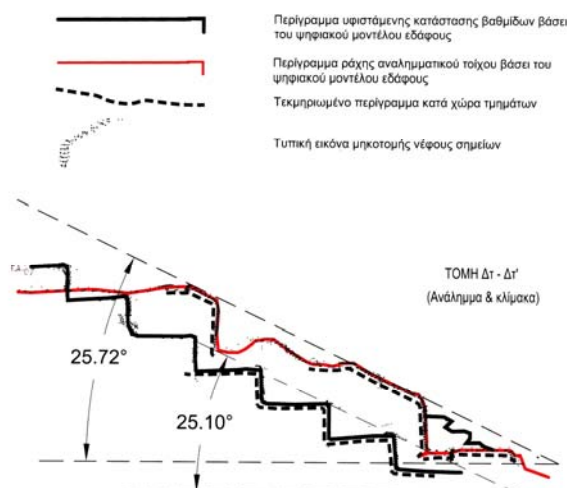
Figure 9. Section of the Western edge of the retaining wall

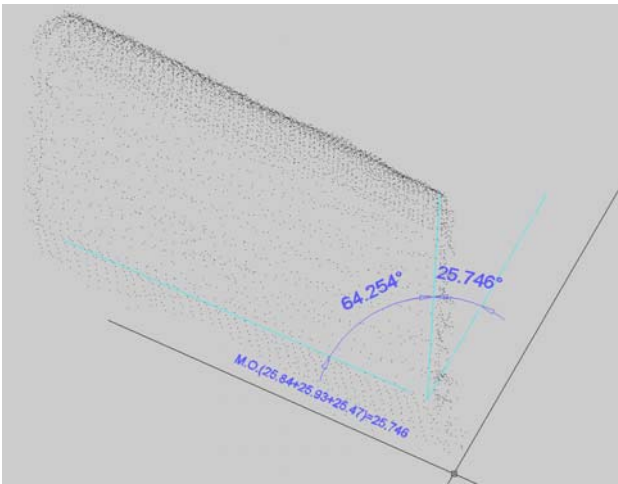
Figure 10. 3D detailed view of the parapet stone

The most significant result of these detailed measurements through the point cloud, was the identification of the original position of the parapet stone No ΔM03 (Drawing. 20 Harisis) to the west wall, instead to the east one, where it was attributed in the past. The inclination of that stone was measured 25.74° (Fig. 15), which is more resembling to the one of the west wall ($25,72^\circ$, Fig 14). Because of the condition of the stone the measurements of inclination were taken at three places $-25.84, 25.47, 25.93$ respectively- for a more accurate result. Multiple measurements have been taken for the inclination of the retaining walls as well.

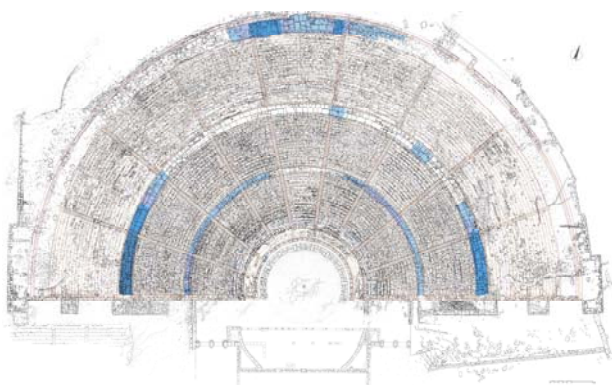
Figure 10. Ground plan indicating the variations from the original levels

3.1.1 Variations of the original geometry (2D) made due to that intervention: They refer mostly to the differences between the geometrical layout and the layout of the rows resulted after that intervention. The detailed DTM testifies the distance between the present position and the authentic one which is given by the plan of the original geometry. (Fig.11)

Moreover, through long sections on the Diazomas have been recorded, their irregular inclination outwards, which occurred after the intervention of 1960, in comparison with the levelled position that the original construction should have. (Fig.10, 11)

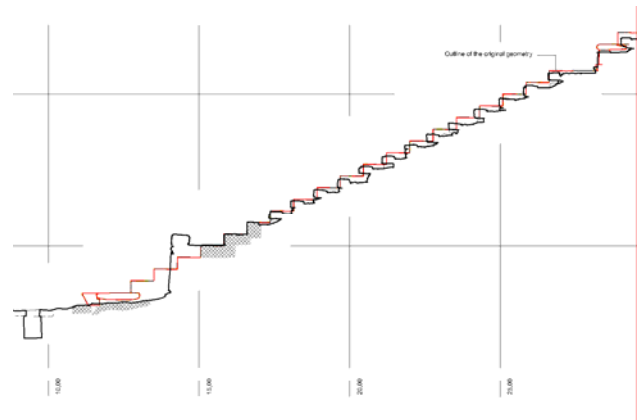
Figure 12. Detail of section indicating variations of levels

3.1.2 Variations of the height of the seats and the Diazomas: Due to the precision of the DTM it is recorded vividly the shorter than the original height (outline in red) of the most repositioned rows of edolia. (Fig. 12)

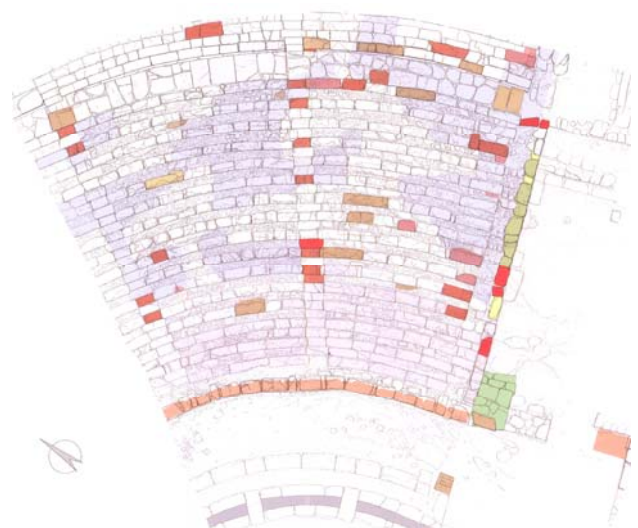
Figure 11. Partial ground plan indicating miss positioned parts

3.1.3 Misspositioned parts: Because of the significant differences of some misspositioned parts, they can be testified from the DTM, easier than from the ortho-photo. This is a secondary contribution of the DTM. Actually its accuracy, provides the differences of these stones which otherwise should have been measured using conventional methods.

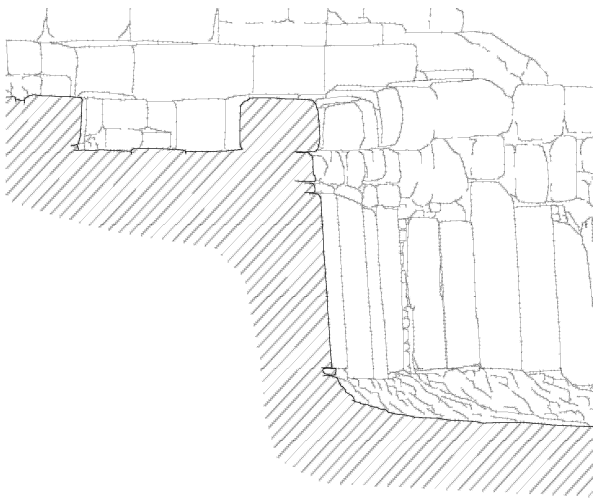
Figure 12. Section of the wall of arena traced out of the DTM

Inclination of the wall of the arena. It has happened probably after damages of the rock edge on which the reused slabs of the wall were based. The DTM quality describes that inclination easily and its variations are also well recorded. In addition to that it can be evaluated where the pressure from the soil and materials behind the wall contribute to that inclination.

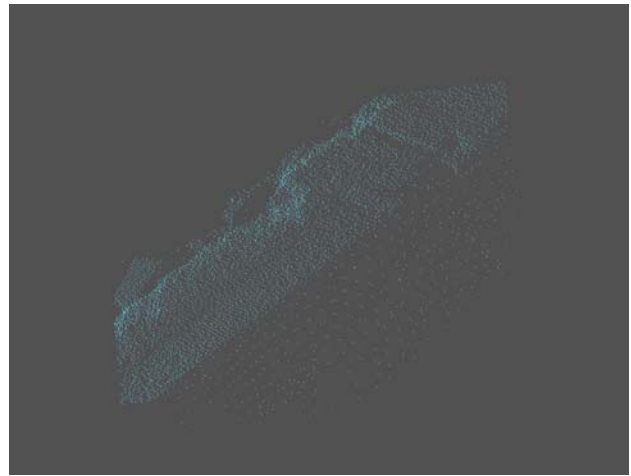
Figure 16. 3D detailed view of an edolium (from DTM)

Despite of the difficulties in recording the curvature of the edolia, the precision of the DTM makes it possible to record the amount of the decay and the loss of the stone mass as well, not only on the top of the seat stone blocks –edolia- but also on their face. In most cases that reduction of the stone because of the fact that the mass loss is more than 1cm, which is the average precision of the DTM, it can be recorded.

The results on the seat stones which have been laser scanned from over than two positions are also well visibly presented in a 3D model. In many cases the scanning reached even the bottom side of the edolia, which have been based on impromptu brackets after the intervention of 1960, due to the loss of their lower part.
