IN SICILIAN ANCIENT THEATRES THREE INTERVENTIONS OF RESTORATIONS IN SICILY

V.L. Ruggirello

Dept. of Project and Building Construction, University of Palermo, viale Delle Scienze, Palermo, Italy
vruggirello@libero.it

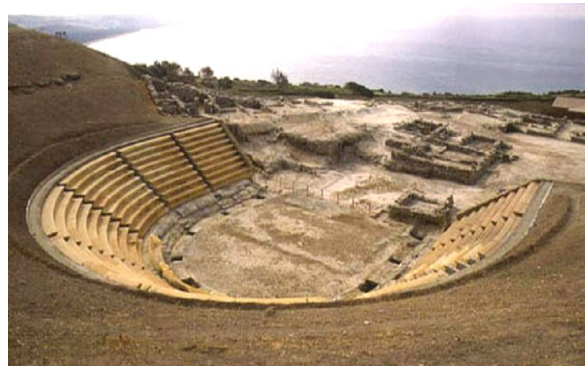
Figure 3. Theatre of Eraclea Minoa with the Minissi's cover

A new intervention of restoration was necessary in 1960: the assignment of planning a cover was given to the Arch. Franco Minissi, which began the works in 1963. The realized plan was based on precise indications, as the transparency that lets to show the monument, the possibility to shape and to model the several parts, allowing an easy reading and understanding of the monument. The created inner tube would have made possible, moreover, a thermal isolation with the task to defend stones from cold. For the execution of such cover, it was necessary to use a shape in Perspex, that would have guaranteed requirement of transparency, figure 3. Contrarily to the plan of Minissi, that previewed some vertical septa realized in perspex, anchored through implantations in aluminium, more than seventy T bars fixed on the tiers trough so many holes, of approximately millimetre 400, walled with grout. An irreversible damage to the entire monument has been created. Moreover some walls in reinforced concrete were executed side by side with the seven *klimakes*, and a system of water-drainage, realized up stream to *kóilon*, with the creation of a channel in concrete. The two lateral heads of the walls of

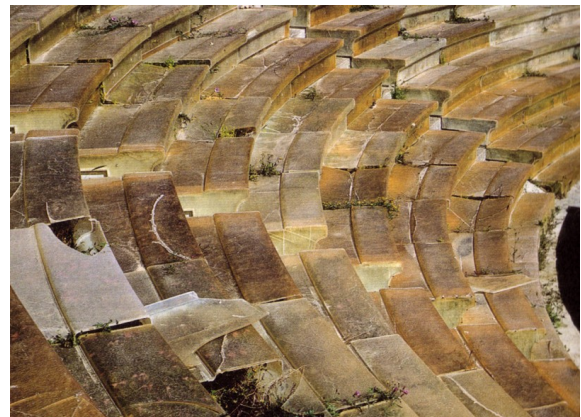
Figure 4. The cover become yellow and under it there was a spontaneous vegetation

The purpose to protect theatral building was soon neglected, accelerating remarkably the degradation processes which are: erosion, pulverizations and disintegration, scaling, gaps, exfoliation, separation, biological patina, efflorescence. The entity and the causes of degradations are various: in the exposed part degradations were caused from chemical and physical effect of the eolian and meteoric action; in the covered part they were caused both by the oxidation and corrosion of the metallic structure, with the consequent fissure of the stone, and by the infesting vegetation that is favoured by the greenhouse effect. It is clear in which state the Theatre appeared when in 1995 the Superintendence of Cultural and Ambient Heritage of Agrigento started an extended campaign of studies finalized to the acquaintance of the causes of degradation and to the corrected execution of the restoration works: the cover had lost its transparency and had become yellow, figure 4; many elements were broken; the supports in iron, originally white painted, were oxidized, folded or broken; under the cover there was a spontaneous vegetation that reproduced the shape of the steps.

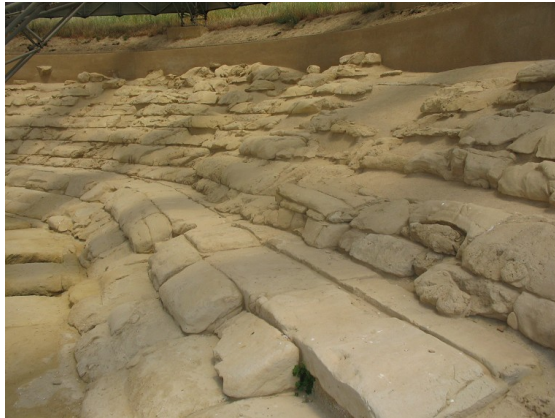
Figure 5. The Koilon of theatre of Eraclea Minoa after the restoration

restoration¹. The successive operation has previewed the disassembly of the old protecting structure, the removal of vegetation and accumulation of ground on the stone, and to the application to spray of ethyl silicate, as general preconsolidating. The operations have interested the removal of iron bars, the removal of the stuccature and cement integrations. The fragments which were, fragile and pulverulent fragments have been dusted and glued with mortar; those ones of greater dimensions have been fixed always with mortar and with some micro-hinges in glass-reinforced plastic, figure 5. Today the Theatre is protected temporarily by a cover that is not incident on the monument and thought in the respect of ambient figure 6.

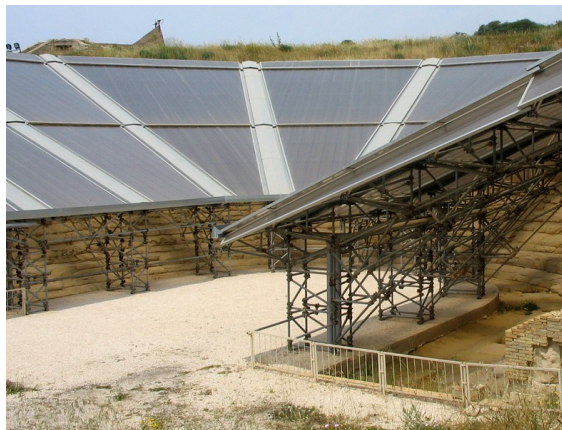
Figure 6. Today the Theatre is protected temporarily by a cover

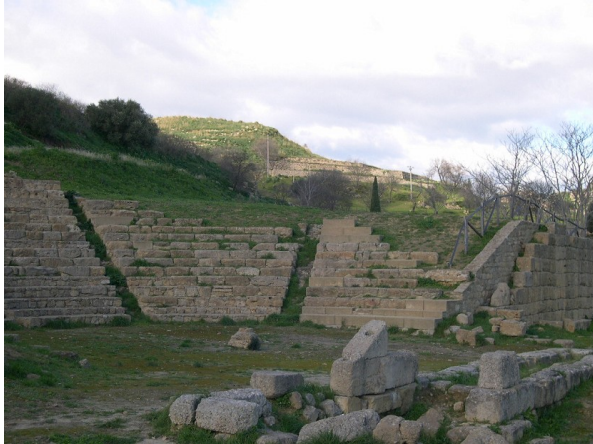
Figure 8. The Koilon of Morgantina's theatre before the last restoration

The *kóilon* is settled, for a quarter, on a open space in light slope of the rocky ridge, on which, in order to emphasize the inclination, filling material composed by rubble granulate, sand and ground, was put with beating and previous wetting. On such foundation a floor of variable thickness, was probably spread with the aim to settle the slope, at last on it stairs were mounted which, for their little compact nature, had to be joined with filling mortar. Thick walls, supported by inner counterforts, the *analémmata*, contained this material. The *analémmata*, constituted by a part which is perfectly orthogonal to the axis of the Theatre and from an other inclined one, like a upside down trapeze, is composed by building double curtain surfaces: the external one has pseudoisodoma waving, while the inner one is irregular, filled up by "box wall" and broken material. A row of limestone blocks marked the shape of the orchestra, an extended semicircle, which has the plan constituted by impermeable sand and clay, figure 8.

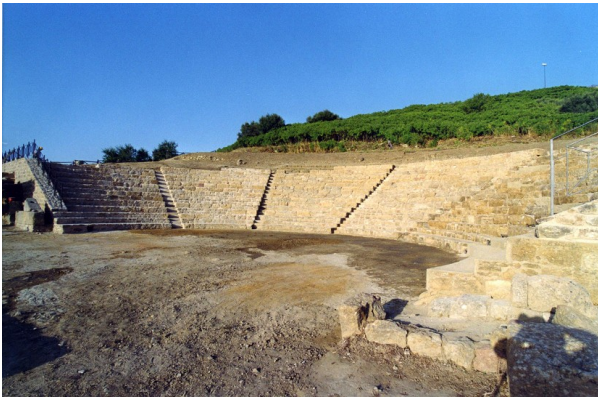
Figure 9. Morgantina's theatre after restoration

extraordinary maintenance; to get material and constructive procedures that are reversible; to assure the benefit of the monument in its physical functional and historical globality, to value the monument and its context, figure 9.

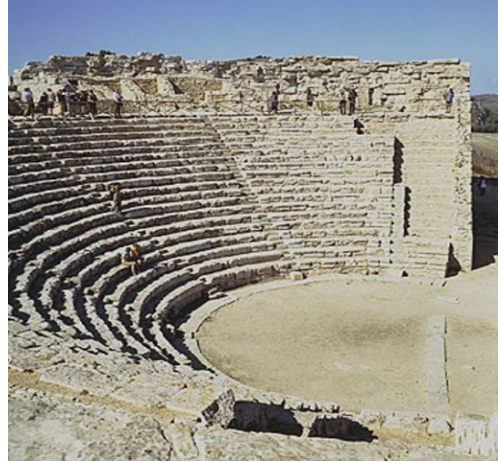
Figure 12. The Koilon of the Segesta's theatre after the restoration

Recently it has been undertaken a new plan of surveying and restoration, terminated in 2001, realized from the Supervising of the BB.CC of Trapani. The plan has not been limited to the surveying of the Theatre, but, on the base of the acquired data, it has allowed to reshape the media-cavea with works of consolidation and completion of the radial septa. The *ima-cavea* has been integrated, in structural gaps, with walls of substruction of the seats, making necessary also the completion of the rectilinear features of the wall of *análemma*. In addition, the superior entrances have been interested by the intervention of restoration, that has restored the paving to the original altitude, figure 12.
