虎跳峡龙蟠右岸斜坡变形的地质力学机制探讨

摘要: 龙蟠为拟建虎跳峡水电站的比选坝址之一, 其右岸斜坡发育大规模的松动变形岩体。结合最新钻孔、平硐等工程地质勘察和 CSAMT 法物探资料, 在分析区域地质环境效应和剖析斜坡岩体变形特征的基础上, 否定了该斜坡为“古滑坡”的定论, 并基于其特殊的斜坡地质结构和特殊的地质孕育环境提出了斜坡岩体变形的地质力学机制: 断裂活动的构造挤压作用造成了近岸岩体的深层破碎; 区域构造应力场的转化使岩体呈先压后拉的受力效应, 地壳抬升、河流下切使深部岩体卸荷 - 拉裂和斜坡后部反倾的软硬相间地层发生了弯曲 - 蠕变和局部倾倒变形; 以坡脚深厚覆盖层压缩和塑性变形为主因, 斜坡后期主要表现为岩体的局部错滑、扩容等自适应性结构调整和追踪顺坡向结构面的累进性破坏变形, 但尚未形成贯通性剪切变形带。龙蟠斜坡的地质结构和变形模式在虎跳峡工程区具有代表性, 因此, 该结论不仅为虎跳峡电站龙蟠坝址抉择提供了理论依据, 也为分析库区斜坡成因演化和评价其稳定性奠定了基础。

DISCUSSION ON GEOMECHANICAL PATTERNS FOR RIGHT BANK OF LONGPAN SLOPE DEFORMATION OF TIGER LEAPING GORGE HYDROPOWER STATION

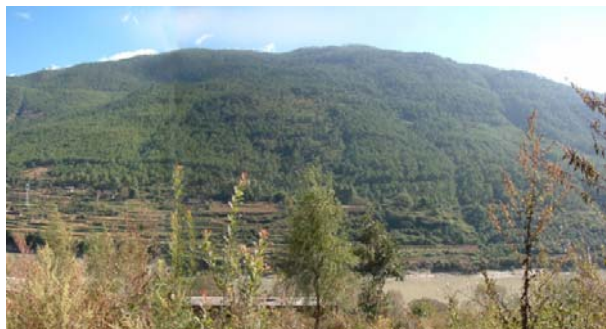
图 1 龙蟠右岸斜坡变形岩体全貌
Fig.1 Picture of the Longpan slope

拟建的虎跳峡水电站位于金沙江干流,设计坝高超过 200 m,正常蓄水位高程为 2 010 m,总库容 $374 \times 10^8 \text{ m}^3$,装机容量 $400 \times 10^4 \text{ kW}$,是金沙江梯级水电开发的龙头水库。拟选龙蟠坝址位于云南省迪庆州中甸县与丽江市交界处,距著名的长江第一湾——石鼓的下游约 26 km 处。在龙蟠右岸发育一大规模松动变形岩体,过去学术界将其成因机制定论为“古滑坡”^[1~4](见图 1),为此导致龙蟠坝址方案搁浅。因其距离下游的上虎跳坝址也仅 18 km,无论作为坝址还是近坝库岸,龙蟠右岸斜坡的稳定性研究对于虎跳峡水利枢纽工程具有极其重要的意义。本文通过最新钻孔平硐以及 CSAMT 勘探资料,在分析区域地质环境效应和剖析斜坡岩体变形特征的基础上,否定了该斜坡为“古滑坡”的定论,并提出了斜坡变形的地质力学机制,为虎跳峡工程规划选址提供了理论依据。

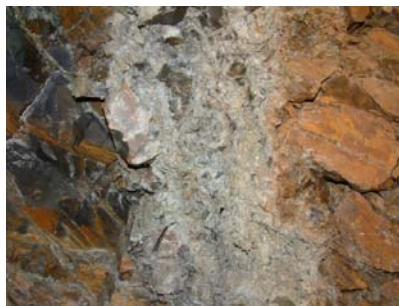
图 6 层间泥化夹层
Fig.6 Weak mud-stratum

源之势，两侧地形坡度与周围岸坡在地貌上极不协调，在高程约 2 100 m 左右的斜坡后缘出现零星台地，从而形成似“古滑坡”地貌^[6, 7]。经勘探表明，坡体近岸和中部岩体破碎松动，且范围极大，从 1[#]平硐看，水平深度约 220 m，从 4[#]、15[#]钻孔看，垂直深度近 200 m。岩体总体保持原有层序，但岩层产状变化较大，倾向为 N12°W~N73°E，倾角由坡体深部至浅部逐渐变缓，深部岩层倾角为 60°~70°，浅部倾角变缓为 10°~40°，在坡体后缘出现平卧岩层。此外，坡体内小断层、层间错动和泥化夹层等十分发育(如图 6 所示)，经 1[#]勘探平硐统计，此类软弱结构面平均间距约为 5 m/条，优势方向倾向坡内，倾角 23°~50°不等。岩体中拉张裂隙发育，图 7 为 1[#]平硐 54 m 硬质砂岩中的拉张裂缝，宽 20~40 cm，深度大于 5 m。此外，第四系崩塌积覆盖层沿着与下覆岩体的接触界面发育有顺坡向滑坡擦痕(如图 8 所示)，但滑移面延展性小，仅为崩塌积物的局部错动滑移。经平硐、钻孔、坑槽探以及 CSAMT 法 V6A 探测，坡体中未见顺坡向贯通性滑移界面或软弱带。

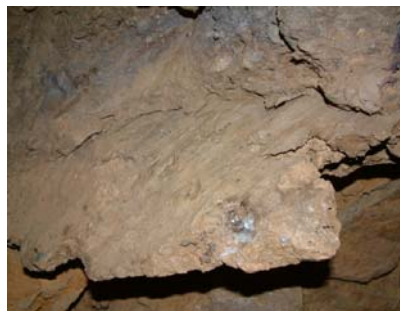
图 8 坡积层中的局部滑移面
Fig.8 A scrape of local sliding
