THERMAL FATIGUE CRACKING OF DIE-CASTING DIES

Original Scientific Paper – Izvorni znanstveni rad

Key words: Die casting, die defect, thermal fatigue, surface cracks

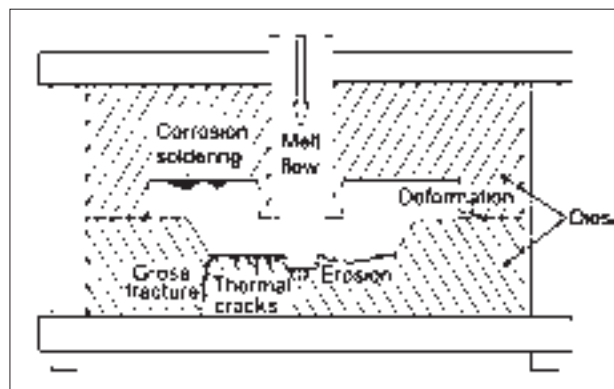
Figure 1. Schematic of defects occurrence on a die-casting die.

Die casting is the process of forcing molten under high pressure into mold cavities (which are machined into dies). The process of die casting is a cost-efficient method of making castings from aluminium, zinc, magnesium and copper-based alloys [1–3]. Dies are exposed to high mechanical, thermal and chemical loads which cause surface defects. These defects are thermal fatigue cracks, erosion of the melt flow, corrosion and soldering of aluminium to the die surface, deformation of contact surfaces of dies and gross fracture (Figure 1) [1-7].

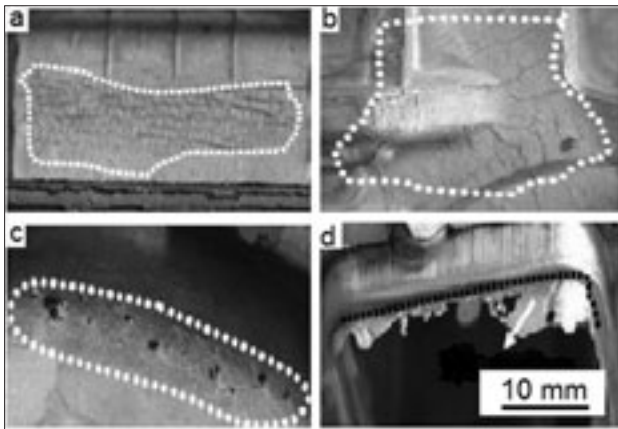
These defects are then reflected on castings. Figure 2 shows surface defects on aluminium castings. Figure 2a shows a worn-out surface, which is caused by the erosion of aluminium alloy melt flow. Figure 2b shows thermal fatigue cracks which occur due to thermal stresses during die casting. Figure 2c shows damage on an aluminium casting due to corrosion and soldering of aluminium to the die surface. The burr is caused by deformation of die parts (Figure 2d).

Figure 2. Surface defects of castings: a) erosion, b) thermal cracks, c) corrosion and soldering, d) deformation.

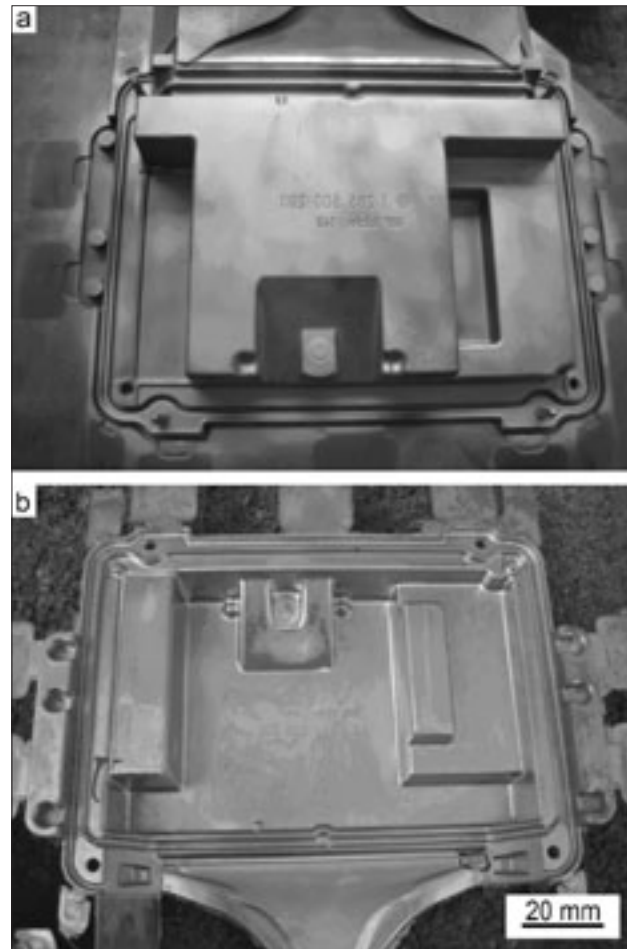
Figure 3. Die-casting die (a) and aluminium casting (b).

The material used in the investigation of thermal fatigue cracking was aluminium alloy AlSi9Cu3 (Table 1). (Figure 3). Experiments were made on an 8 MN cold chamber machine in actual production runs. The temperature of the aluminium melt was 680 °C and the total cycle time was 60 s during which the die was closed 25 s

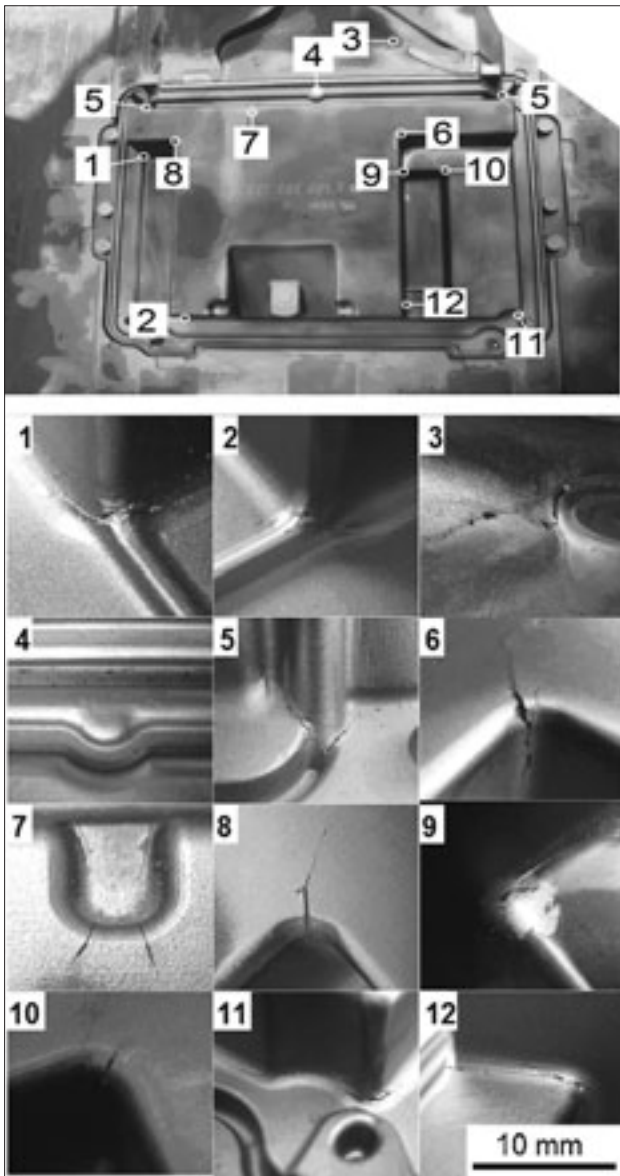
Figure 4 presents the locations of the surface defects on the dies and detailed photos of these defects. The identified local surface defects did not appear at the same time, i. e. at the same number of cycles.

They are numbered according to the time of occurrence; the first was observed at the edge at location 1 and the last defect was observed at location 12. The majority

of these surface defects generally occur on edges and corners. They tend to occur first at corners and edges with small radiuses. Locations closer to the gate were also subjected to higher temperature gradients and consequently higher stresses.

Figure 4. Locations of die surface defects and their detailed photos.

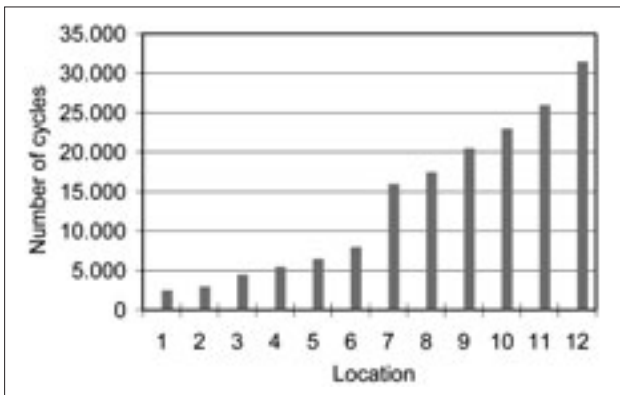
Figure 5 shows the locations and number of cycles at which the first thermal fatigue cracks occurred. At location 1 the first thermal crack occurred at around 2500 cycles, at location 2 at 3000 cycles and at locations 3 at 4000. Before 5000 cycles the cracks occurred at locations 1, 2, 3. The cracks at locations 4, 5, 6 were first detected after 6000, 7000 and 8000 cycles, respectively. The cracks at locations 7 and 8 were first observed at 16000 and 17000 cycles, at locations 9 and 10 at 21000 and 23000 cycles, and location 11 and 12 at 26000 and at 32000 cycles, respectively.

Figure 5. Die defect-crack occurrence (number of cycles).

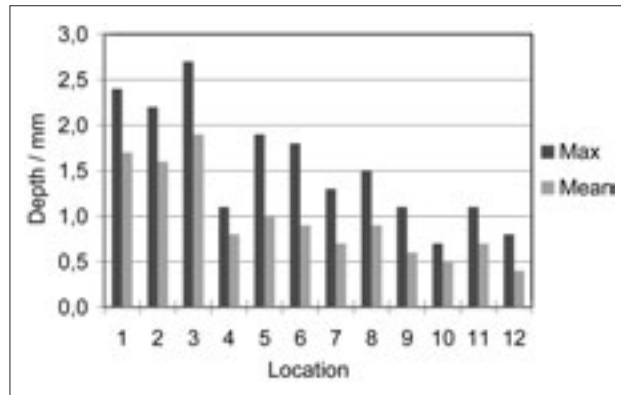
Figure 6 shows mean and maximum crack depth at different locations. Mean values of depth vary from 0,4 mm to 1,9 mm, and the maximum depths from 0,7 mm

Figure 6. Mean and maximum crack depth and their locations.

to 2,7 mm. The deepest cracks occurred at locations 3, 1, 6 and 2 with the maximal depths measured at 2,7 mm, 2,4 mm, 2,3 and 2,2 mm, respectively. The deepest cracks showed a tendency to occur near the die gate, where higher temperature gradients caused higher thermal stresses. The local stress concentrators (corners with small radiuses) additionally raised these stresses, which caused the local accumulation of plastic strain.

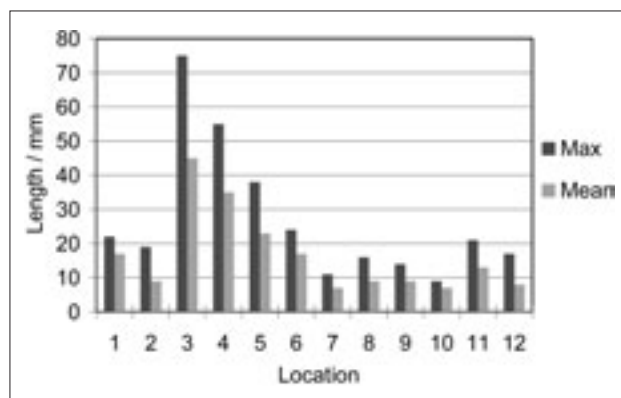
Figure 7. Mean and maximum surface crack length of and their locations.

Figure 7 shows mean and maximum length of cracks and their locations. Mean values vary from 7 mm to 45 mm and the maximum values from 9 mm to 75 mm. The longest cracks occurred at locations 3, 4, 5 and 6 with the maximal length measured at 75 mm, 55 mm, 38 and 23 mm, respectively.

The longest cracks also tend to occur near the die gate due to higher temperature gradients, which cause higher thermal stresses.

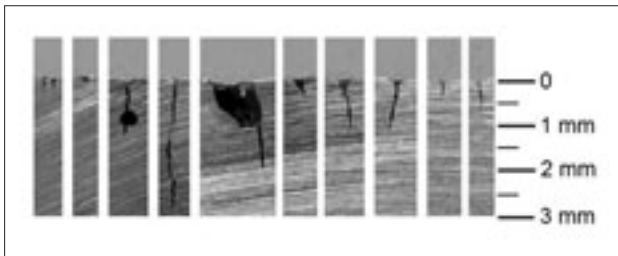
Figure 8 shows typical cross-sections of thermal fatigue cracks (found near the die gate at location 3). Depth of cracks amounts from a few tenths of a millimeter to a few millimeters. The deepest crack reaches the depth close to 3 mm. Width of cracks amounts approximately to 0,1 mm. The width is narrower at the tip of the crack (a few hundredths of a millimeter) and wider on the surface (a few tenths of a millimeter). The larger crack width on the surface is a consequence of melt erosion that causes constant loss of die material.

Figure 8. Cross-section of thermal fatigue cracks.

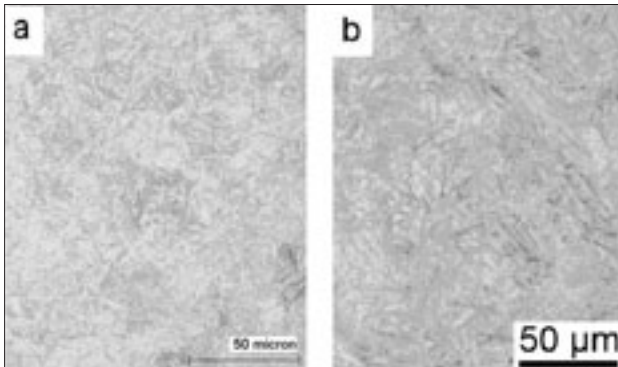
Figure 9. Microstructure of die material: a) near the surface and b) 3 mm below the surface.

Crack initiation is accelerated by gradual softening of die surface material during operation of the die [9, 11]. This is caused by tempering due to high temperature of aluminium alloy. Figure 9 shows microstructures of die material near the die surface (Figure 9a) and three millimeters below the die surface (Figure 9b).

The microstructure near the die surface (Figure 9a) has been changed due to high temperature that leads to tempering of the martensite. The tempering of the martensite caused a decrease in hardness by about 130 HV (Figure 10) on the die surface compared to hardness of the die material deeper in the core. Decrease in die material hardness consequently led to decreasing material resistance against thermal fatigue cracking.

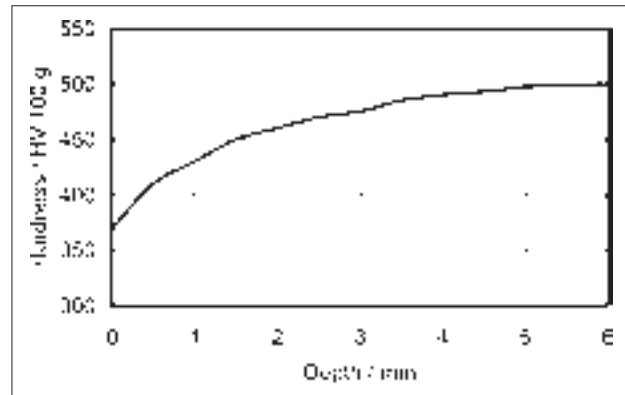
Figure 10. Die material hardness versus depth from surface.
