Hurricane Effects on South Florida Water Management System: A Case Study of Hurricane Wilma of October 2005

Wossenu Abtew and Nenad Iricanin¹

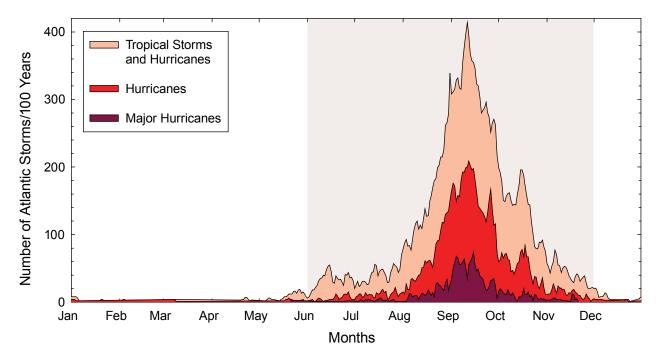
Figure 1. Distribution of North Atlantic tropical storms from 1906 through 2006. Data source (<u>http://weather.unisys.com/hurricane/atlantic/index.html</u> accessed on November 15, 2007). Shaded area denotes hurricane season (June through November).

The distribution of tropical systems, excluding depressions, from 1906 through 2006 is shown in Figure 1. Eighty-two percent of tropical storms and hurricanes occurred from the beginning of August through the end of October. Between 1871 and 1996, 114 tropical systems affected the Florida peninsula with approximately 50 percent of the systems being hurricanes (Attaway, 1999). A tropical system is classified as tropical storm when maximum sustained wind speeds reach 63 km h⁻¹ and as hurricane when wind speeds are at least 119 km h⁻¹. Hurricanes strengths are further categorized based on wind speed (in km h⁻¹) as follows: Category 1 (119-153), Category 2 (154-177), Category 3 (178-209), Category 4 (210-250) and Category 5 (> 250).

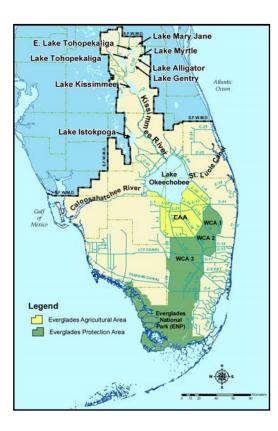
Figure 2. The South Florida Water Management District with water management infrastructure (canals, lakes and impoundments).

The South Florida Water Management System extends from Orlando to the north to the Florida Keys to the south (Figure 2). It covers an area of 46,400 km² extending across 16 counties. The SFWMD manages the region's water resources for flood control, water supply, water quality and natural systems needs. The region's water management system consists of lakes, impoundments, wetlands, and canals that are managed under a water management schedule based on flood control, water supply, and environmental restoration. The general surface water flow direction is from the north to the south, but there are also water supply and coastal discharges to the east and the west. The major hydrologic components are the Upper Kissimmee Chain of Lakes, Lake Okeechobee, Lake Istokpoga, the Everglades Agricultural Area (EAA), the Caloosahatchee Basin, St. Lucie Basin, the Lower East Coast and the Everglades Protection Area (EPA). The Upper Kissimmee Chain of Lakes is a principal source of inflow to Lake Okeechobee. The primary source of inflow into Lake Okeechobee is the Kissimmee River (C-38 Canal) which drains the Upper Kissimmee (4,194 km²). Lower Kissimmee (1,882 km²) and part of the Istokpoga water management basins. Other inflows into Lake Okeechobee include flows from Lake Istokpoga and Lake Istokpoga Surface Water Management Basin, 1,082 km² (through C-40, C-41 and C-41A canals), Fisheating Creek, the Taylor Creek-Nubbin Slough Basin and reverse flows from the Caloosahatchee River, the St. Lucie Canal, and the EAA (Abtew et al., 2007).

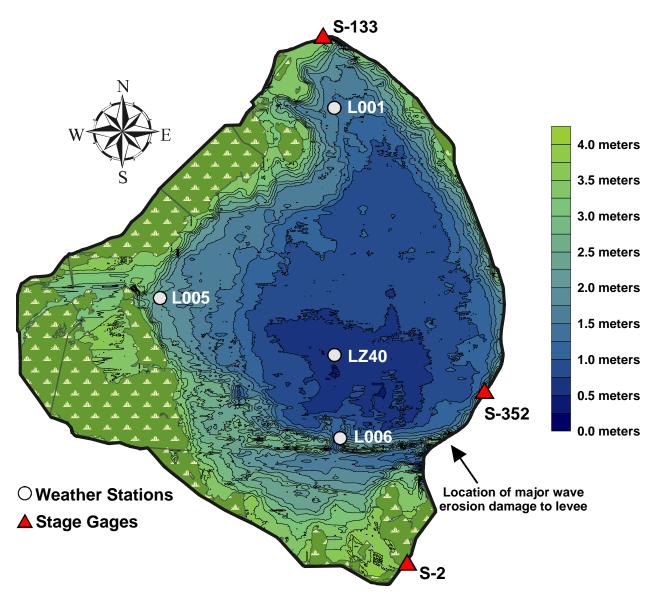
Figure 3. Map of Lake Okeechobee bottom elevations with locations for weather stations (circles), water level measurement sites (triangles), and location of levee erosion.

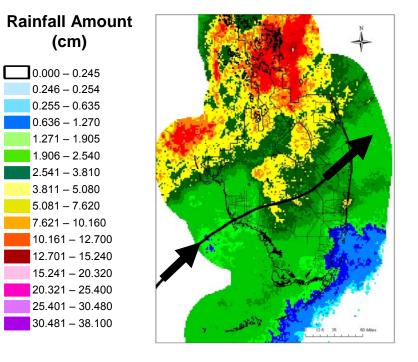
Figure 4. Path of Hurricane Wilma across South Florida on October 24, 2005 and cumulative rainfall amounts generated by the hurricane (October 22-25, 2005).

According to the National Hurricane Center (Pasch et al., 2006), Hurricane Wilma formed as a tropical depression on October 15, 2005, east-southeast of the Grand Cayman Island. On October 18th, Wilma became a hurricane moving west-northwestward towards the Yucatan Peninsula. Wilma strengthened to a Category 5 hurricane on October 19th, with a record low pressure of 882 mb (661.7 mm mercury), a record for an Atlantic hurricane. The hurricane made landfall on the island of Cozumel, Mexico, as a Category 4 hurricane. A day later, Wilma crossed the Yucatan Peninsula after prolonged battering of the northeastern section and re-emerged in the Gulf of Mexico on October 23rd as a Category 1 storm. While being steered toward the west coast of South Florida, Wilma strengthened further and made landfall as a Category 3 hurricane near Cape Romano at the southwest corner of South Florida on October 24th. During its swift crossing of South Florida to the Atlantic (4.5 hours), Wilma weakened to a Category 2 hurricane. The path taken by Hurricane Wilma across South Florida and the rainfall coverage are depicted in Figure 4.

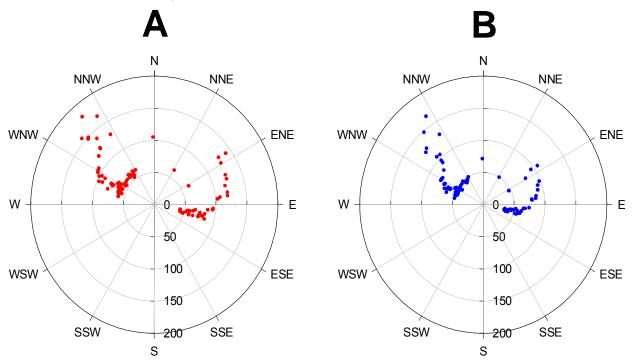
Figure 5. (A) Maximum gust wind speed (km h^{-1}), (B) Average wind speed (km h^{-1}) and wind direction at L006 weather station in Lake Okeechobee during Hurricane Wilma at 15-minute intervals (October 24th, 2005).

Four weather stations are located within Lake Okeechobee. Gust wind speed, average wind speed, and wind direction data were collected during Hurricane Wilma at three of the weather stations (L001, LZ40, L006). Weather station L001 (located at the northern side of the lake) registered instantaneous maximum gust wind speed of 172 km h⁻¹, while weather station L006 (located in the south-side of the lake) registered instantaneous maximum gust wind speed instantaneous maximum gust wind speed (sampled every 10 seconds; maximum in 15 minutes) and 15-minute average wind speed and direction over the lake correspond with the area of levee erosion and high water levels. Wind direction over the lake is clearly depicted as east-northeast (ENE) from the front side of the hurricane and northwest (NW) from the backside of the hurricane (Figures 5A and 5B). Both the gust and average wind-speed data show that the back side of the hurricane had higher wind speeds than the front side. The elevation at which wind speed was measured was 11.7 m NGVD as verified at station LZ40.

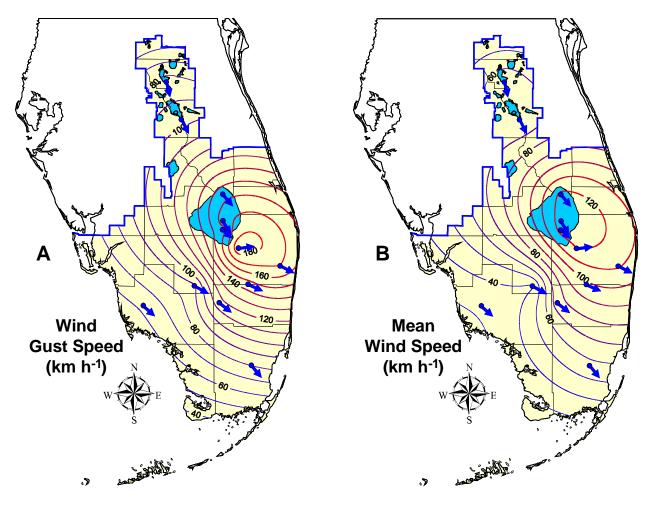
Figure 6. (A) Maximum gust wind speed (km h⁻¹) and (B) 15-minute average wind speed and directions from Hurricane Wilma over South Florida at 10:30 am on October 24th, 2005.

Hurricane winds can generate high waves and storm surge, and the energy from the back-and-forth battering of an earthen levee can result in cutting the levee. Also, failure can occur around structures on the levee. Several areas were eroded along the lake levee as Hurricane Wilma passed through the area. If the wave setup and storm surge exceed the height of the levee, then washout could occur to the lake side, top, and outer side of the levee. The wave setup and storm surge from Hurricane Wilma exceeded the maximum reading capacity of water level recorders on the perimeter of Lake Okeechobee. Survey from the watermark preserved by District staff at the S-2 pump station, at the southern levee, indicated the wave setup and storm surge had reached 9.34 m NGVD. The lake water level at the time was 4.76 m NGVD, resulting in a wave setup of 4.58 m at the southern end of Lake Okeechobee. The maximum gust wind speed over the lake occurred at 10:30 am on October 24th, 2005 from the back winds of the hurricane. Figures 6A and B depict the spatial pattern and magnitude of the hurricane gust and 15-minute average wind speed at the time of peak and wind directions. Part of the levee was eroded from waves generated by Hurricane Wilma (Figure 7). The maximum wind speed and the direction correspond to this segment of the lake levee that was severely eroded (Figure 3, 6A, 6B and 7). Gust wind speed at the farthest north area of the District was 60 km h⁻¹ and 40 km h⁻¹ at the southern tip of the District.

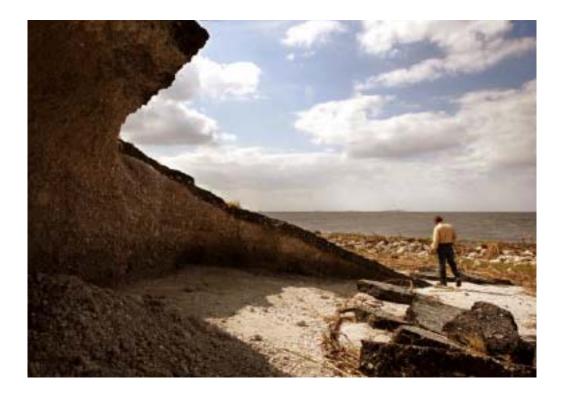
Figure 7. Wave erosion damage to the Herbert Hoover Dike of Lake Okeechobee from Hurricane Wilma (Bromwell et al., 2006).

1926 and 1928, respectively (Bromwell et al., 2006). In 1947 and 2005, the dike around Lake Okeechobee experienced significant levee erosion from hurricane-generated wave setup and storm surge. Water control structure and canal performance is decreased due to vegetation and other debris accumulation from hurricane activity. Of all the hurricanes that affected South Florida during the 2004 and 2005 hurricane seasons, Hurricane Wilma (October 24th, 2005) produced the most damage to the Herbert Hoover Dike of Lake Okeechobee. The effects of Hurricane Wilma on South Florida, specifically Lake Okeechobee, are discussed in this paper.

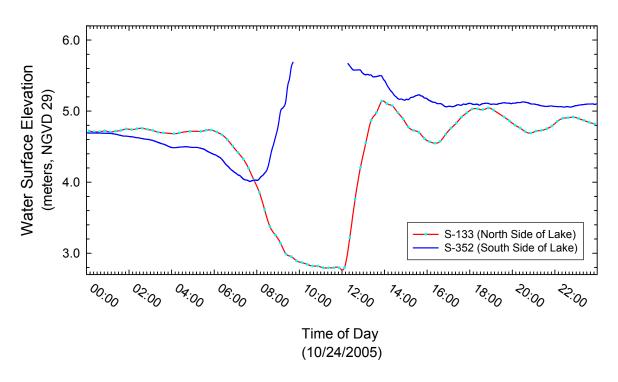
Figure 8. Water surface elevation changes in Lake Okeechobee during the passage of Hurricane Wilma over South Florida at gauge S-133 (upwind) and S-352 (downwind). The break in elevation for the S-352 gauge resulted in wave height exceeding water level sensor maximum reading.

level as it is out of the range of normal operations. Two gauges, one from the north, upwind, (S133) and one from the south, downwind, (S352) depict the water level tilt in a limited way (Figure 8).

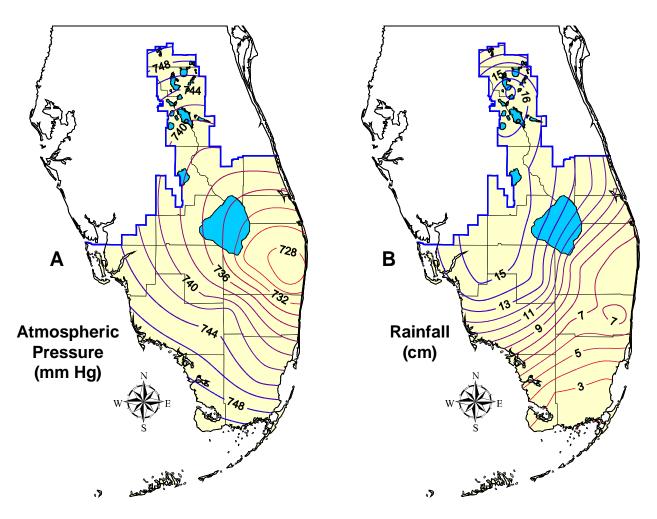
Figure 9. (A) Atmospheric pressure (mm mercury) at peak wind speed over Lake Okeechobee (10:30 am on October 24, 2005) and (B) rainfall (cm) from Hurricane Wilma (October 22-25, 2005).

is asymptotic, the radius of maximum wind, and radius of the point of interest (Myers, 1954). The pattern of the pressure spatial distribution has a similar pattern to the wind speed spatial distribution with low pressure corresponding to high wind speed as expected (Figures 6A, B and 9A). The minimum 15-minute average pressure through the duration of the hurricane over South Florida was 713 mm mercury (950 mb) measured at STA5WX weather station (7:45 am on October 24, 2005) southwest of the lake. Minimum pressure over the lake occurred earlier than the maximum wind speed over the lake (Figure 10).

Rainfall from Hurricane Wilma ranged from a spatial average of 17 cm over the Upper Kissimmee rain area to the north to 3 cm over the Everglades National Park to the south (Figure 9B). The rainfall was higher in the left quadrant of the hurricane and lower on the right quadrant (Figure 4, 9B). The characteristics of rainfall from a tropical system are that the spatial coverage is large with regional effect. This type of coverage results in generation of a very large volume of water over the region in a short time. The isohyetal map (Figure 9B) shows the spatial rainfall from Hurricane Wilma accumulated from October 22 through October 25, 2005, during the influence of the hurricane. Runoff associated with the hurricane rainfall had a lingering effect on the lake. Rise in lake stage results in a high rate of discharge to manage the lake water level. Such discharges include releases to environmentally sensitive estuaries to the east and to the west. Fortunately, Hurricane Wilma moved quickly through the area. Slower movement of the hurricane might have had extensive hydrologic and structural impact that would have included large-scale flooding as wave erosion increases with duration of impact.

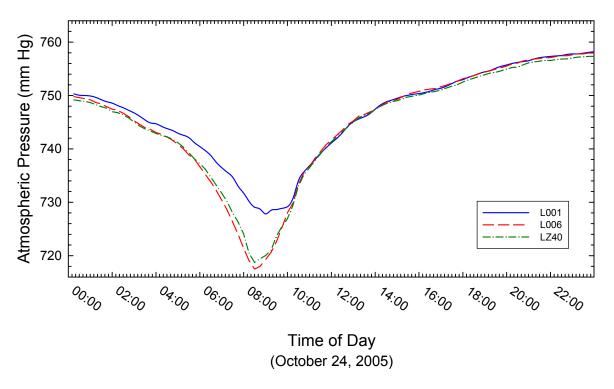
Figure 10. Atmospheric pressure changes (in mm of Hg) over Lake Okeechobee during the passage of Hurricane Wilma over South Florida; L001 (north), L006 (south central) and LZ40 (south).

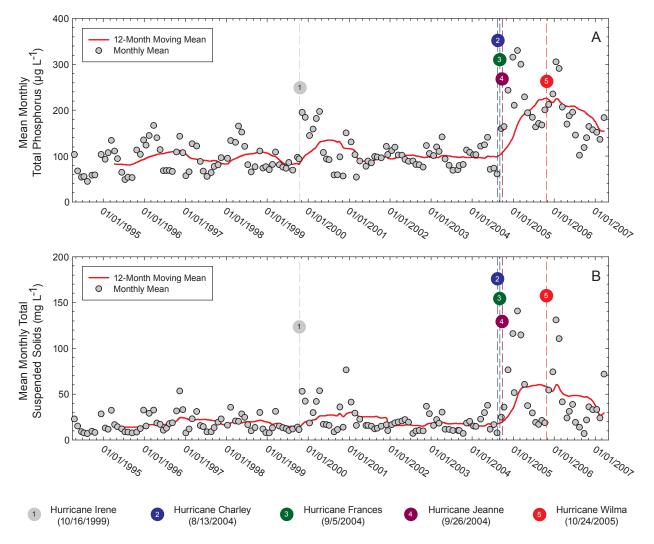
Figure 11. Spatial monthly mean total phosphorus concentrations (top) and total suspended solids (bottom) in Lake Okeechobee from May 1994 through March 2007. Vertical lines show dates when hurricanes directly impacted the lake. Data following March 2007 were not included in plot due to severe drought conditions

During the pre-hurricane period, spatial monthly mean TP and TSS ranged from 45 to 167 μ g L⁻¹ and 7 to 53 mg L⁻¹, respectively (Figure 11). Temporal mean concentrations for this period were 90 μ g L⁻¹ for TP and 18 mg L⁻¹ for TSS. The 12-month moving average line for the pre-hurricane period shows no major trend in the data.

By May 2000, spatial mean TP and TSS concentrations in the lake decreased (Figure 11). Although Lake Okeechobee did not experience any direct impact from hurricanes from May 2000 through the first half of August 2004, lake management and a severe drought affected the lake and may have contributed to reducing the impact from Hurricane Irene. From April 25 through June 30, 2000, the lake was under a "managed recession" and water levels were brought down to improve the lake's littoral region. By the start of 2001, Lake Okeechobee was experiencing a severe drought which lasted well through September 2001. As a result of these conditions, TP and TSS concentrations during the period from May 2000 through August 12, 2004, were comparable to pre-hurricane levels (Figure 11). The 12-month moving average line is relatively flat suggesting no trend for the period.

Following this relatively quiescent period, the lake was affected by three hurricanes within two months (Figure 11). Concentrations of TP and TSS in Lake Okeechobee increased from August through December 2004 with temporal means of 189 μ g L⁻¹ and 52 mg L⁻¹, respectively, with maximum monthly concentrations reaching 316 μ g L⁻¹ and 116 mg L⁻¹. Over the next 10 months, TP and TSS concentrations remained high (Figure 11).

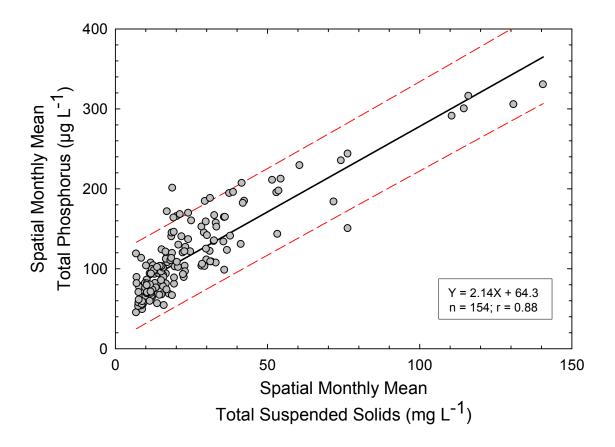
Figure 12. Correlation plot of spatial monthly mean total suspended solids with mean monthly total phosphorus concentrations in Lake Okeechobee from May 1994 through March 2007. Dashed lines show the 95th prediction intervals for the regression.

When net phosphorus loads to Lake Okeechobee are evaluated for the period impacted by Hurricane Wilma, it is evident that increased TP and TSS levels observed in the lake resulted from internal resuspension rather than net inputs from outside sources. In addition, phosphorus in the water column is strongly correlated with suspended solids. Using spatial monthly means from May 1994 through March 2007, a strong positive linear relationship (r=0.88) was found between TSS and TP (Figure 12). Suspended solids limit growth of submerged vegetation by reducing the depth of light penetration. The hurricanes uprooted and dislocated vegetation from wetlands and littoral zones around the lake resulting in increased suspended detritus.

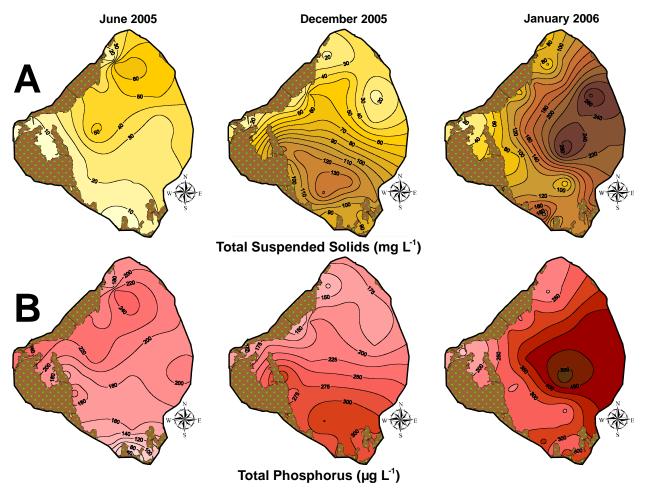
Figure 13. Isoline maps showing lake-wide concentrations of (A) total suspended solids and (B) total phosphorus in Lake Okeechobee starting from the beginning of the 2005 hurricane season (June 2005), December 2005, and January 2006.

At the start of the 2005 hurricane season (June 2005), TP and TSS levels across the lake did not exceed 250 μ g L⁻¹ and 100 mg L⁻¹, respectively. In addition, more than 50 percent of the lake (based on the isoline maps) had TP concentrations less than 200 μ g L⁻¹ (Figure 13). Immediately following the hurricane season (December 2005), 72 percent of the lake exhibited TP concentrations more than 200 μ g L⁻¹ while 23 percent of the lake had TSS levels greater than 100 mg L⁻¹. By January 2006, more than 90 percent of the lake exhibited TP concentrations in excess of 200 μ g L⁻¹ (Figure 13). Additionally, approximately 69 percent of the lake had TSS levels greater than 100 mg L⁻¹ for this month. Both parameters generally exhibited higher concentrations in the limnetic zone than nearshore or littoral regions following the hurricane (Figure 13).

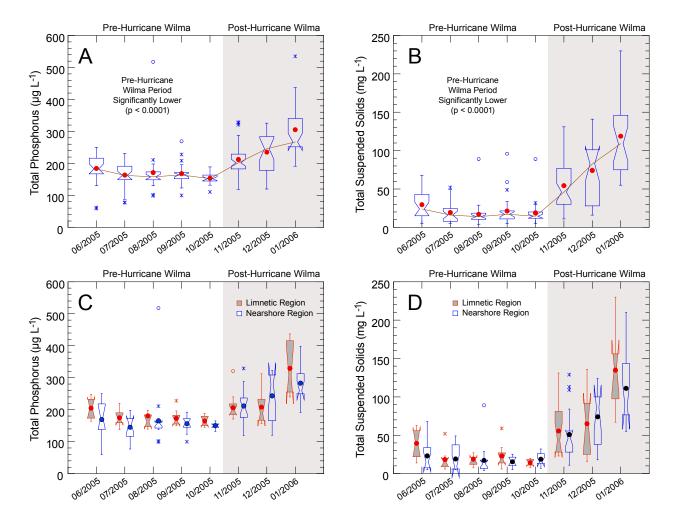
Figure 14. Monthly box-and-whisker plots of total phosphorus concentrations (A and C) and total suspended solids (B and D) in Lake Okeechobee from the start of the 2005 hurricane season (June 2005) through January 2006. Plots A and B contain data for all in-lake monitoring stations while plots C and D contain only stations located in the limnetic and nearshore regions. The solid circles represent the mean and the notch represents the median concentration. Upper and lower boundaries of boxes are 25th and 75th percentiles. Upper and lower whiskers represent the lowest and highest values not outside 2 standard deviations from the median. Shaded region in each plot denotes the post –Hurricane Wilma data.

Temporal distributions of monthly in-lake TP and TSS concentrations measured at monitoring stations in Lake Okeechobee, from June 2005 through January 2006, are shown as notched box and whisker plots in Figure 14. Figures 14A and 14B show TP and TSS concentrations for all monitoring stations. Nearshore and limnetic TP and TSS concentrations were also plotted for the same period to show spatial distribution for these two parameters (Figures 14C and 14D). In all cases, TP and TSS concentrations were lower prior to Hurricane Wilma. Following the hurricane, median concentrations for all monitoring stations increased significantly from 163 μ g L⁻¹ to 240 μ g L⁻¹ for TP and from 16 mg L⁻¹ to 74 mg L⁻¹ for TSS.

A statistical comparison of TP and TSS data for the pre- (June 2005 through October 2005) and posthurricane (November 2005 through January 2006) periods was performed using a non-parametric test (Mann-Whitney) because the data were not normally distributed. A significance level (α) of 0.05 was used to indicate statistical significance. The analysis showed TP and TSS concentrations for these two periods were statistically different (p-value <0.0001) with the post-hurricane period having significantly higher concentrations. In addition, a Kruskal-Wallis test was used to determine whether the months of the prehurricane period had statistically different concentrations. The results indicate that TP and TSS concentrations during the pre-hurricane period were statistically different between months (p-values at 0.007 and 0.049, respectively). A post-hoc analysis, using the Mann-Whitney test, revealed that June 2005 TP and TSS concentrations were significantly higher (p-value <0.04) than the other four months of the pre-hurricane period. It has to be noted that water quality for October 2005 was sampled two weeks prior to Hurricane Wilma and was included in the pre-hurricane data. This decreasing trend in TP and TSS concentrations for the pre-hurricane period is shown in Figure 14.
