## ANALYSIS AND REMEDIATION OF THE 2013 LAC-MÉGANTIC TRAIN DERAILMENT

Suzanne Brunke<sup>a</sup>, Guy Aubé<sup>b</sup>, Serge Legaré<sup>c</sup>, Claude Auger<sup>d</sup>

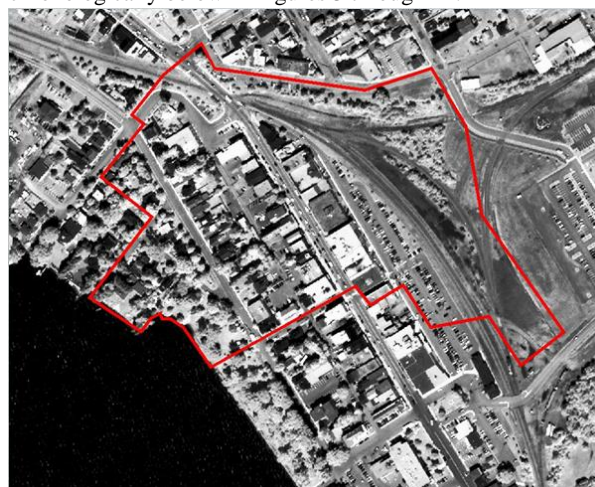
Figure 3. Pre-Derailment Image of Lac-Mégantic, WorldView-1 image acquired June 29, 2012. © DigitalGlobe 2012

Nine high resolution optical images are displayed chronologically below in Figures 3 through 11.

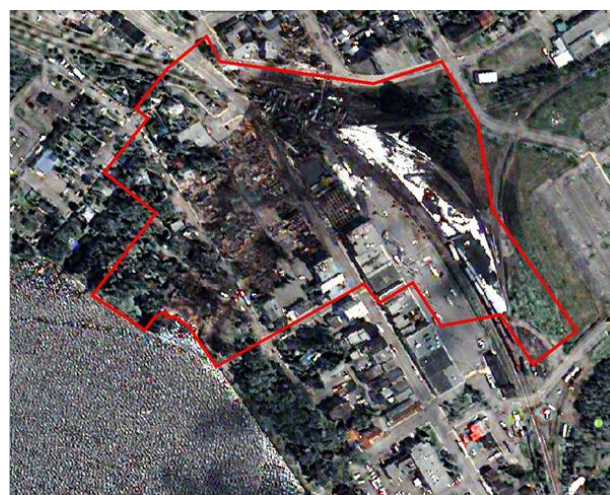
Figure 4. Post-Derailment Image of Lac-Mégantic shows the devastation of the town in the QuickBird image acquired July 7, 2013, one day after the disaster. © DigitalGlobe 2013

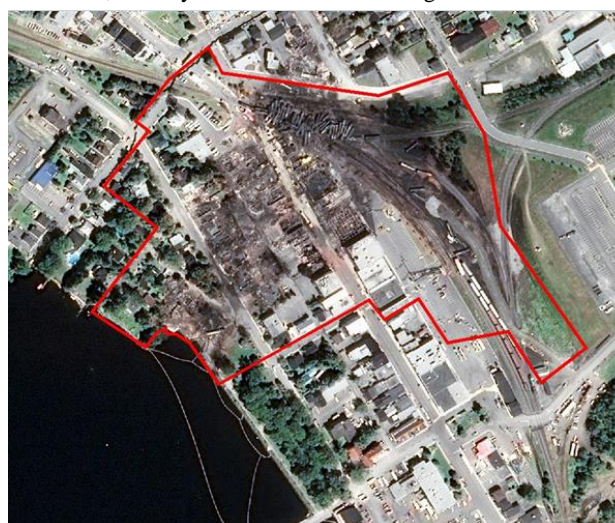
Figure 5. Pléiades image acquired one week post derailment on July 13, 2013. © CNES 2013, Distribution Airbus DS

In Figure 5 above, the Pléiades image acquired one week post derailment shows considerable rubble where buildings were located; the train tanker cars remain unmoved though there has been some removal of debris. Booms to contain oil were deployed on the lake, and are visible in the satellite imagery.

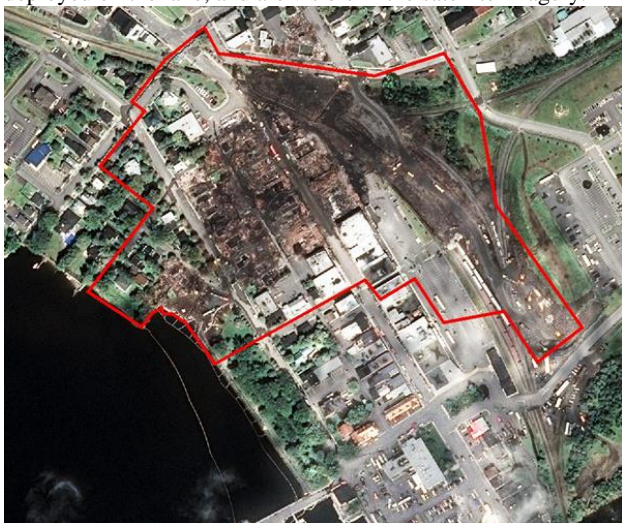
Figure 6. Pléiades image acquired three weeks post derailment on July 29, 2013. © CNES 2013, Distribution Airbus DS

In Figure 6, just over three weeks post derailment, the majority of the train tanker cars have been removed as well as a considerable amount of debris from the fallen buildings from within the red zone. Additional booms can be seen deployed on Lac-Mégantic. In Figure 7, crews continue to remove debris and contaminated soil from the area.

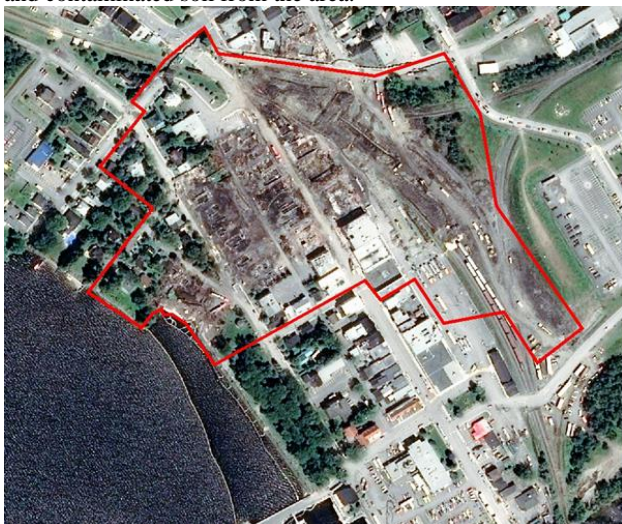
Figure 7. Pléiades image acquired on August 2, 2013.  
© Airbus Defense 2013

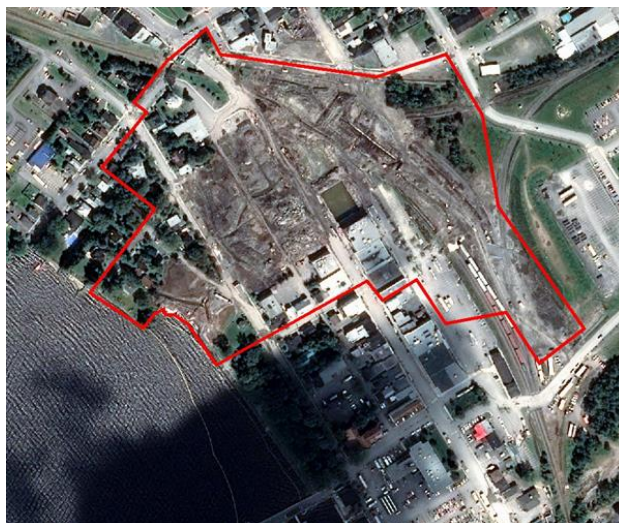
Over a month after the derailment and subsequent explosion, Pléiades acquired a cloud-free image on August 15, 2013 as seen in Figure 8. Further excavation of the site continues, and can be monitored easily with the high resolution optical imagery. Most building foundations have now been removed and water has accumulated in one former building location where soil had been excavated. There are fewer vehicles that remain on site.

Figure 8. Pléiades image acquired over a month post derailment on August 15, 2013. © CNES 2013, Distribution Airbus DS

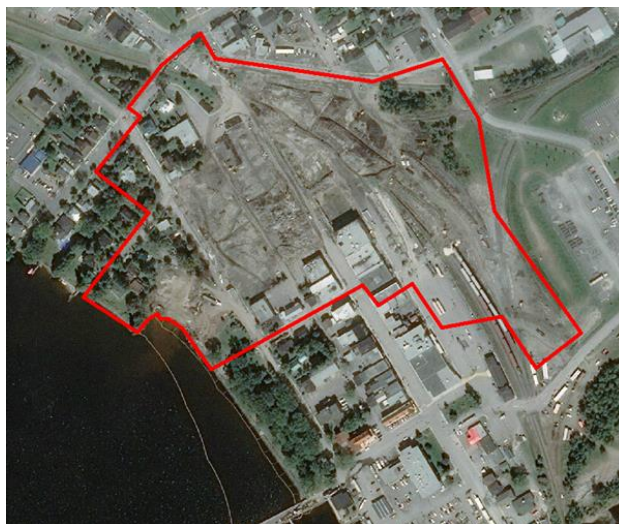
Images shown in Figures 9 and 10 illustrate the further progress of the reclamation effort by crews on the ground. Most debris and contaminated soil has been removed, the water has evaporated from the building excavation sites.

Figure 9. Pléiades image acquired on August 24, 2013 shows the progress of the reclamation effort.  
© CNES 2013, Distribution Airbus DS

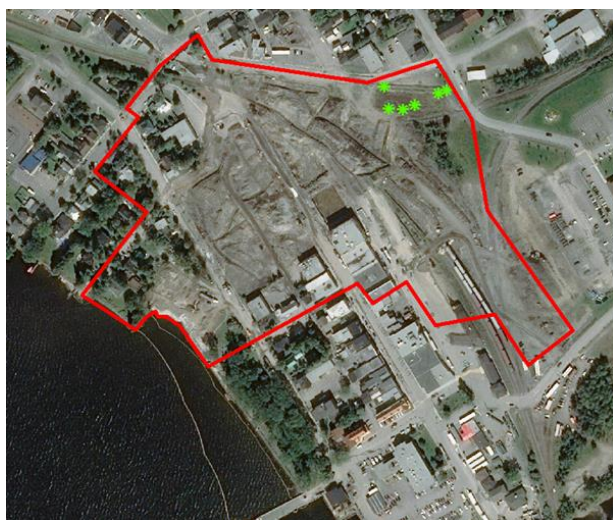
Figure 10. Pléiades image Acquired on September 6, 2013 shows the removal of a stand of trees highlighted in green.  
© CNES 2013, Distribution Airbus DS

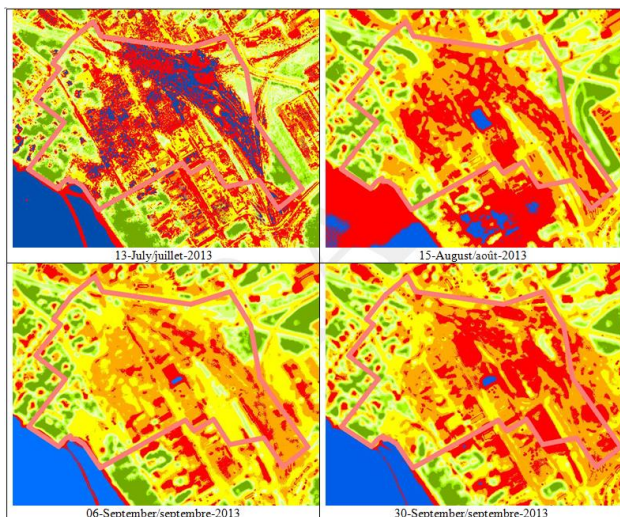
The NDVI results were grouped into 10 classes and are illustrated in Figure 15. Blue or red colours show very low values typically associated with water or bare earth. Orange and yellow were either transitional or indicative of stress or considered to be a low value typically characterized by soil and low density of any biomass. Anything that is green was considered vegetation. An increasing deep colour of green represents an increased amount of biomass.

Figure 15. Time progressive NDVI results for the Lac-Mégantic Red Zone. © MDA, All Rights Reserved.

The changing NDVI results visible in the remaining vegetation for the progressive dates after the explosion is due primarily to the removal of soil, and the changing of seasons. Yearly monitoring will determine whether the hydrocarbons that leached into the ground will significantly impact the health of the remaining trees and parks over the next decade.

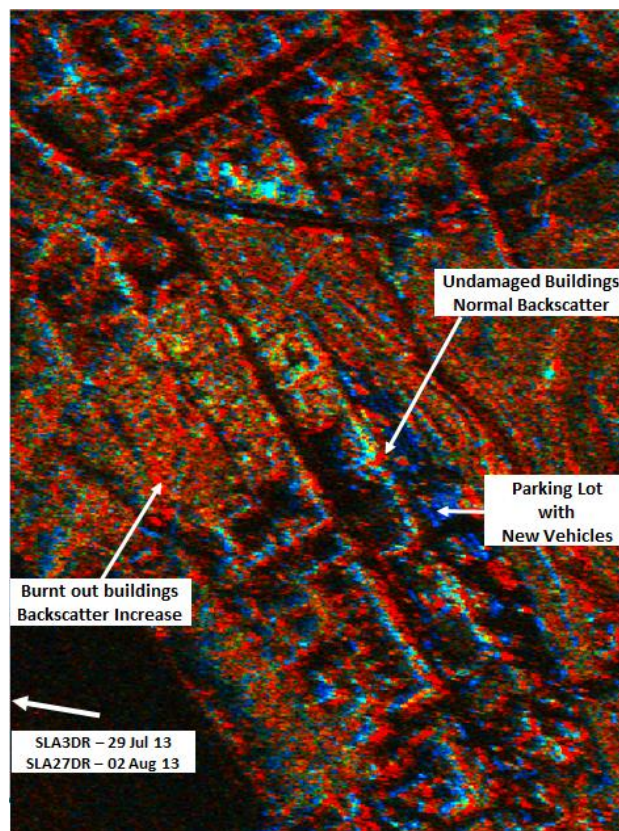
Figure 16. Comparing change between image dates of 29 July, 2013 and 2 August, 2013.

Comparing the intact buildings in the commercial district in the lower center portion SAR image in Figure 16 with the buildings that were destroyed by the fire, the clean specular surface characteristic of buildings is no longer present, and the returns from those areas on the SAR imagery are quite noisy from the debris on the ground. The parking area shows an increase of vehicles between the two SAR images.

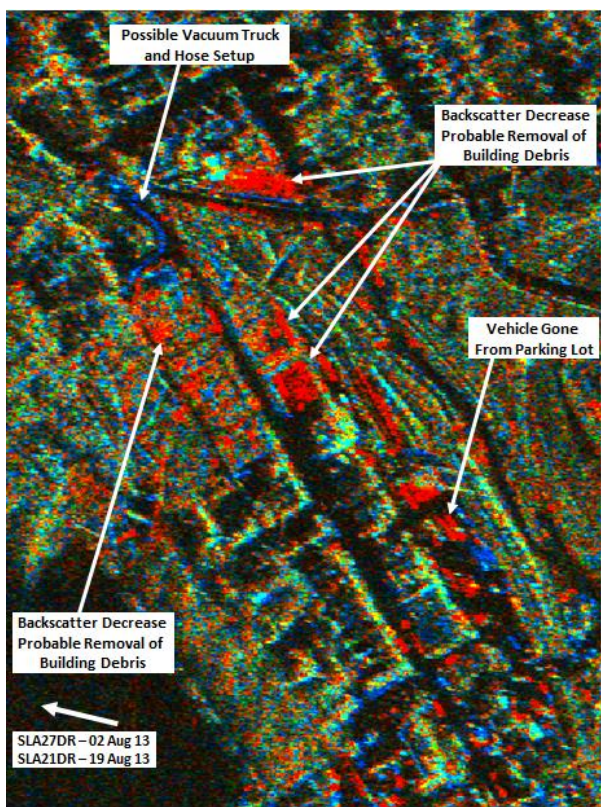
In Figure 17, the red returns from the areas of destroyed buildings signifies that the damaged material is being removed. Significant changes are seen in the amount of building debris, it appears that the vehicles or equipment have been removed from the parking lot. There is a new blue return that is sitting in the middle of the north end of Rue Frontenac with a long winding return running down the middle of the street into the destroyed portion of the town. It is assessed as a probable vacuum truck with a tanker unit and the blue line would represent a hose set up. They are probably removing oil and water that has collected in the building foundations and the streets/yards.

Figure 17. Comparing change between image dates of 2 August, 2013 and 19 August, 2013.

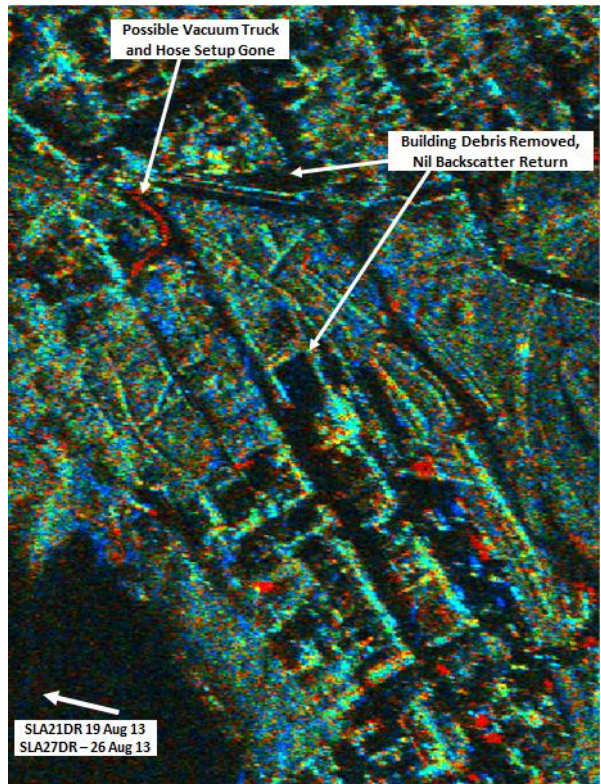
Figure 18. Comparing change between image dates of 19 September, 2013 and 29 September, 2013.

The first change evident in Figure 18 is that the vacuum truck and hose set up has been removed. The three areas of red from the previous SAR comparison have come back as very specular indicating that all the material has been removed, and there is likely only smooth concrete remaining. The parking area east of the commercial district continues to see vehicles coming and going. The bulk of the destroyed area on the southwest side of the road continues to show work being done to remove material.

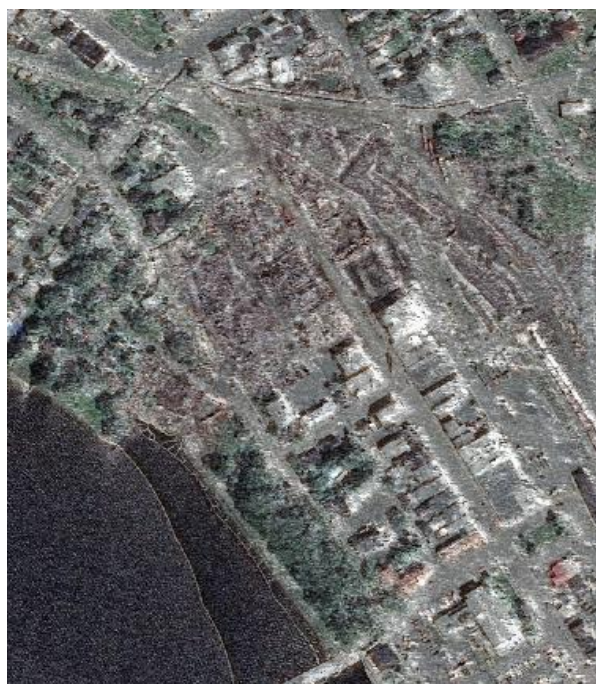
Figure 19. Both Pléiades and RADARSAT-2 were acquired on August 2, 2013 to generate this Fused RGB Composite.

Figure 19 was generated by fusing the multispectral bands of the colour Pléiades image and the intensity of RADARSAT-2 Spotlight image, both acquired on August 2, 2013. The resulting image shows the colour from the optical scene coupled with the texture and finite details from the SAR and can aid in SAR interpretation.

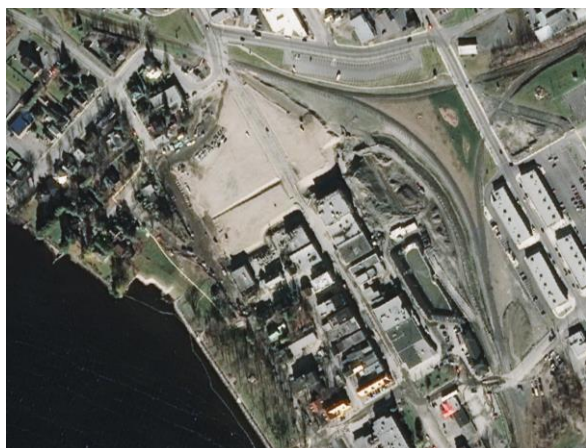
The following Figures 20 and 21 further demonstrate the use of high resolution satellite imagery to maintain yearly monitoring on the progress of the site remediation. Figure 21 shows the additional buildings that have been removed due to wide-spread contamination of hydrocarbons below the building framework.

Figure 20. This Pléiades image Acquired on November 3, 2014 illustrates the progress of the remediation 16 months post-derailment. © CNES 2014, Distribution Airbus DS

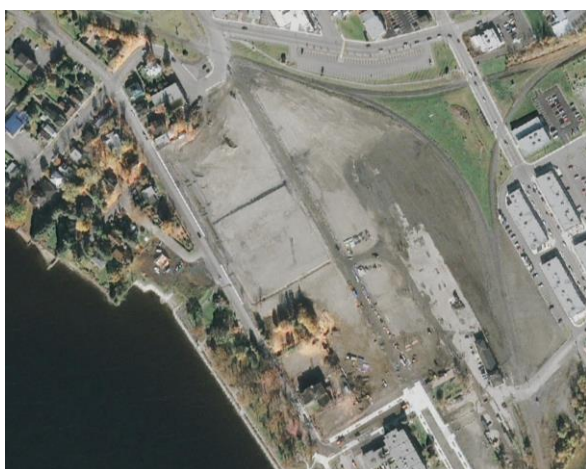
Figure 21. This Pléiades image from October 19, 2015 is the most recent optical image of the disaster site, note the number of newly removed buildings.
