BRIDGING THE GAP BETWEEN GLOBAL AND LOCAL STRATEGIES OF ARCHITECTURAL CONSERVATION, EXAMPLES OF THE CURRENT SCENARIOS IN INDIA.

Manogna Kavuru

Department of Architecture, Built environment and Construction Engineering, Politecnico di Milano – Lecco,
manogna.kavuru@mail.polimi.it

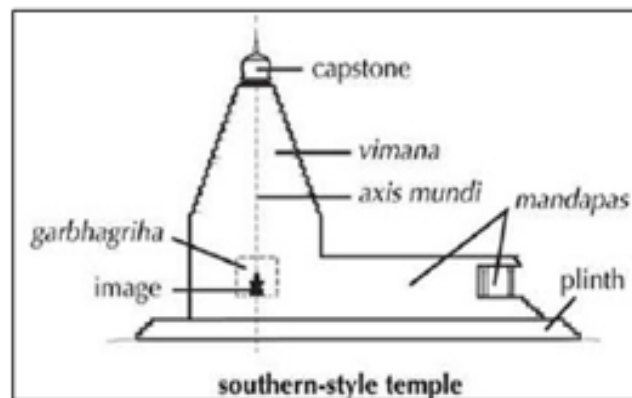
Figure 1 Elements of Dravidian Style Temple (Vardia, 2008)

- The principle component is the temple itself and is called the *Vimana*. It is almost always square in plan and surmounted by a roof that is pyramidal; it contains the sanctum where the idol of the god or his emblem is located.
- The porticos are called as *Mandapas* or *Mantapams*, they are provided to shade the entrance of the inner sanctum.
- The gateways also known as the *Gopurams* that are the fundamental features in the quadrangular enclosures that surround the temples. The size of the *Gopurams* change from temple to temple.
- Pillared halls otherwise known as *Chaultris* were used for various purposes; historically people who used to visit from far off places used it as resting places.

Besides these, a temple always comprises of temple tanks or wells for water (used for the daily rituals in the temple and for the basic ablutions of the people who visit them temple);

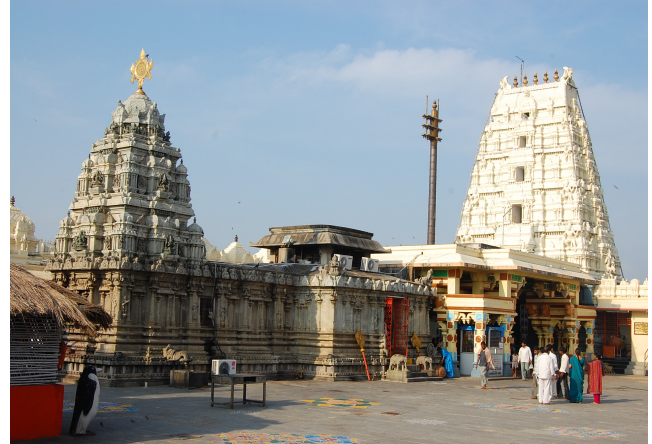
Figure 2 Srikalahasthi Temple

The Temple was constructed during the *Pallava* Period of the 10-11th century and most of the current remaining structures were made under the reign of the King Kulathuna Chola during the end of the 11th century. Later additions included a hundred pillared *mandapam* or portico commissioned by Sri Krishnadevaraya of the *Vijayanagara* Dynasty during the 16th century. The main temple is carved out of a single stone hill and the later added parts were made of brick masonry with stone supports at some significant places (Chandra, 2000).

The main *Gopuram* on the right side of the Temple was built in the 16th century, as a symbol of victory is called the *Rajagopuram* and was 136feet in height. It had been observed over the last decade that cracks had been appearing on the *Gopuram* and a critical crack developed 25 years ago had grown into a vertical fissure and ended at the base layer. This was specifically prominent few weeks before the collapse of the structure (see figure 3) and a commission was ordered to consider the issue. However, before any work of restoration could commence, the *Gopuram* collapsed at 8:30pm on May 26, 2010. (V.Sundaram, 2010)

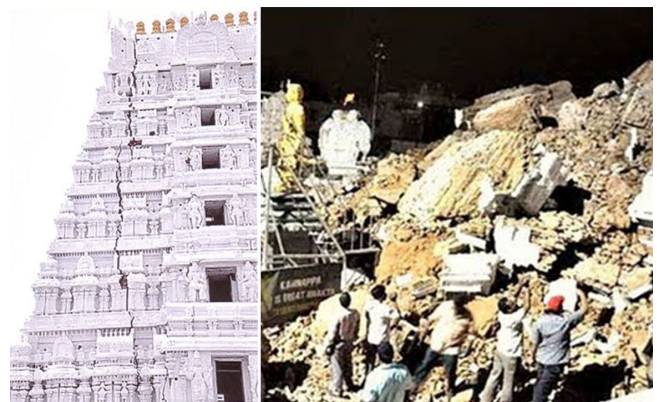
Figure 3 Gopuram before and after collapse (V.Sundaram, 2010)

The collapse had been attributed to the rampant bore well digging in the area as well as the occurrence of the '*Laila*' cyclone in the state of Andhra Pradesh. An enquiry commission had been ordered to look into the issue and it was proposed that the *Gopuram* be rebuilt with support from the Archeological survey of India. On January 17, 2017, the new *Gopuram* was inaugurated. The new structure was supposed to be reminiscent of the past and was to include relics from the collapsed *gopuram*. However the new *gopuram* does not indicate in anyway which materials are new and which are old and is of different dimensions than the old *gopuram* (Indian Express news service, 2017).

It can be observed in both the cases that maintenance or mainly the lack of it is the problem. Crack development was observed on both the structures; nevertheless, they were not monitored and the cracks increased exponentially in size leading to the collapse of the structure. The authorities that were instated to take care of the buildings were incapable of preventing the mishaps and furthermore the suggestions post these happenings were regarding the demolition of the existing structure and construction of a new structure very like the previous one. This approach constitutes the diminishing of the cultural value of the structure and the concept of preservation is lost. It is imperative that the Indian system incorporates some techniques adopted by other countries, such as preventive maintenance and planned conservation to safeguard its cultural built heritage.

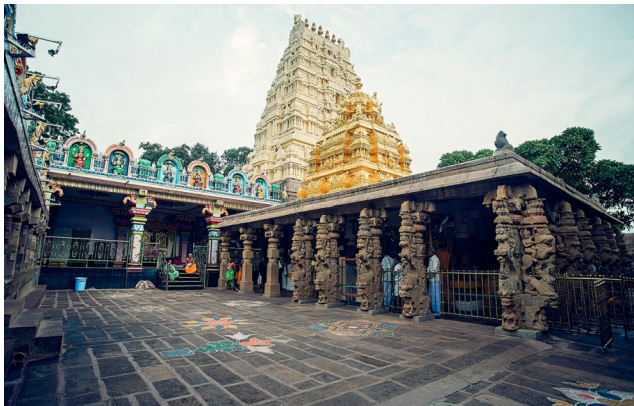
Figure 4 Srisailam Temple (Srisailam Devasthanam, 2016)

Archeological studies suggest that inhabitation of *Srisailam* dates back to 30,000-40,000 years. Epigraphical evidences show relations to that the place was closely linked to the *Satavahanas*, the first rulers of the South Indian region. Inscriptional evidences suggest the Architectural features to belong to the *Chalukya* period (AD 624-848). The *Kakatiyas* (AD 953-1323) had contributed to the development of the temple. Later, renovations were introduced by the *Vijayanagara* rulers (AD 1336-1678). The construction of the *Rajagopuram* is accredited to Sri Krishnadevaraya of this dynasty. Since the construction of the temple occurred over a period of time, it can be observed that various elements of the temple are made of different materials. The main temple inner sanctum being made of stone, the surrounding gopurams are noted to be made of brick masonry (Srisailam Devasthanam, 2016).

The *Shivaji Gopuram* as it is famously known can be dated to be about 500 years old. The 82ft high structure collapsed at 2.10am on October 3rd, 2012. Located on the northern side of the temple, the gopuram is believed to be constructed by the King Shivaji, hence the name. It had served as one of the main entrances to the *Mallikarjuna* temple of *Srisailam*. (The Hindu, 2012) Circa 1962-64 some cracks were noticed to develop on the gopuram due to stresses caused by the decaying of wooden beams inside the gopuram. The state government had then carried out the necessary repairs, which included cement plastering.

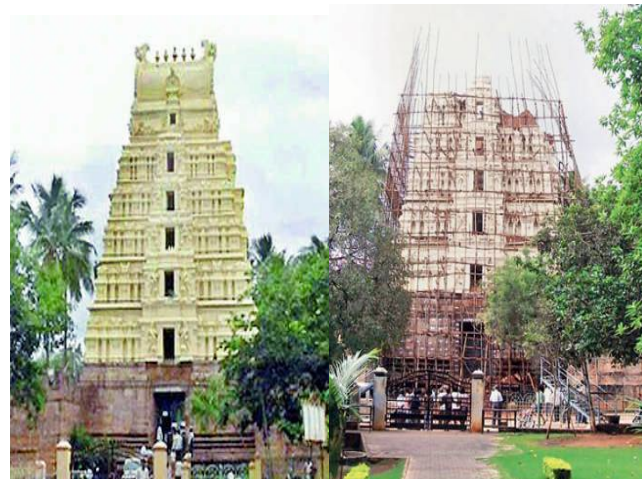
Figure 5 Shivaji gopuram – before and after collapse (indiatemplesinfo, 2012)

was noticed that the *Shivaji* gopuram was the weakest. A decision was then made to demolish it completely to rebuild a new one, but it did not happen due to concerns raised by the state archeological department. However, by 2012, the situation had worsened and the internal cracks from before had worsened and penetrated to the exterior of the brick gopuram, while the wooden paneling on the interior was completely decayed, the internal plaster was deteriorated too and finally more than half of the structure collapsed. (YoungIntach, 2012)
