# 日本高松冢古坟微生物病害及其防治研究概述

**摘要:** 高松冢古坟是日本国宝级文化遗产,对其实施的原址保护一度是文物保护界的样板工程和国际典范,然而正是逐渐失控的微生物病害导致古坟解体搬迁至异地保护,复杂的人为介入手段是否有助于墓葬壁画的原址保护,值得更进一步探讨和反思。本研究回顾了高松冢古坟自发掘至今的保护历程,重点总结了侵害古坟石室及壁画微生物类群的调查分析及其防治措施的研究。通过对古坟病害微生物群落特征、环境因素变化及防治干预措施等方面相关文献资料的全面梳理和解读,客观评价了该遗址所取得的研究进展及经验教训,为我国乃至世界其他同类环境中壁画保护提供启示与借鉴。

## Review of microbial deterioration and control of Takamatsuzuka Tumulus, Japan

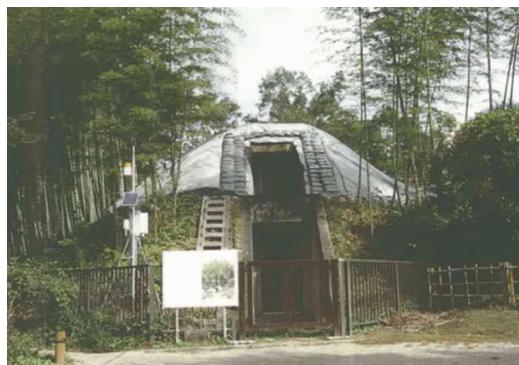
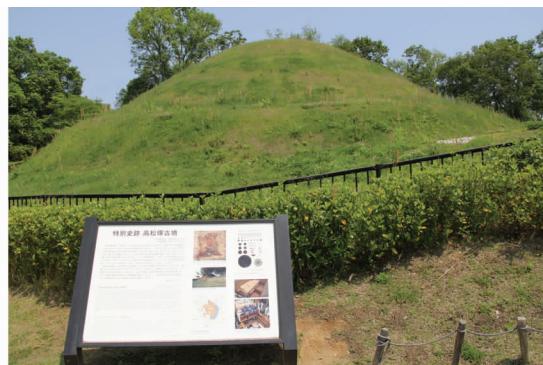
图 1 高松冢古坟丘部全貌

究所开展紧急文物调查时发现了古坟<sup>[1-2]</sup>。古坟建造于飞鸟时代末期(藤原京时期 694 年—710 年,相当于我国盛唐时期),周边有钦明陵、天武·持统陵、文武陵等。古坟呈馒头形,底部直径约 18 m,高约 5 m,系版筑夯土。古坟自发现便开展了一系列研究和原址保护工作,遗憾的是最终解体搬迁异地保护(图 1)。

(a) 解体前

(b) 解体后

**Fig. 1** View of the whole Takamatsuzuka Tumulus before and after dismantlement

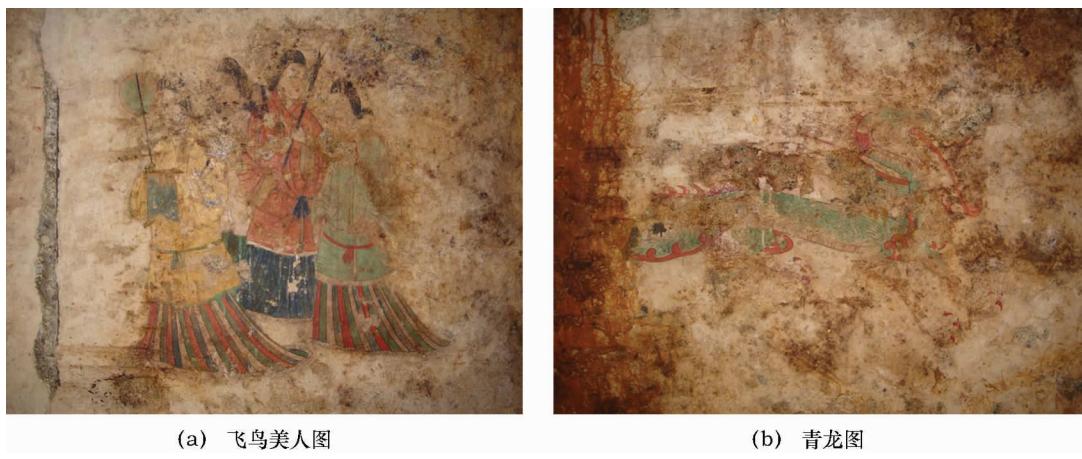
图2 高松冢古坟内壁画

1972年3月21日,开启石室后发现珍贵壁画。石室系横穴式石椁,由凝灰岩石块堆砌而成,内部南北纵深26.55 cm,东西横宽104.5 cm,上下高113.4 cm。石室内壁画绘制于灰泥层上,数厘米厚,其艺术风格与陪葬于唐高宗乾陵的永泰公主墓壁画相似,画面由飞鸟美人图、星宿图以及四神图等内容组成(图2)。壁画色彩富丽,线条精致,与之前在日本熊本、大分、福冈等地发现的粗犷简约的壁画不同,为二战后日本考古界最大发现,为研究唐代中日文化交流提供了重要资料<sup>[3-4]</sup>。日本政府在石室开

**Fig. 2** Wall painting images named Asuka Beauty and Dragon of Takamatsuzuka Tumulus

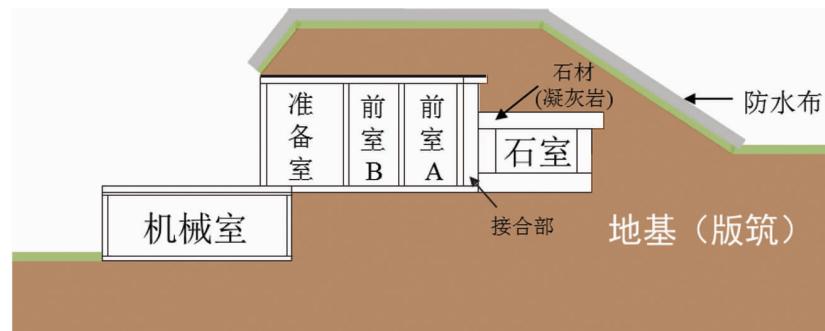
图3 设置保存设施后的高松冢古坟结构图

高松冢古坟曾在公元12或13世纪遭过盗掘。考古人员1972年从原盗洞向里挖掘发现壁画后,日本文化厅随即邀请法国和意大利的专家对古坟的保护方案和修复方法进行了探讨研究,最终决定原址保护。维持石室内温度、湿度相对稳定成为重点工作,在古坟石室前相继建立了前室A、前室B、准备室和机械室,并将盗洞口作为石室的出入口(图3)。为恢复和维持石室考古发掘前的原始环境条件,1974—1976年在石室南侧增设了温度、湿度控制设备。

**Fig. 3** Structure diagram of Takamatsu Tumulus after installation of preservation facilities

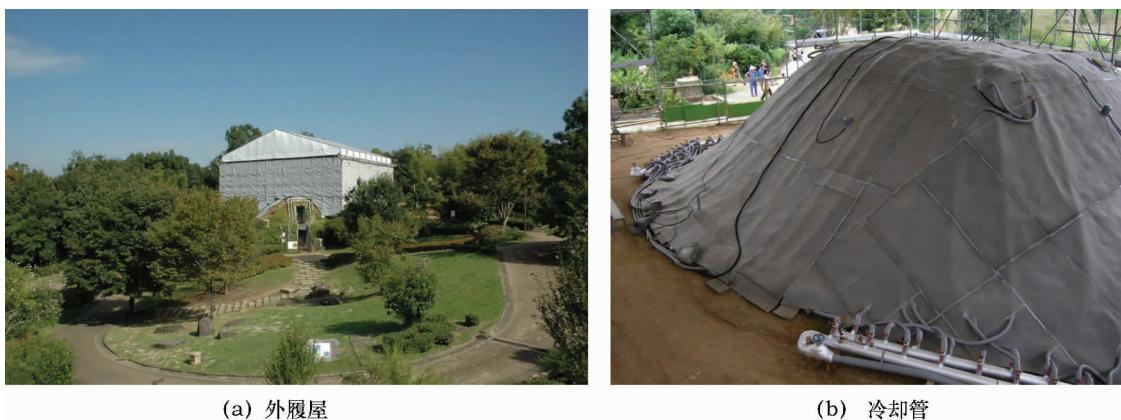
图4 高松冢古坟封土堆降温措施

关于2000年后石室壁画霉菌大爆发的原因,有专家认为是坟丘上方附生植被改变造成的,建议铲除坟丘上的竹林和榉树林。2003年9~10月,清除了坟丘上部植被,并铺设防水布,这一举措虽然有效控制了坟丘部的浸水问题,但造成了石室内温度的上升<sup>[20,35]</sup>。2004年9月,清除了坟丘下方植被,并撤去防水布,架设覆屋(图4a)。在覆屋替换防水布后,石室温度逐渐下降,证明覆屋有遮蔽阳光和降低温度的效果<sup>[35,44]</sup>。

在未安装冷却管之前,石室温度曾达20℃,造成霉菌大量繁殖。2005年9月古坟的冷却管安装完毕并实施紧急冷却对策,石室温度控制在10℃,有效防止了壁画表面的干燥和结露,为之后石室解体工作做准备<sup>[7,44]</sup>(图4b)。冷却管安装后一段时间,霉菌生长得到了抑制。2006年2月石室霉菌再次爆发<sup>[45]</sup>,表明目前人为介入的手段很难控制石室内微生态环境。也有研究通过模拟实验计算分析发现,用一定厚度的土壤覆盖暴露的石室对于控制石室温度增加和内表面干燥效果较好<sup>[43]</sup>。

**Fig. 4** Cooling measures of covering house and cooling pipe at the outside heap of Takamatsuzuka Tumulus
