VISIBLE AND THERMAL IR DOCUMENTATION OF A MASONRY BRICKWORK BUILDING

J.L. Lerma^a, C. Mileto^b, F. Vegas^b, M. Cabrelles^a

Figure 1. Country house

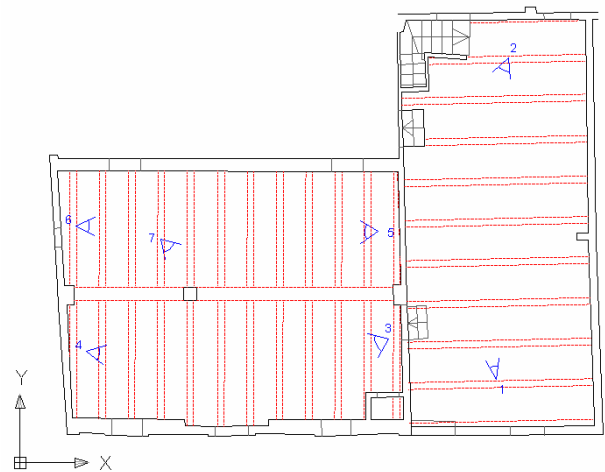
Figure 6. AutoCad drawing of the beams framing the first story. This cad images was built up after acquiring seven pairs of images (check angular symbols)

Next set of images was taken inside and empty room on the first storey in order to reflect the floor structure of regular beams. It was even possible to report beams by means of thickness. Fig. 5 shows one out of seven pairs of images (visible and thermal), used to build up a vector map about the structural analysis on this level (Fig. 6). For that purpose, visible images were rectified without control points by making use of a wooden square target and mosaiced to create a continuous raster image. In a similar way, thermal IR images were also rectified over the visible mosaic to overlay beams drawings (in AutoCad format).

It is interesting to notice how the heat transfer from the beams is transmitted outwards in a way that is hardly dependent on upper materials with small thickness (diameter smaller than 4 cm) such as bricks and plaster.
