*The Sichuan Earthquake: structural engineering
perspectives*

Ray KL Su

Post-Earthquake Field Study

29 June to 3 July 2008, a post-earthquake field investigation team comprising of the earthquake engineering researchers from The University of Hong Kong, The University of Melbourne and The Swinburne University of Technology visited the earthquake affected areas.

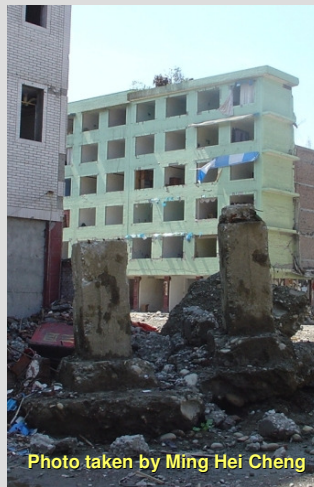
Settlement of columns

Typical column foundations
