Trends analysis of river bank erosion at Chandpur, Bangladesh: A remote sensing and GIS approach

ABSTRACT

Bangladesh which is mainly formed by alluvial deposits faces riverbank erosion very often due to regular shifting of river channels. The present study has undertaken to study the trends of riverbank erosion at Chandpur district. Landsat TM & MSS Satellite image from 1980-1990 and Google Earth high resolution satellite imagery from 2002-2010 were used to delineate the historical changes of the river especially to the left bank alignment of the river course. The study revealed that for long time this area has been suffering with the erosion problem and shifting characteristics of Meghna River. Analysis also showed that in the history of last thirty years erosion rate was higher in the decade of 1990 to 2002 than other two decades and about 3517 sq meter area was eroded. But in the recent interpretation results shows deposition is higher than erosion.

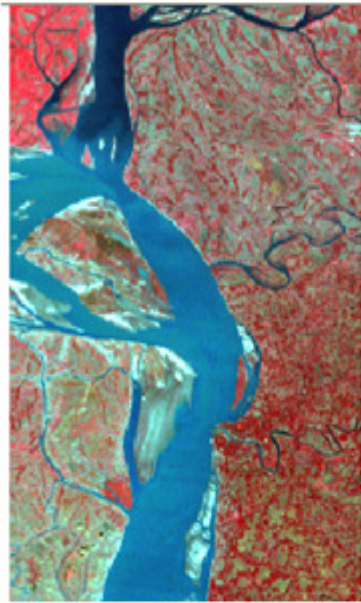
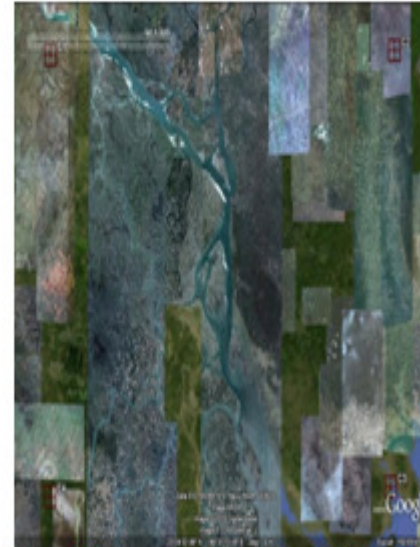
Plate A Landsat TM Image Acquisition
Date: 07-Jan-1990
Source: SPARSSO, Bangladesh

Plate B Landsat MSS Image Acquisition
Date: 05-Jan-1980
Source: SPARSSO, Bangladesh

Plate-C Google Earth-March 10, 2008

Plate-D Google Earth-May 04, 2010

Figure 2: Landsat MSS, Landsat TM and Google Earth satellite imagery of the study area from 1980-2010.

River bank line were derived, using certain precise zooming of pixel where bank line was demarcated and digitized accurately in between bank line and adjacent water features pixel. Geo-referenced Landsat TM and Landsat MSS were considered at the preliminary stage to delineate the river left bank line. All the satellite data were acquired on same dates, viz., 5 January 1980 and 7 January 1990, but at different times. Due to non-availability of recent satellite imagery after 1990 researchers choose the worldwide acceptable Google Earth high resolution satellite imagery to know the latest scenarios of the bank line displacements compare to the previous decade. Additionally, series of Google Earth high resolution satellite imagery on the basis of its availability (using historical imagery toolbar) were also acquired from 10 March 2002 to till 4 May 2010 at different times with different dates. For that Google earth latest 6.2v was used to acquire the satellite imagery. Among these, only four imageries are shown in Figure 2 with four different plates. Other relevant GIS ready map such as district, upazila and union level map of study area were used as ancillary data. The detail information of used maps and images for this study are listed in table 1.

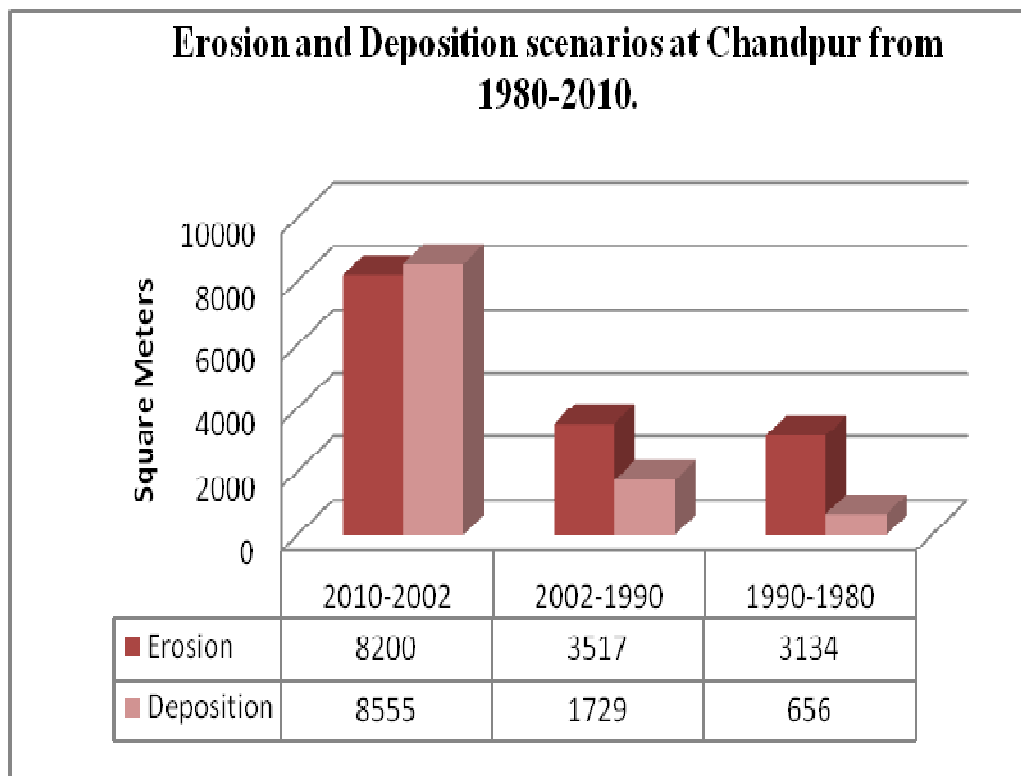
Figure 6: Erosion and deposition status at Chandpur from 1980-2010.

The above figure shows that erosion rate at Chandpur was higher (8200 sq meter) in the decade of 2010 to 2002 than other two decades and the average rate of erosion in this decade is 1025 sq meter/year. Whereas the decade 1980-1990 and 2002-2010 shows the average erosion rate is 313.4 sq.m/year and 1025 sq meter/year respectively. The area of deposition was 656 sq meter in 1980-1990 and but in recent decade (2002-2010) it is about 8555 sq meter (Figure 6).

The year wise data (last three decades) on erosion and deposition are calculated and showing in Graph (Figure 6) which has been constructed from these values (year vs. erosion area) to interpret the trends of river left bank erosion. The erosion and deposition bar diagram indicates increase in erosion in between 1980-1990 and 1990-2002 periods.
