Experiences with forest reclamation of settling basins after industrial processing of manganese ore and pyritic shales

P. Čermá k^1 , F. Fér²

J. FOR. SCI., 53, 2007 (11): 516–522

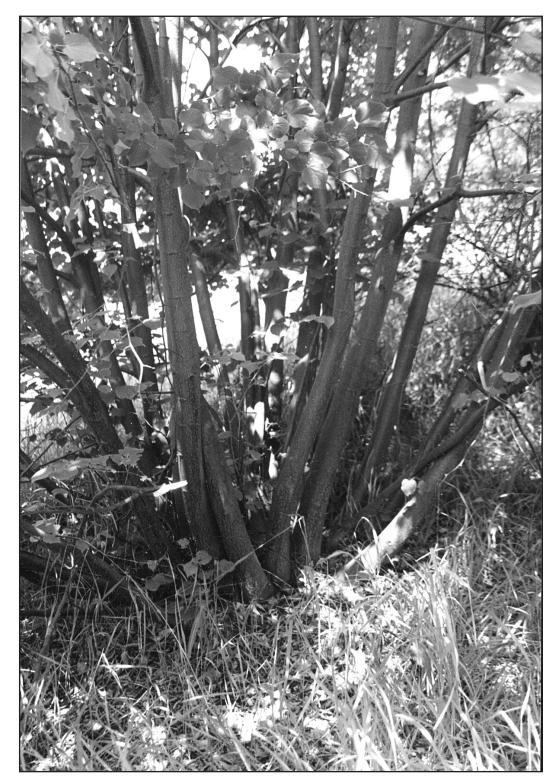
Fig. 1. Multiple trucks (*Tilia cordata* Mill.), frequent state of development also in *Betula verrucosa* Ehrh., *Acer pseudoplatanus* L., *Fraxinus excelsior* L., *Sorbus aucuparia* L.

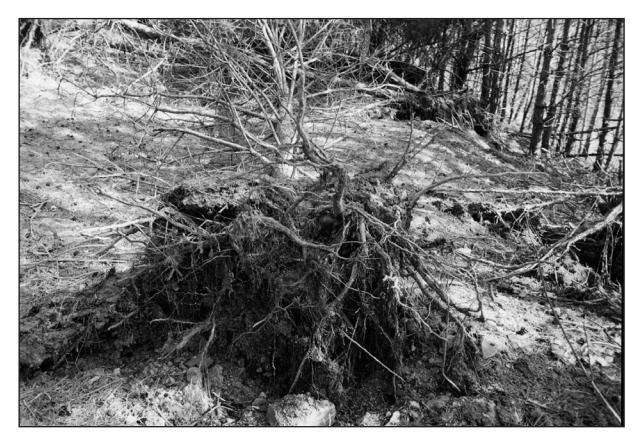
Fig. 2. The state of the root system of *Pinus sylvestris* L. in the slope part of dump (taproot – twin root is not developed)

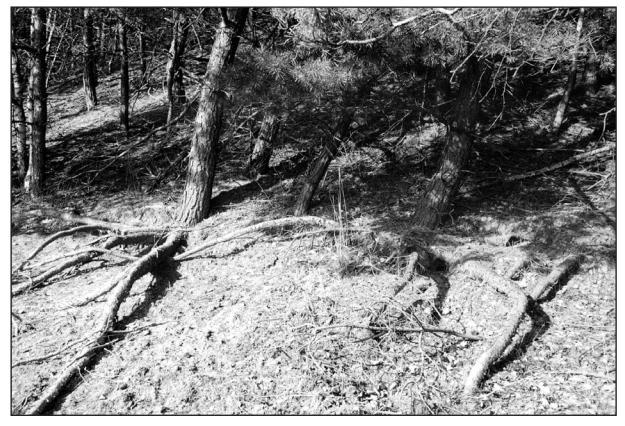
Fig. 3. The initial stage of *Pinus sylvestris* L. windfall (the static load of the set of horizontal roots is not in correlation with the developing aboveground part)

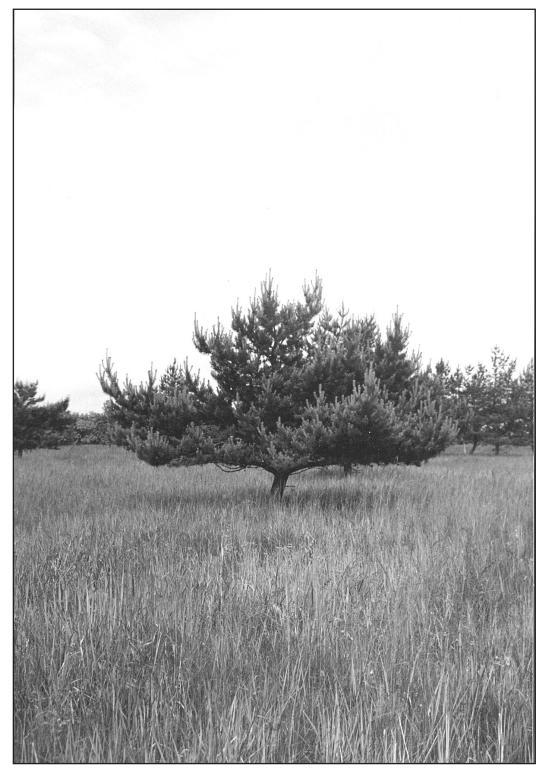
Fig. 4. Frequent developmental state in *Pinus sylvestris* L. (thickening of the basic part of stem, stagnation of height increment)

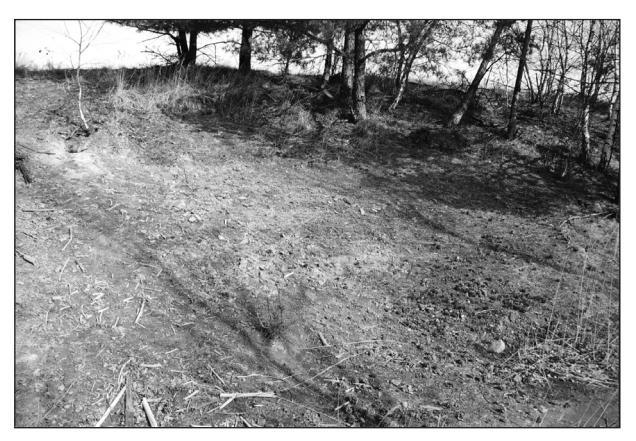
Fig. 5. The vegetation state characteristic of the dump surface damaged by water erosion with surface occurrence of deposited industrial waste
