*The Sichuan Earthquake: structural engineering
perspectives*

Ray KL Su

Post-Earthquake Field Study

29 June to 3 July 2008, a post-earthquake field investigation team comprising of the earthquake engineering researchers from The University of Hong Kong, The University of Melbourne and The Swinburne University of Technology visited the earthquake affected areas.

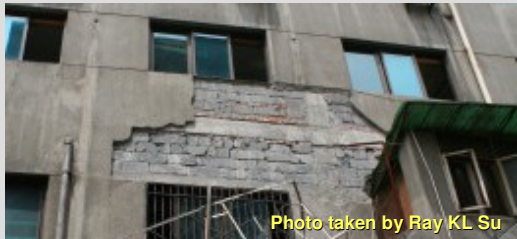
Quite serious damage to plasters and movement joints

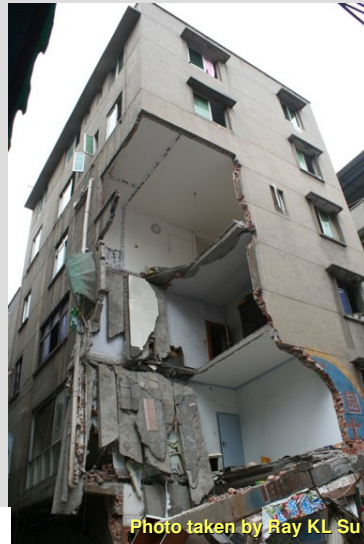
Partial collapse of a six storey building

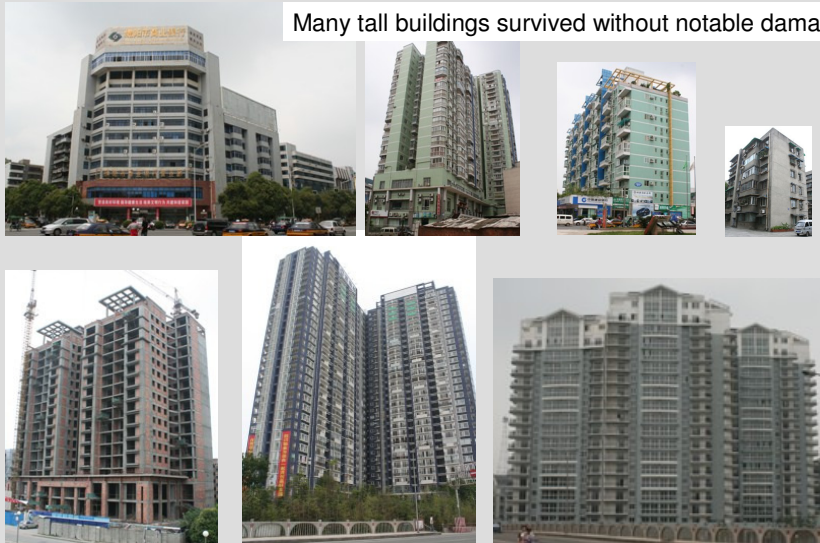
Many tall buildings survived without notable damage

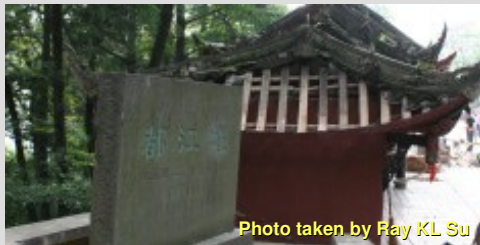
Serious damage
to an old timber
temple

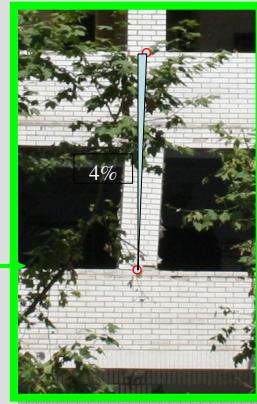
4% inter-storey drift ratio is too high for unreinforced masonry structures

- With the infill walls above the RC beams, the RC columns supporting the beams often failed first. (Strong columns weak beams difficult to implement)
- Unreinforced brick structures could partially collapse when the inter-storey drift ratio is higher than 4%.

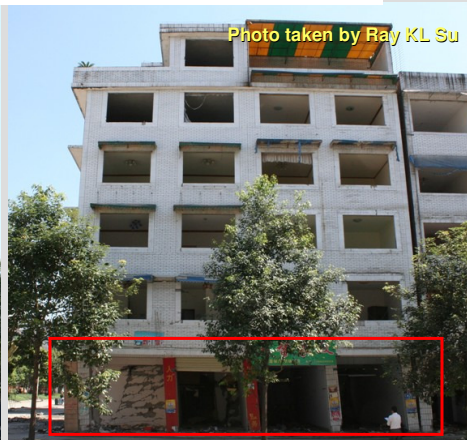
Front View

A 6-storey building with soft-storey damage but without collapse

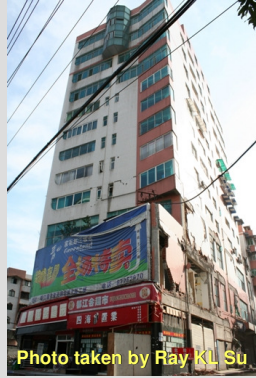
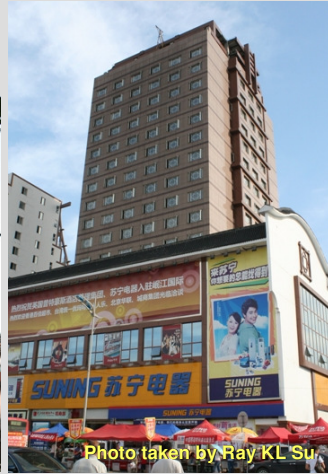
12 to 16 storey high-rise buildings with negligible damage

- All medium-rise buildings (>10 storeys) passed the earthquake attack.
- Low-rise brick buildings with precast slab failed badly under seismic load.
- A proper tie system (with internal and peripheral ties) and appropriate joint details should be provided for precast structures to improve their overall structural integrity.

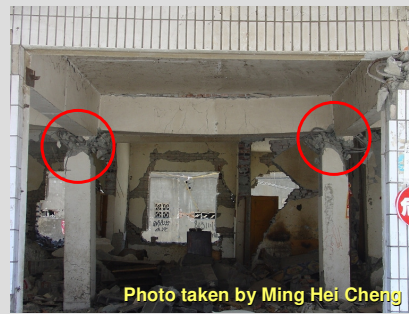
Beams failed in shear rather than bending, no formation of plastic hinge

- The RC beams supporting the infill walls usually failed in shear rather than bending.
- After a lot of damage to columns, significant amount of gravity load was transferred from columns to infill brick walls. (without infill wall, building would experience very large settlement)

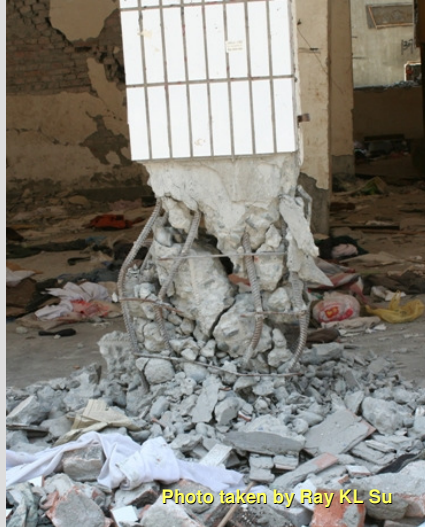
Columns failed in bending and axial load

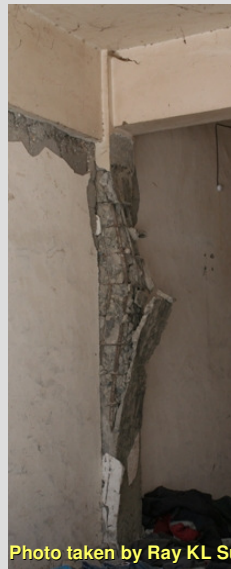
Columns failed in buckling

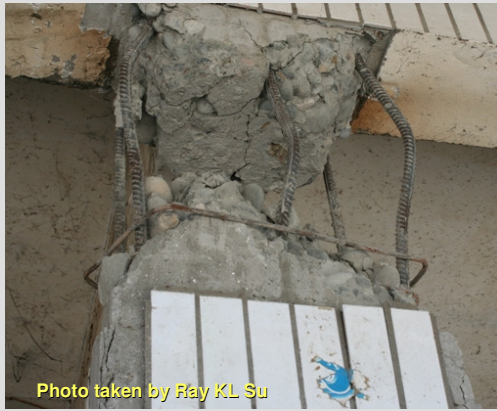
Column failure poor design or workmanship

Insufficient links

Poor compaction, too many coarse aggregates
